RESEARCH MEMORANDUM

TUFT STUDIES OF THE FLOW OVER A WING AT
FOUR ANGLES OF SWEEP

Gerald Hieser

July 10, 1947

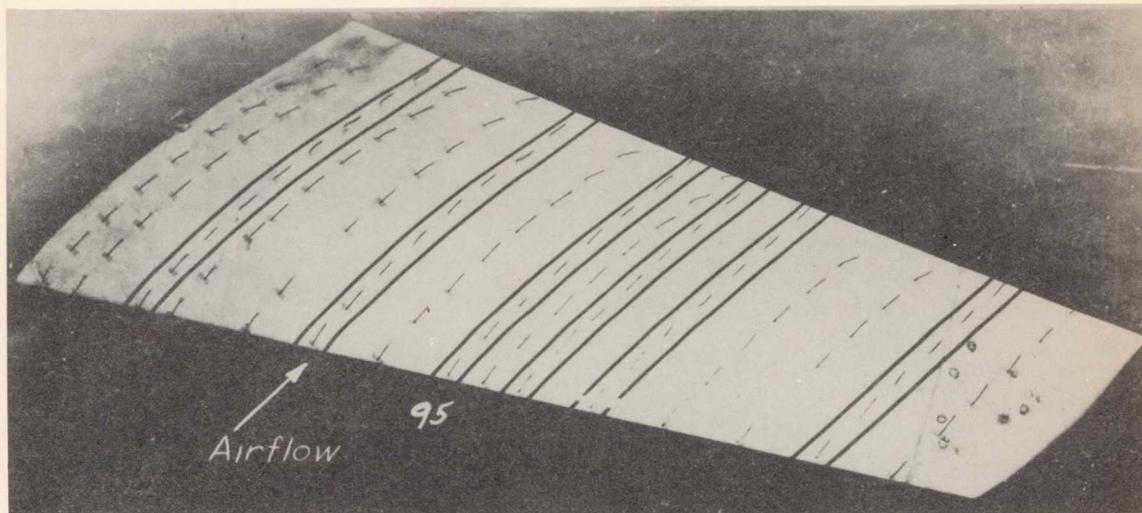
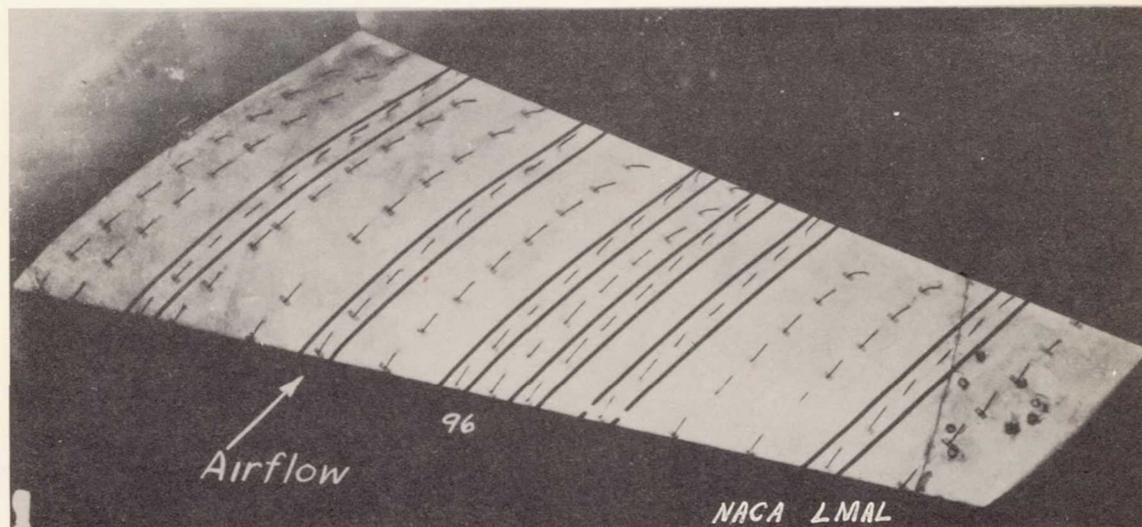
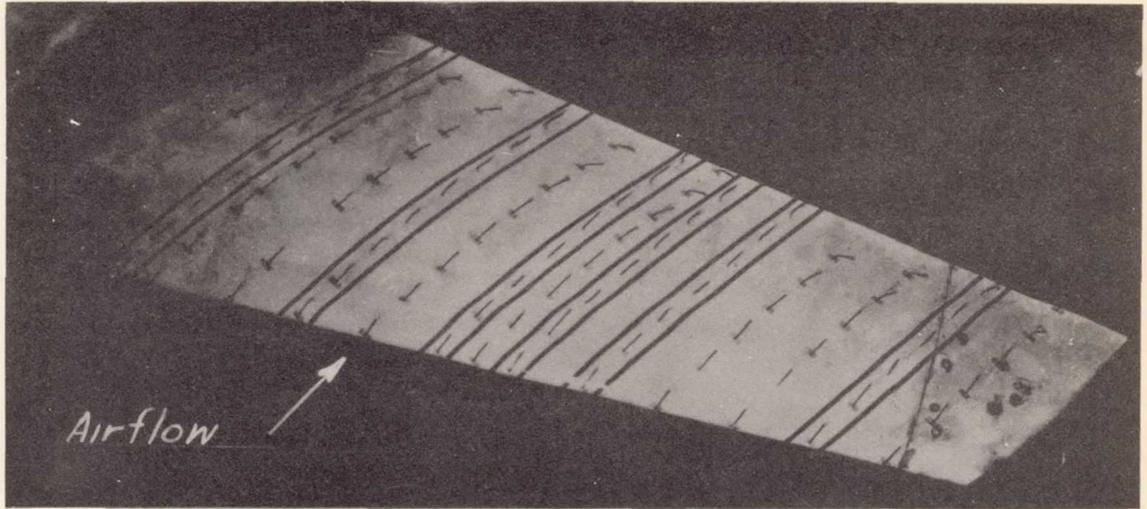
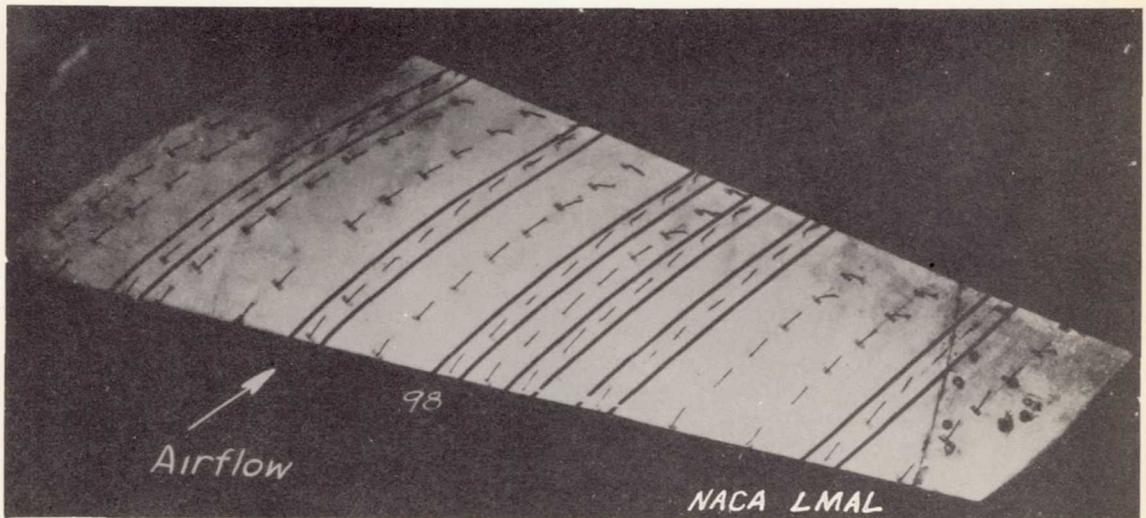
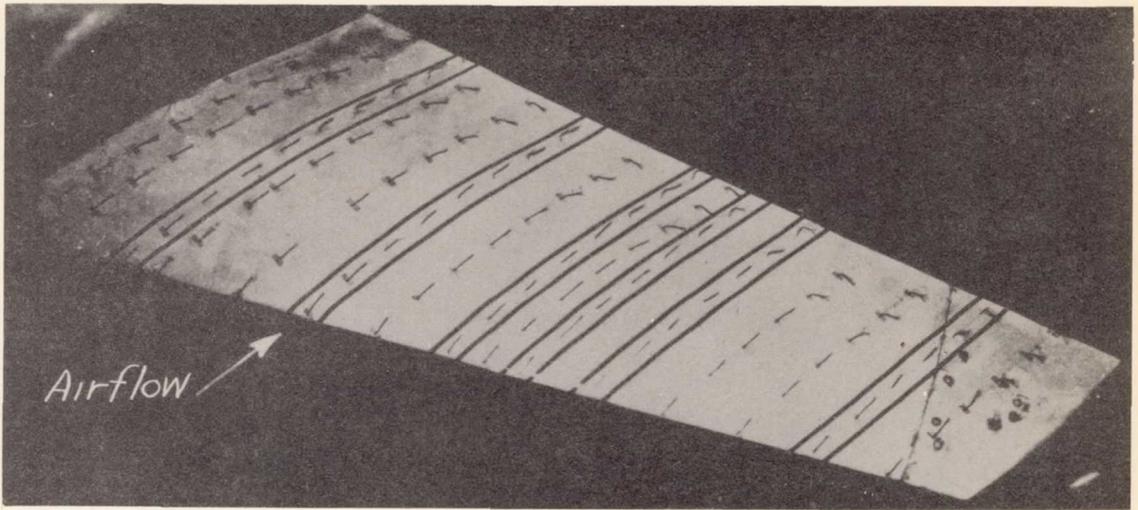
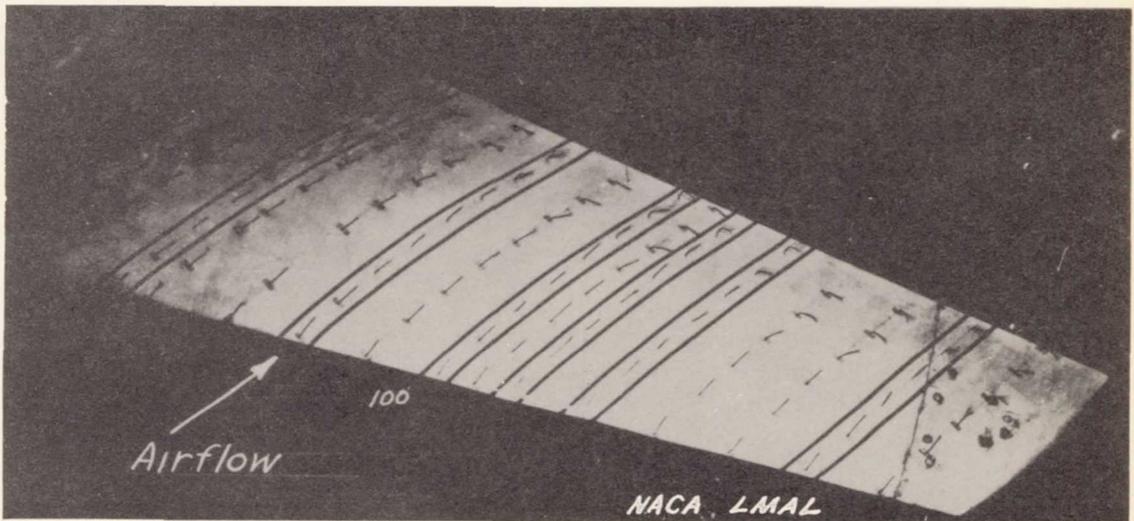
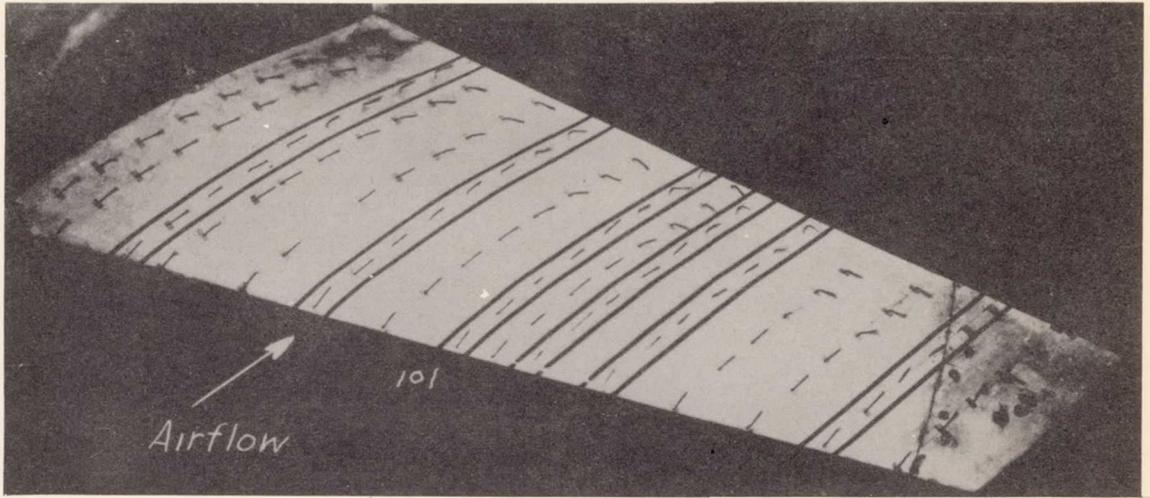
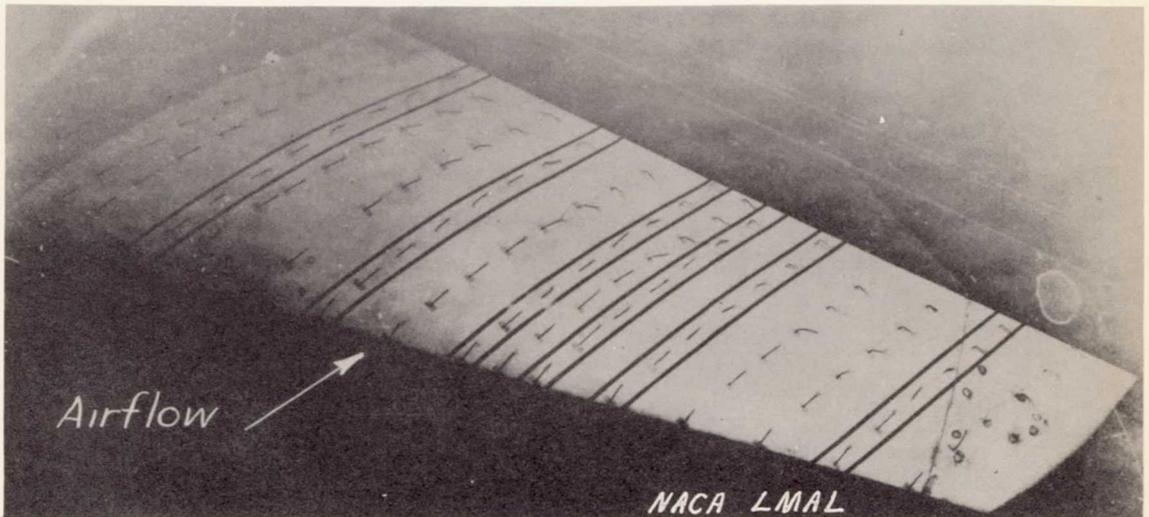
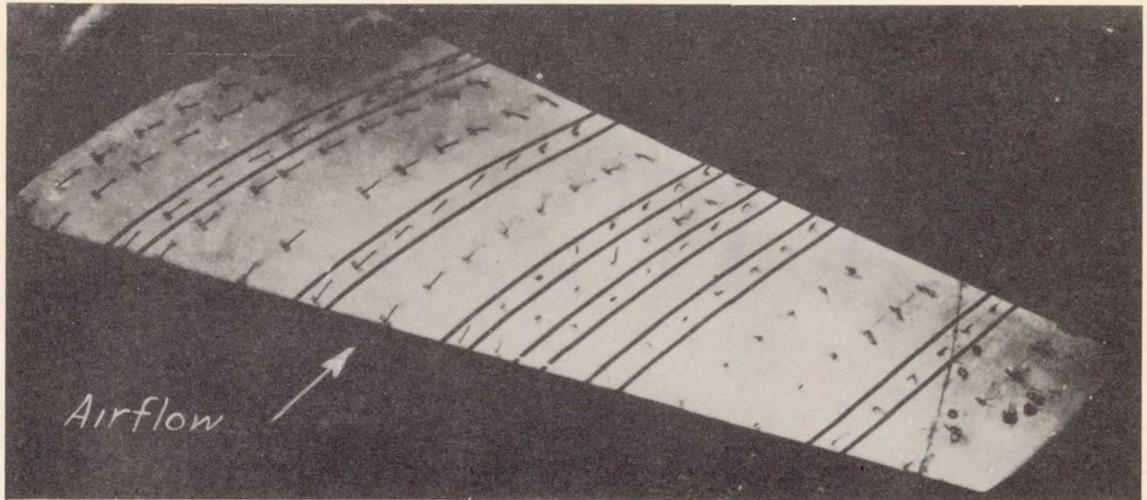
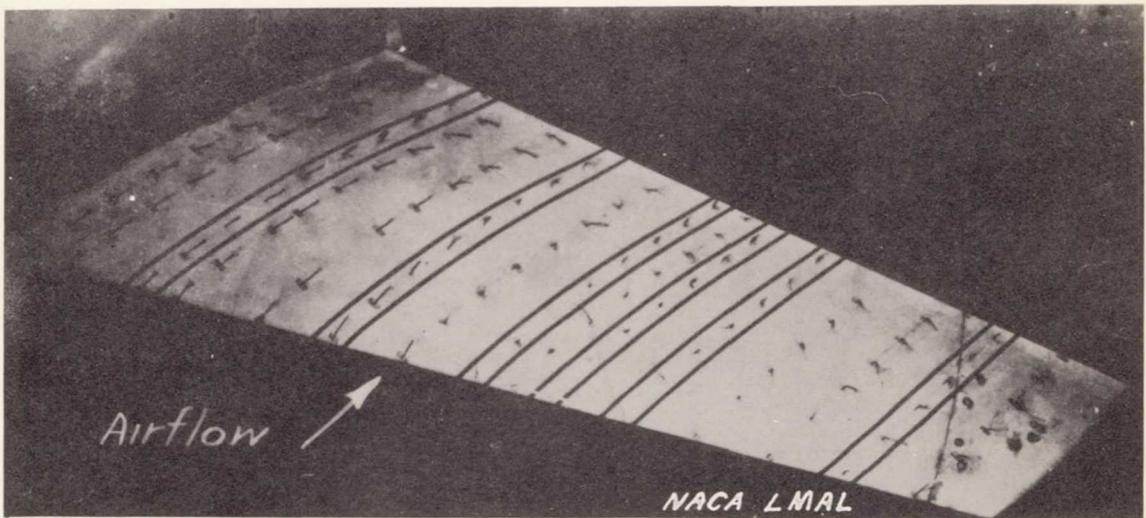
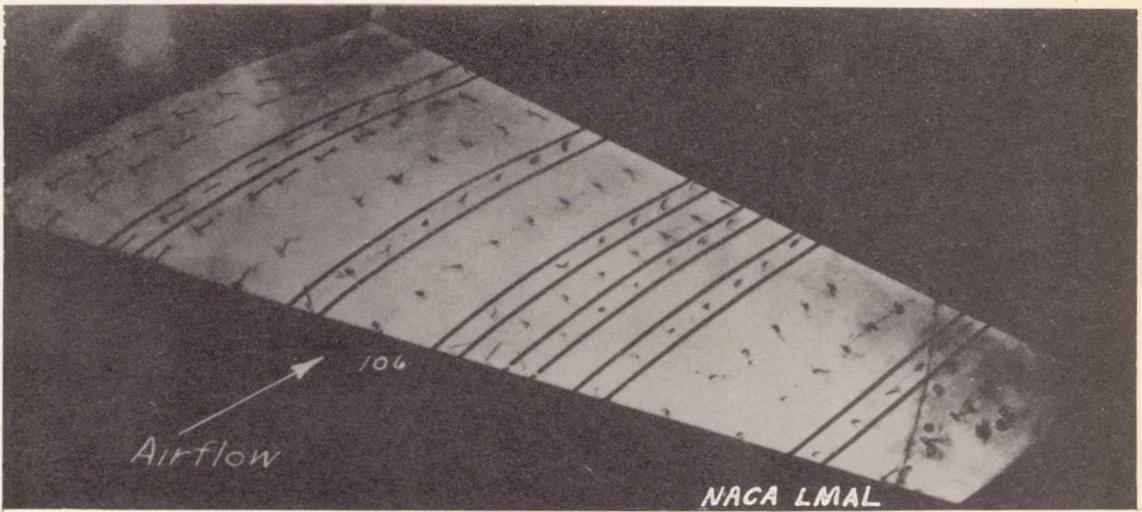
Figure 11.- Tuft patterns on a 65_2 -215 wing, $\Lambda = 30^\circ$, $M = 0.13$.

The patterns for 30° of sweep are presented in figures 11 and 12. In general, the progress of stall appeared similar to that of the 0° sweep configuration except that separation near the tip occurred earlier, and the spanwise flow along the rear portion of the wing was outward and more prominent. The tufts show a rapid transition of flow between 19° and 20° , denoting an abrupt stall.

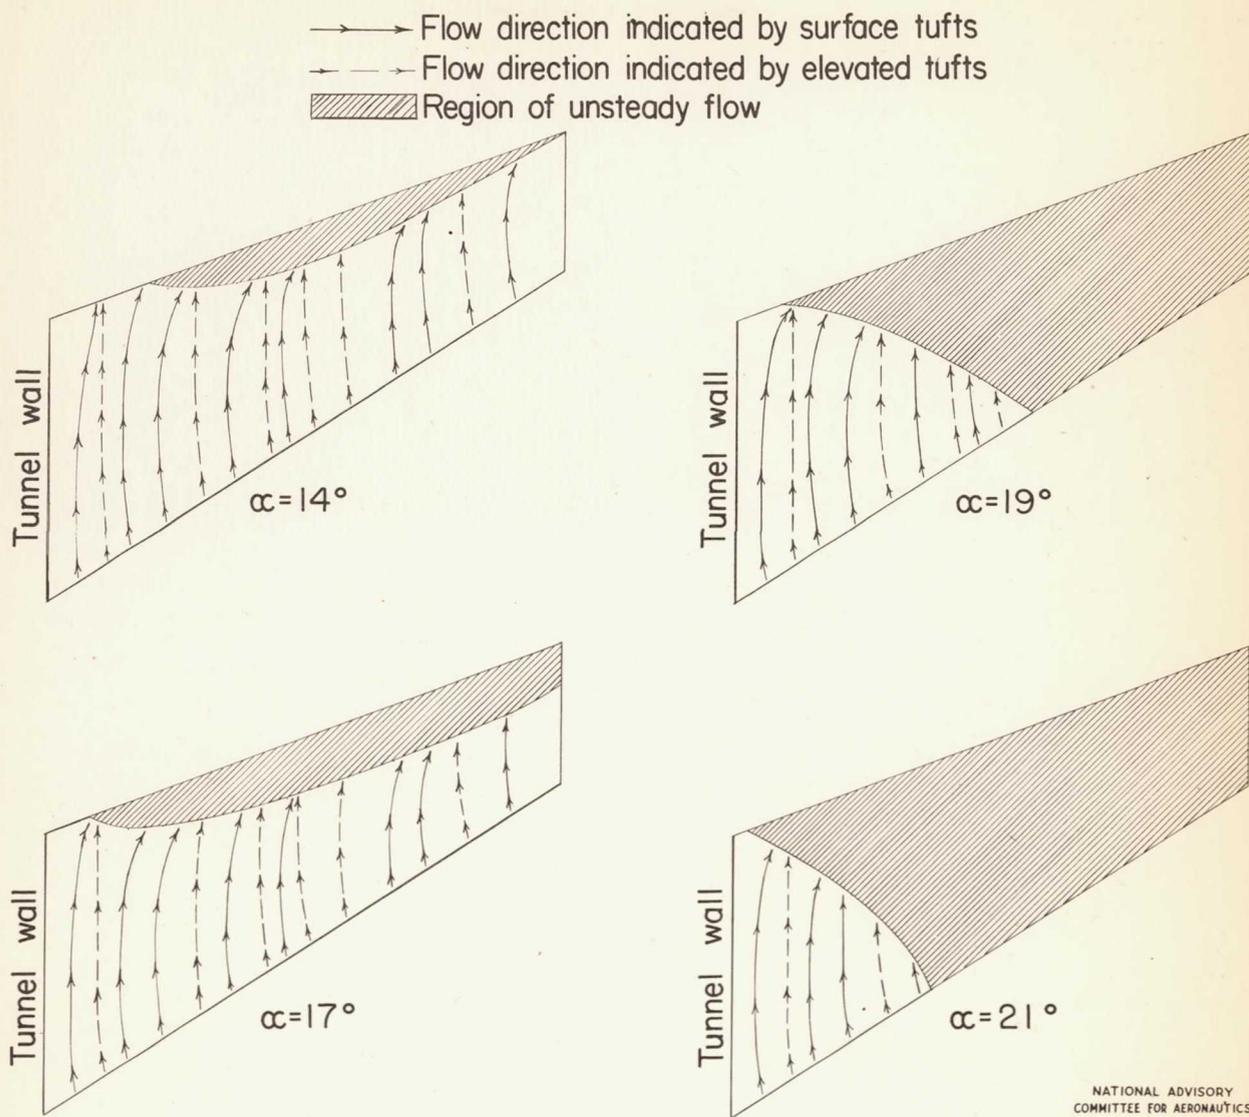
Figure 12.—Flow patterns indicated by tufts on a 65₂-215 wing at various angles of attack. $\Lambda = 30^\circ$. $M = .13$.

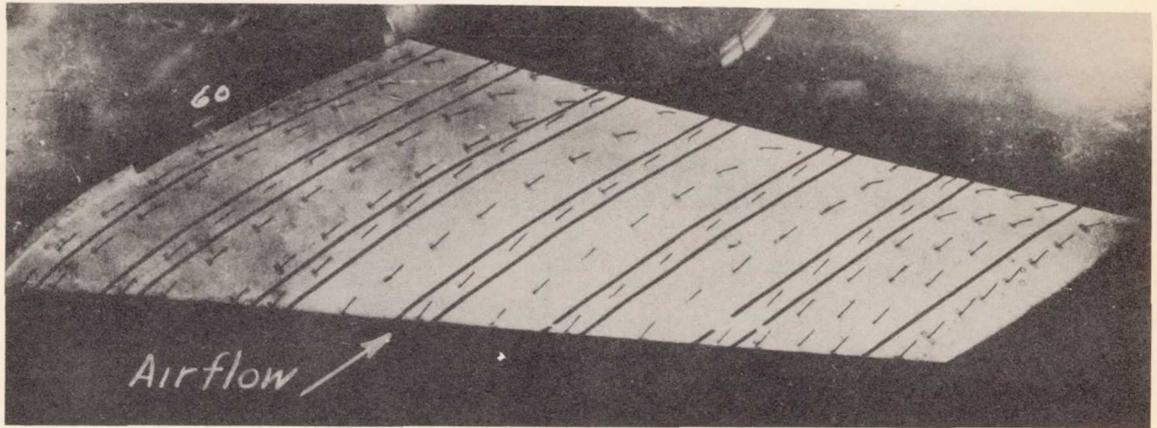
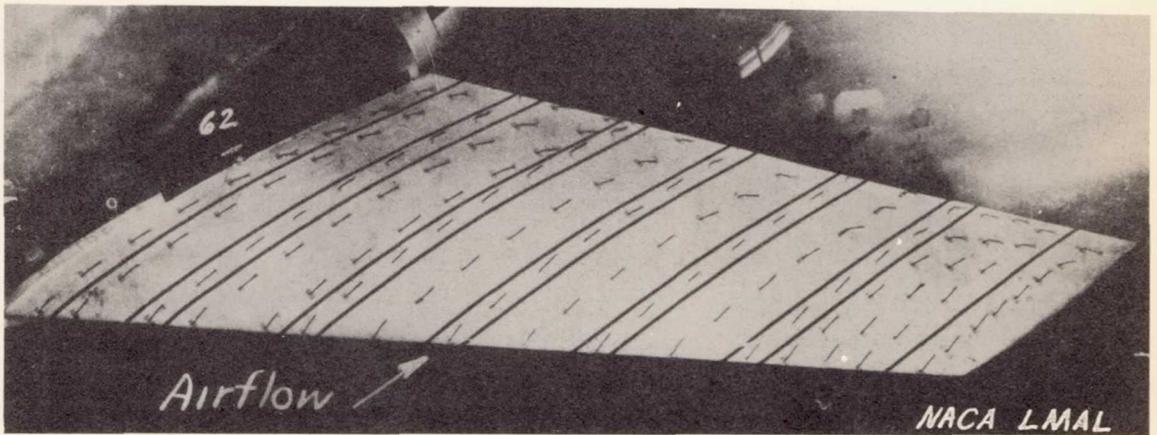
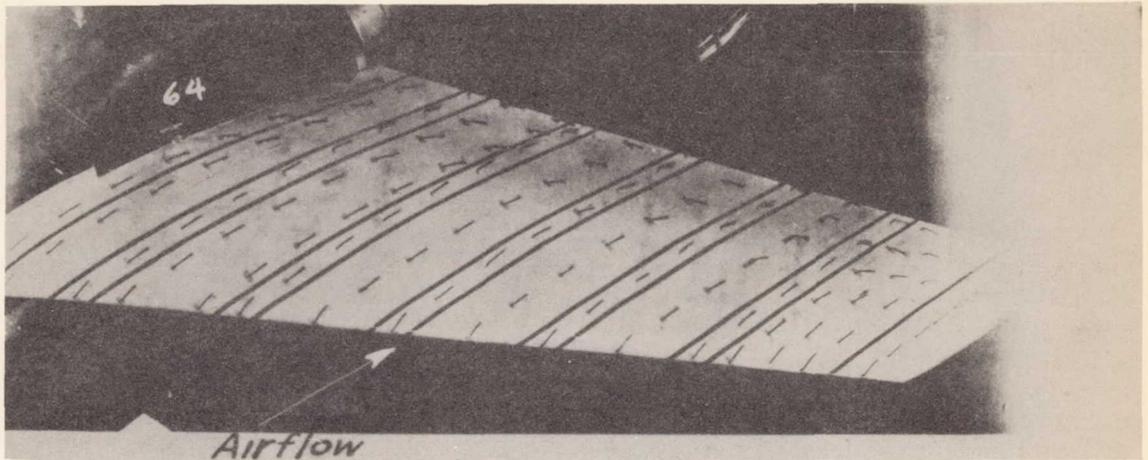
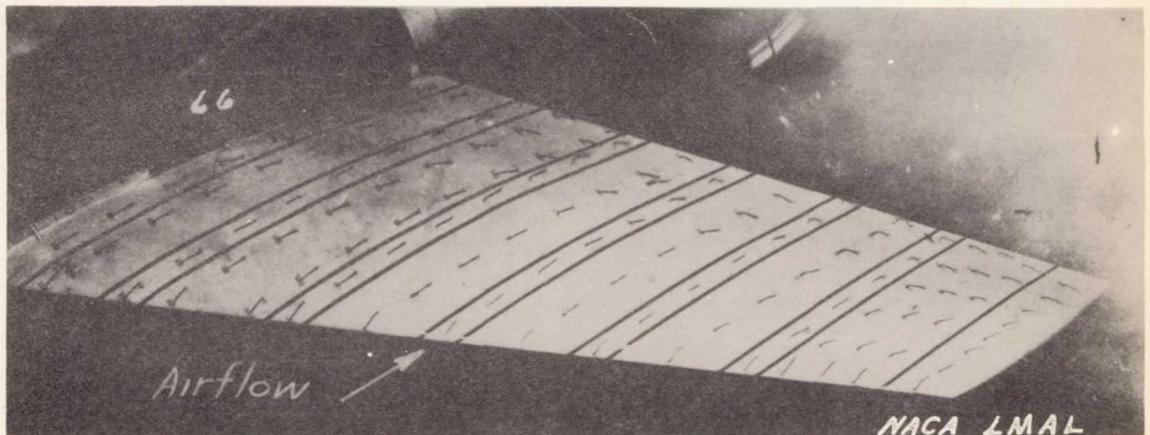
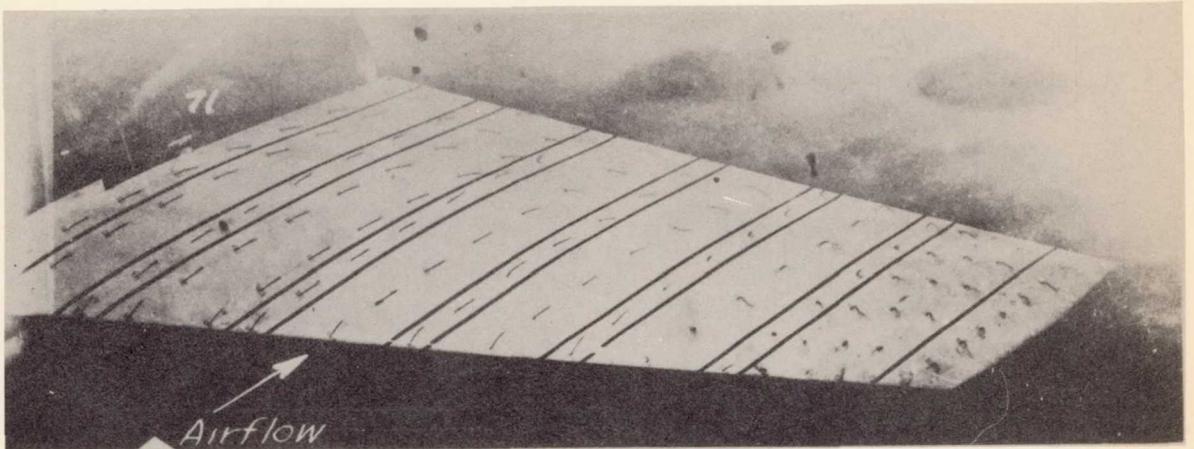
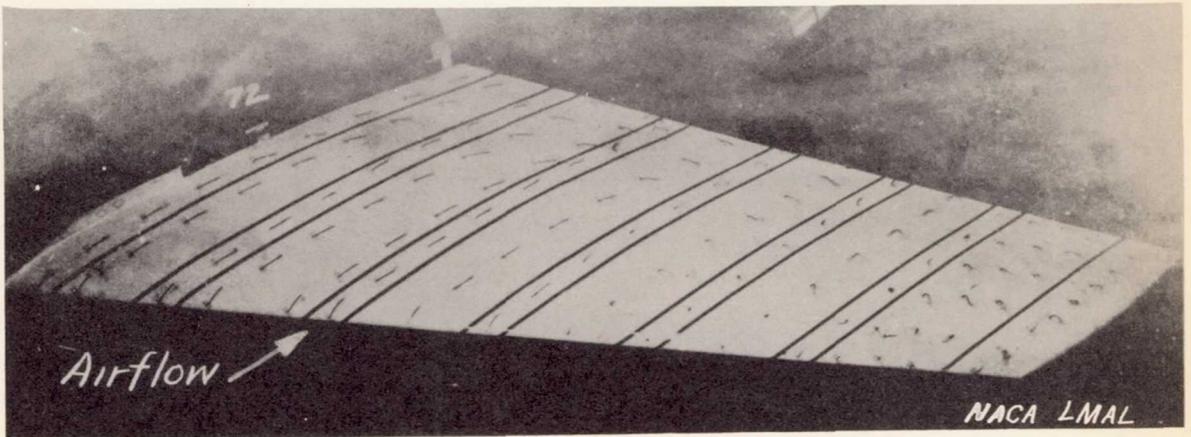
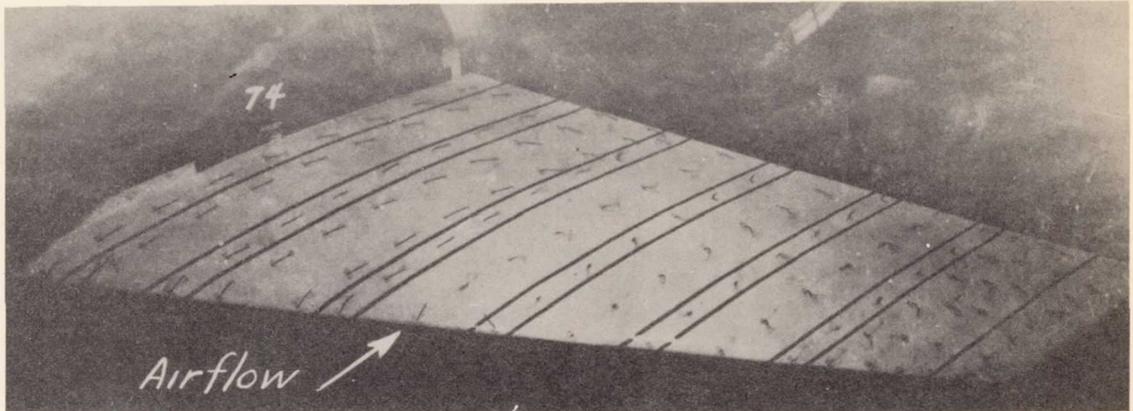
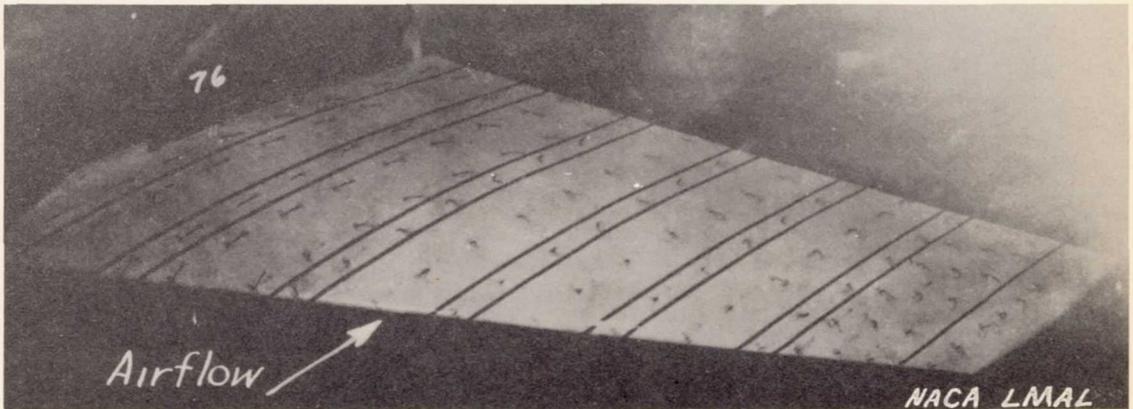
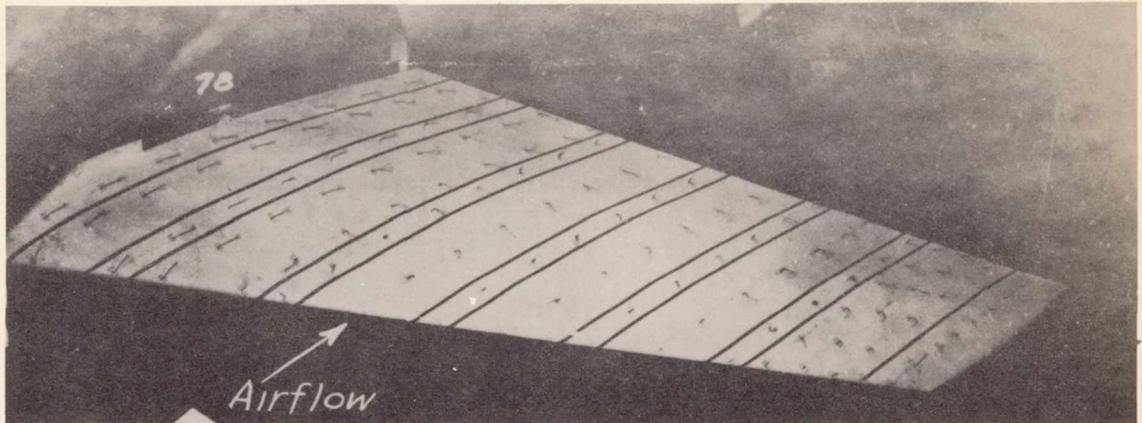
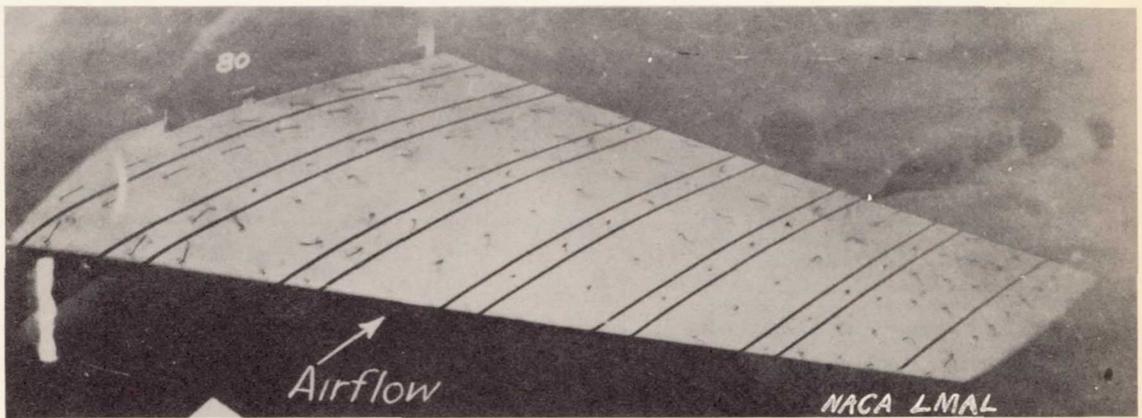
Figure 13.- Tuft patterns on a 65_2 -215 wing, $\Lambda = 45^{\circ}$, $M = 0.13$.

The tuft surveys for the 45° sweep configuration are shown in figures 13 and 14 for angles of attack through the stalling range. These figures show that the flow patterns were similar to those for 30° of sweep except that separation at the tip began at a lower angle of attack for the 45° sweep configuration. A rapid change in the flow characteristics over the outer portion of the wing between 18° and 19° is indicated, denoting that an abrupt stall occurred at the tip only. Above 19° the progress of separation was gradual and moved from the tip and trailing edge to the inboard and forward portions of the wing. No abrupt stall over the wing in general is indicated at angles of attack up to 28° .

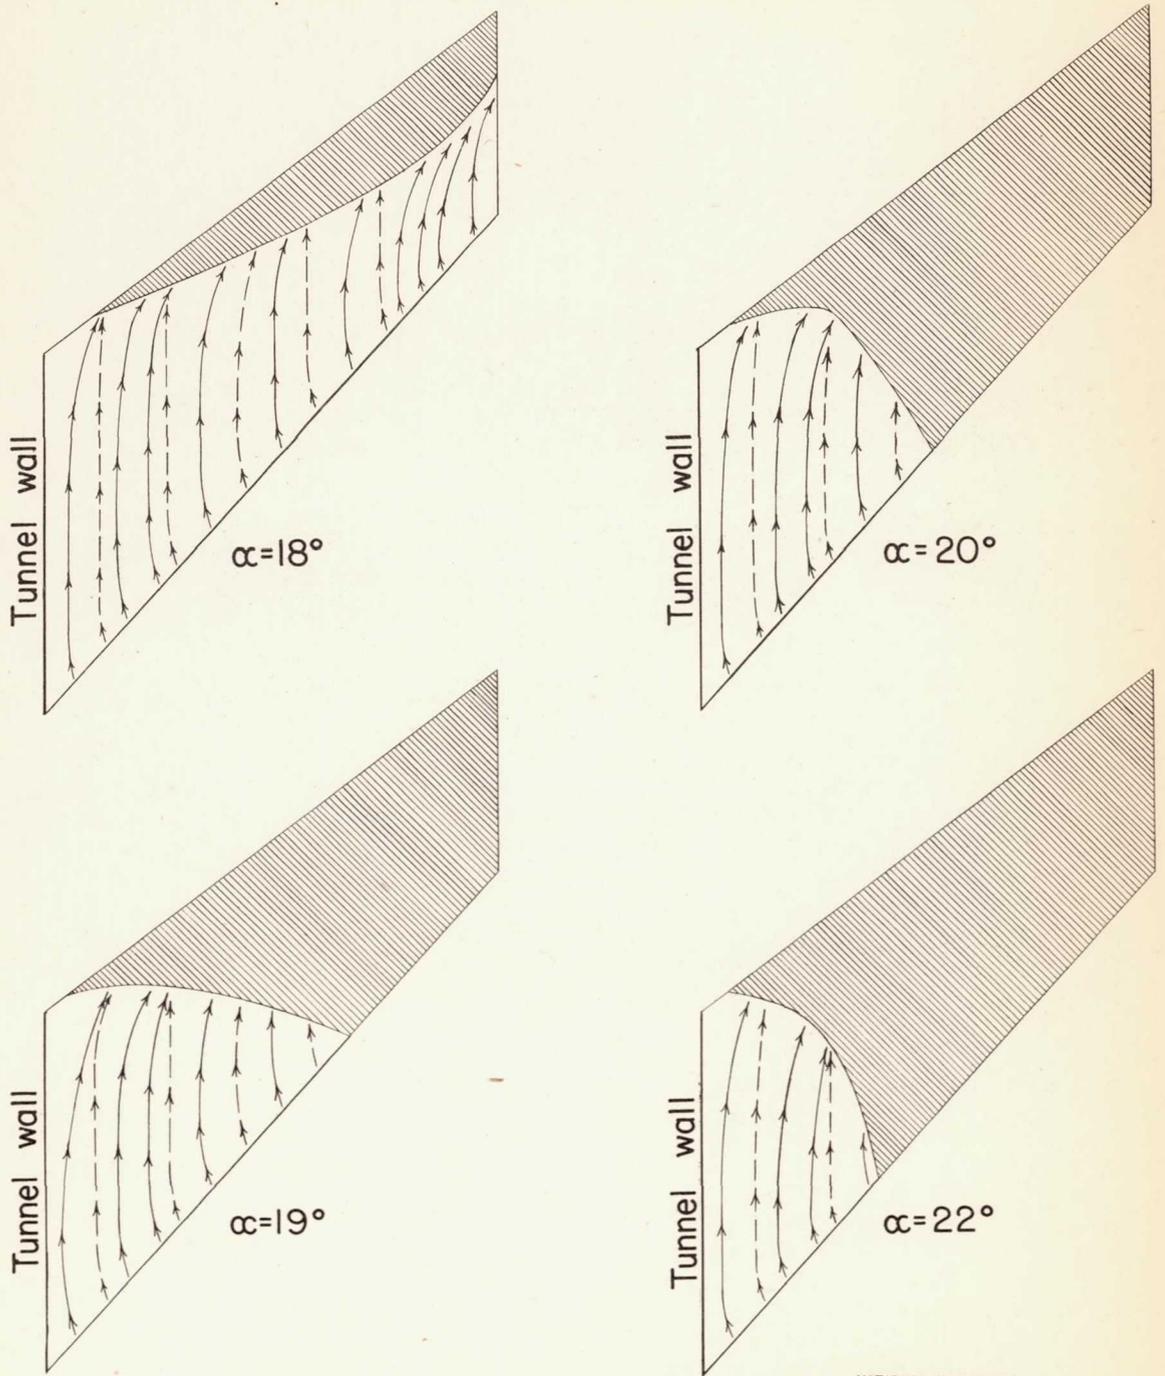
Figure 14.—Flow patterns indicated by tufts on a 65₂-215 wing at various angles of attack. $\Lambda = 45^\circ$. $M = .13$.

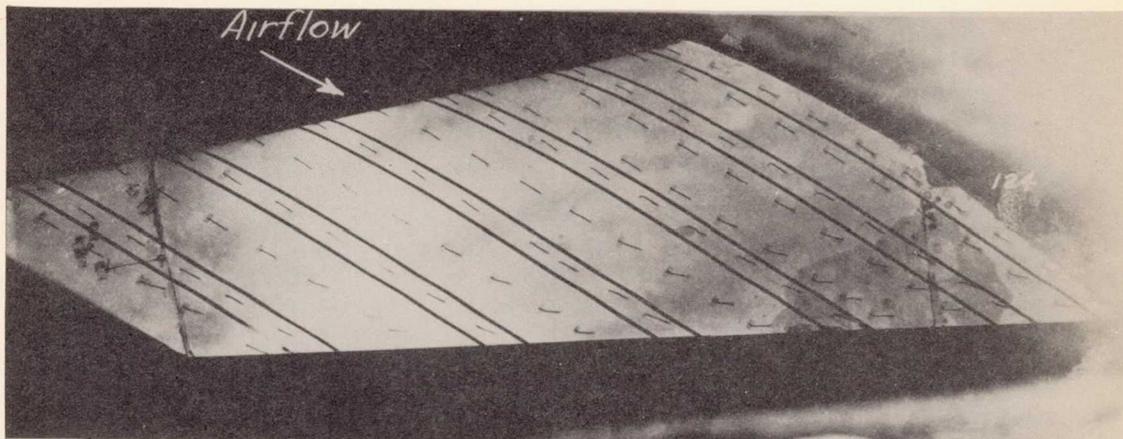
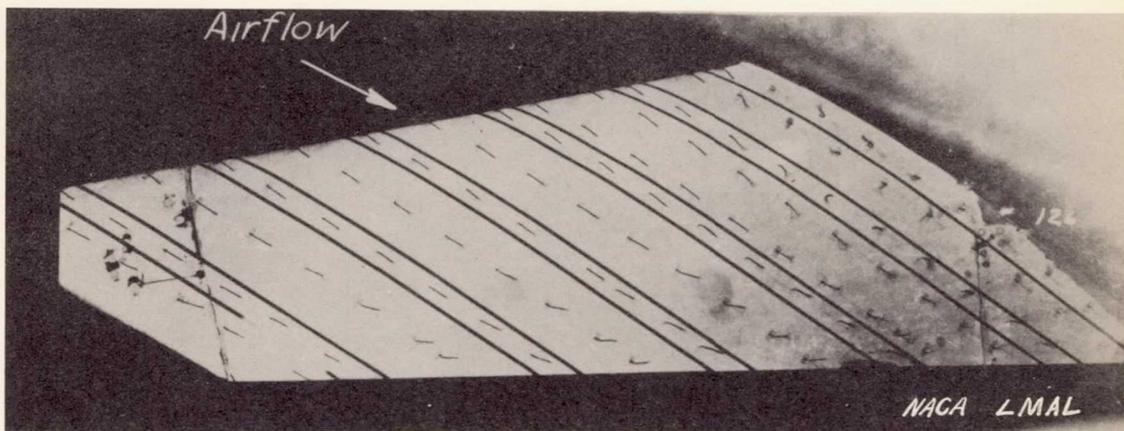
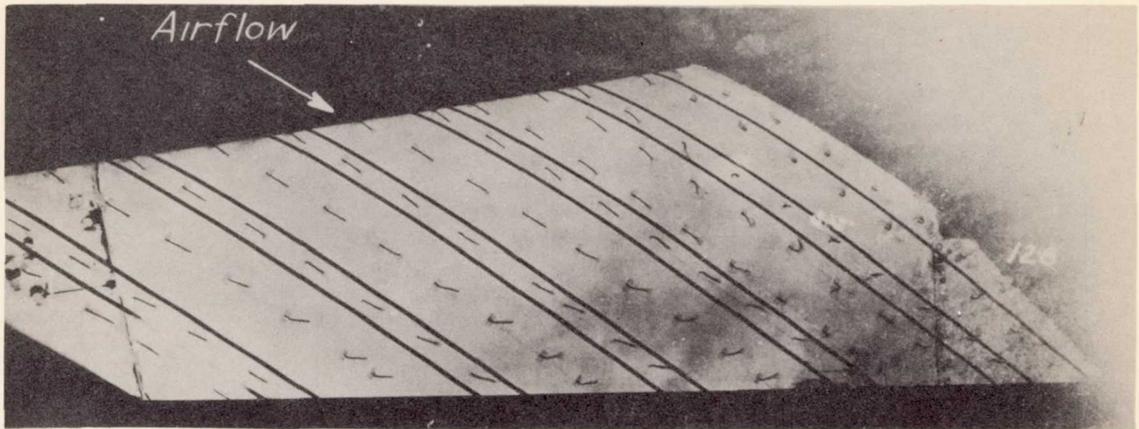
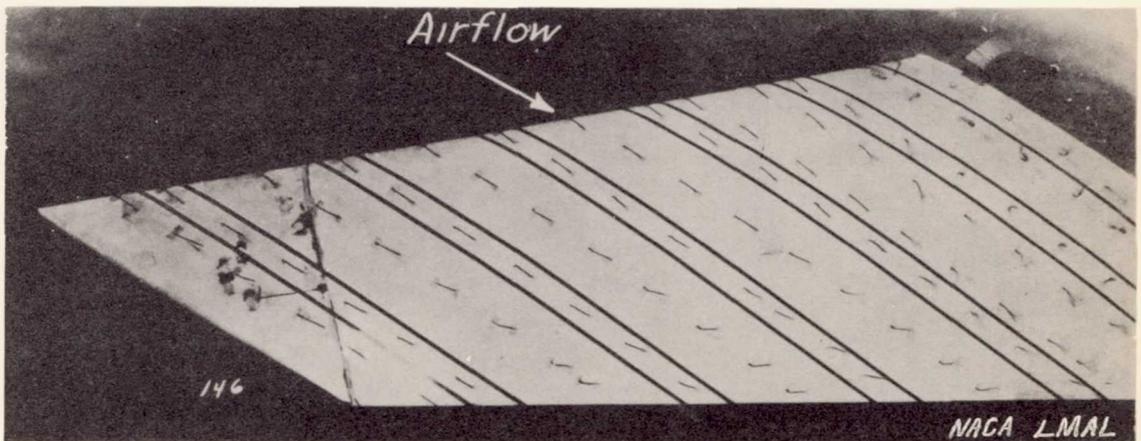
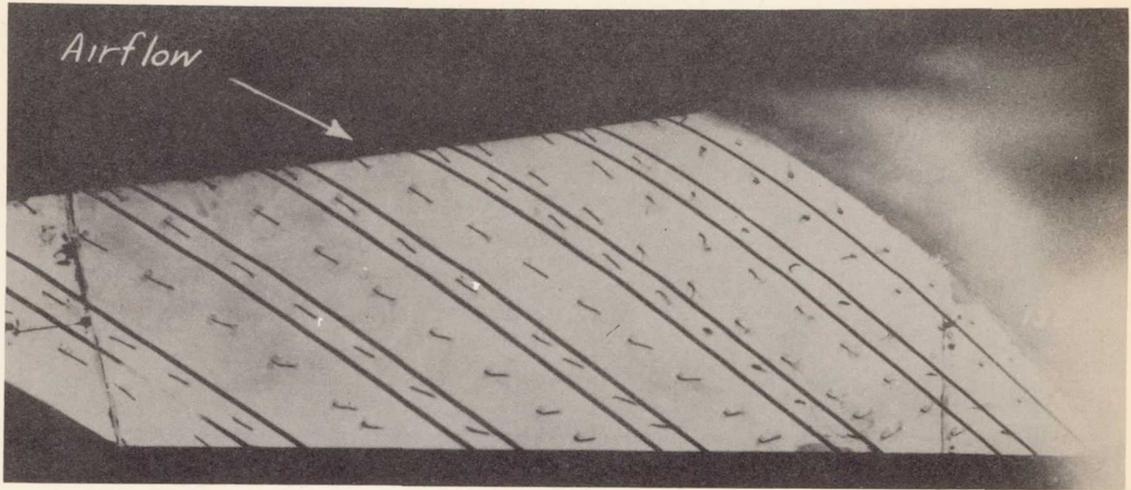
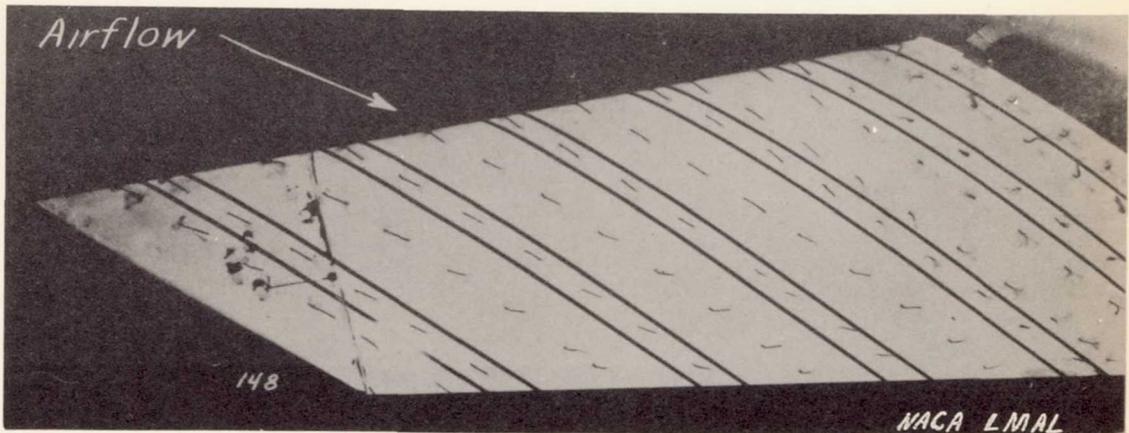
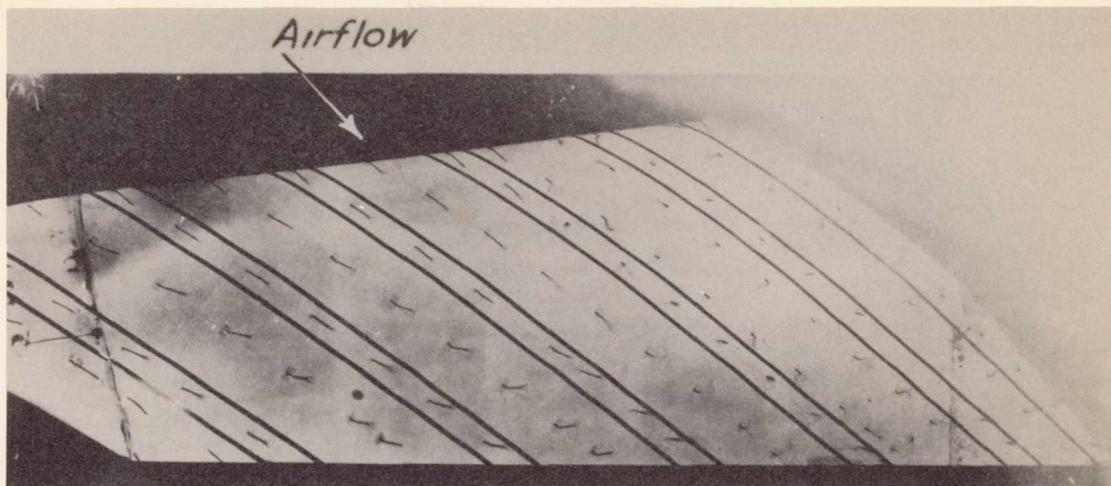
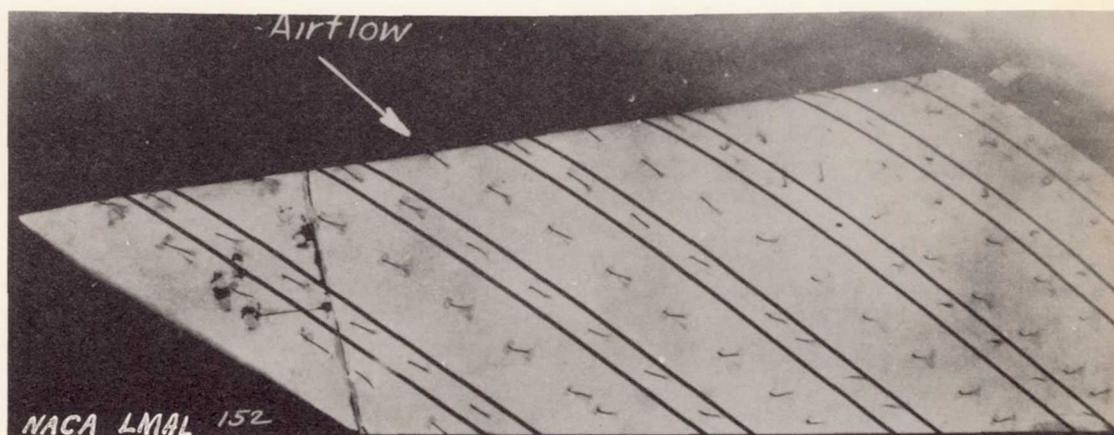
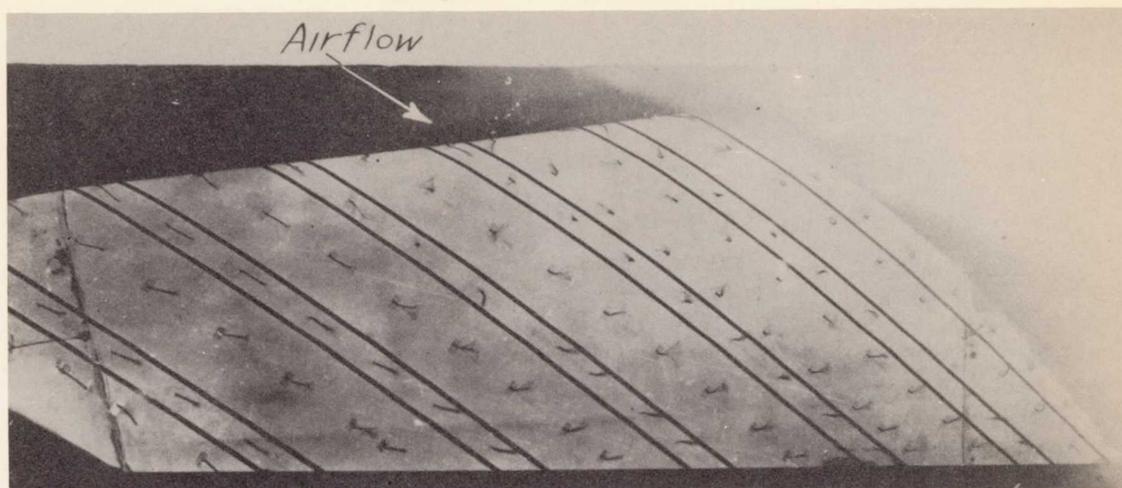
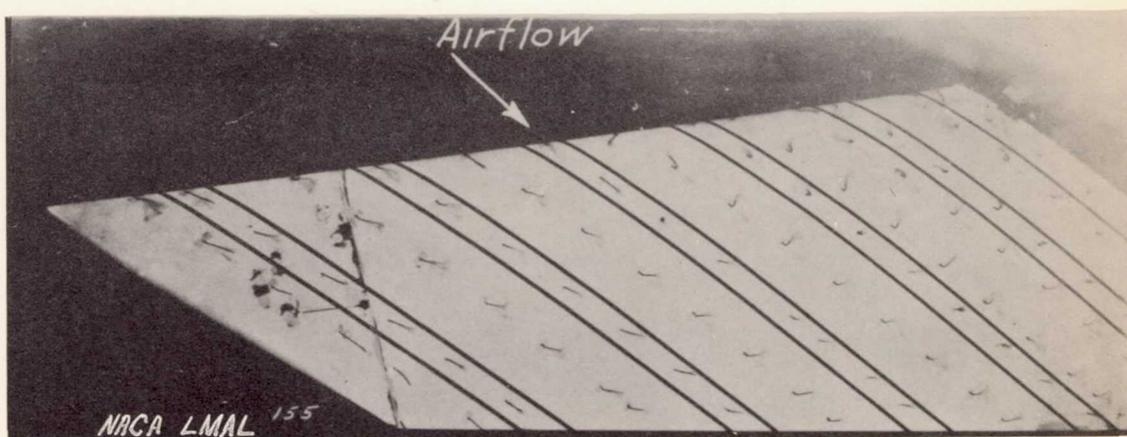
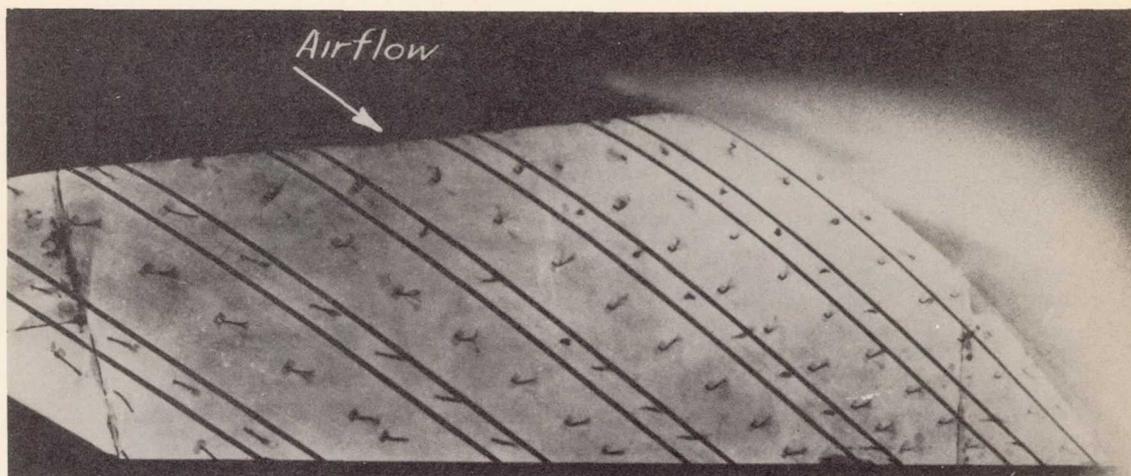
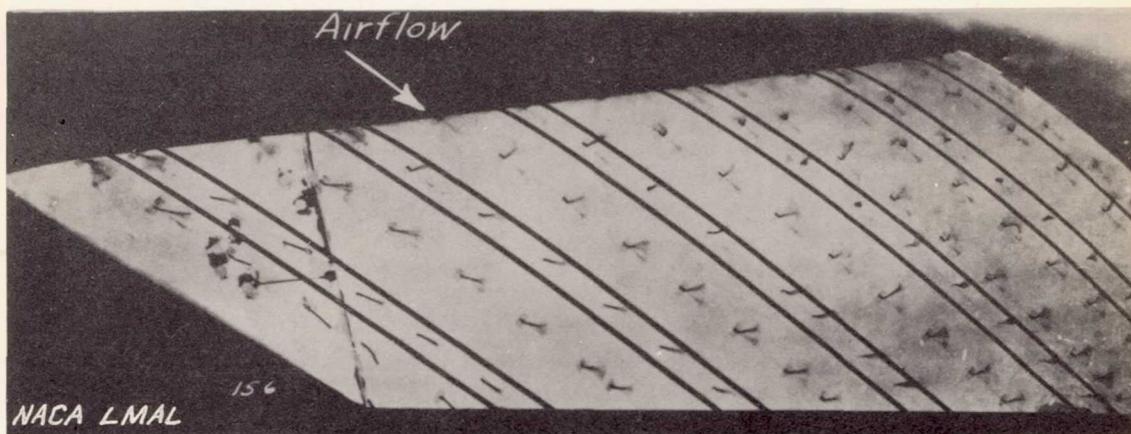
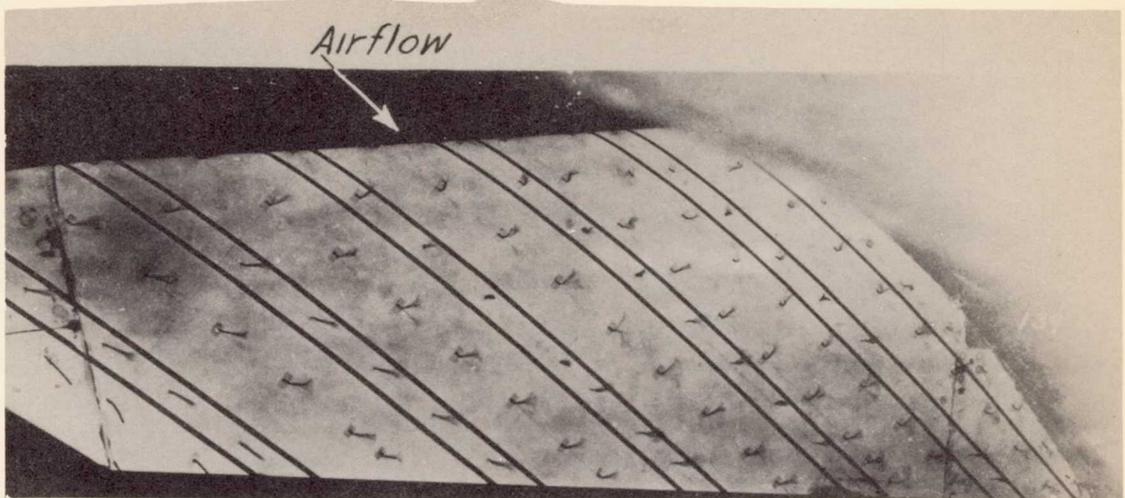
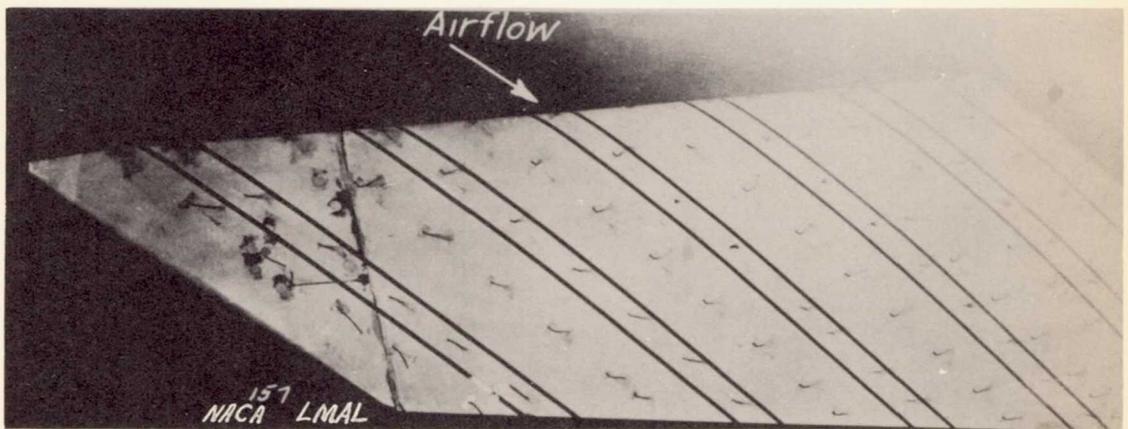
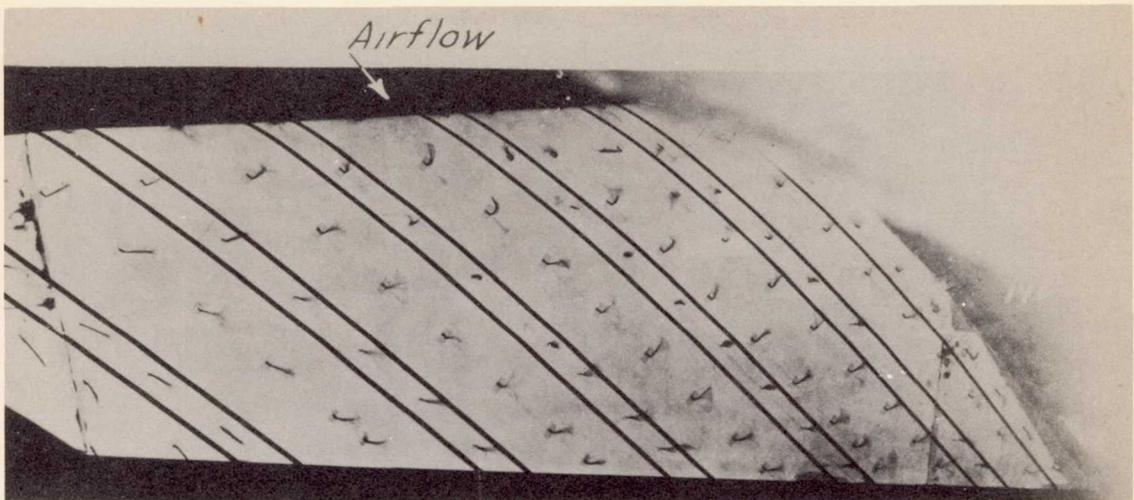
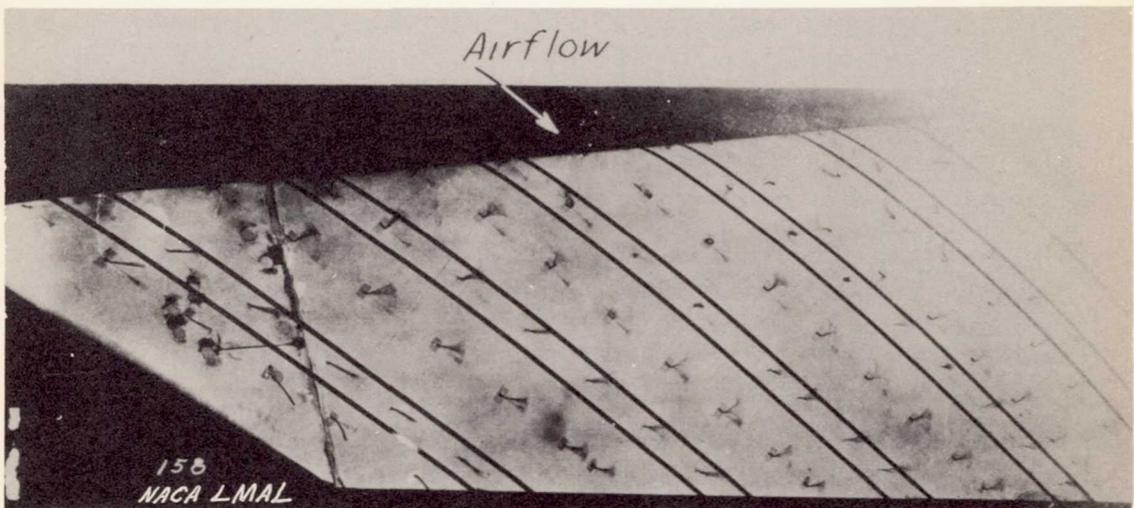
Figure 15.- Tuft patterns on a 65₂-215 wing, $\Lambda = -45^\circ$, $M = 0.13$.

The tuft photographs for the -45° sweep configuration at angles of attack ranging from 8° to 28° are presented in figure 15. Sketches showing the patterns of streamlines are shown in figure 16. Some of the photographs at high angles of attack (fig. 15) were repeated since the entire wing could not be photographed without shifting the camera. Separation at -45° sweep began on the inboard portion of the wing at about 12° angle of attack and progressed outward slowly until an angle of 28° was reached where the wing was almost entirely stalled. An inward flow over the rear portion of the wing is shown clearly.
