RESEARCH MEMORANDUM

TUFT STUDIES OF THE FLOW OVER A WING AT
FOUR ANGLES OF SWEEP

Gerald Hieser

July 10, 1947

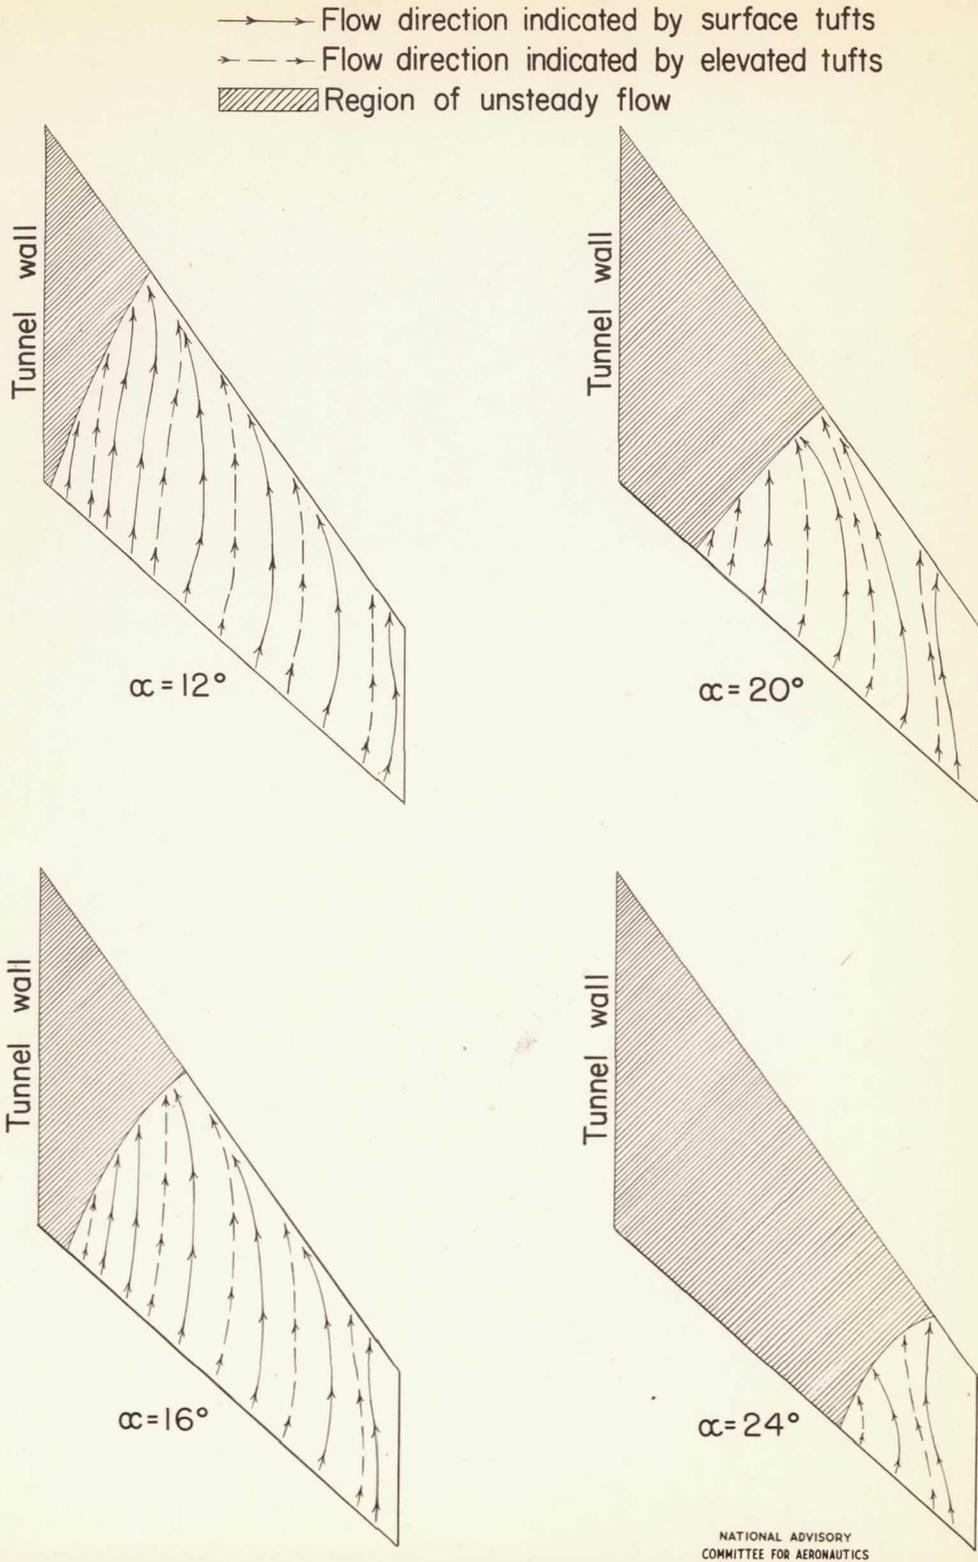
Figure 16.— Flow patterns indicated by tufts on a 65₂-215 wing at various angles of attack. $\Lambda = -45^\circ$. $M = .13$.

The tuft photographs for the -45° sweep configuration at angles of attack ranging from 8° to 28° are presented in figure 15. Sketches showing the patterns of streamlines are shown in figure 16. Some of the photographs at high angles of attack (fig. 15) were repeated since the entire wing could not be photographed without shifting the camera. Separation at -45° sweep began on the inboard portion of the wing at about 12° angle of attack and progressed outward slowly until an angle of 28° was reached where the wing was almost entirely stalled. An inward flow over the rear portion of the wing is shown clearly.
