RESEARCH MEMORANDUM

DITCHING TESTS OF A $\frac{1}{20}$ -SCALE MODEL

OF THE NORTROP B-35 AIRPLANE

Lloyd J. Fisher

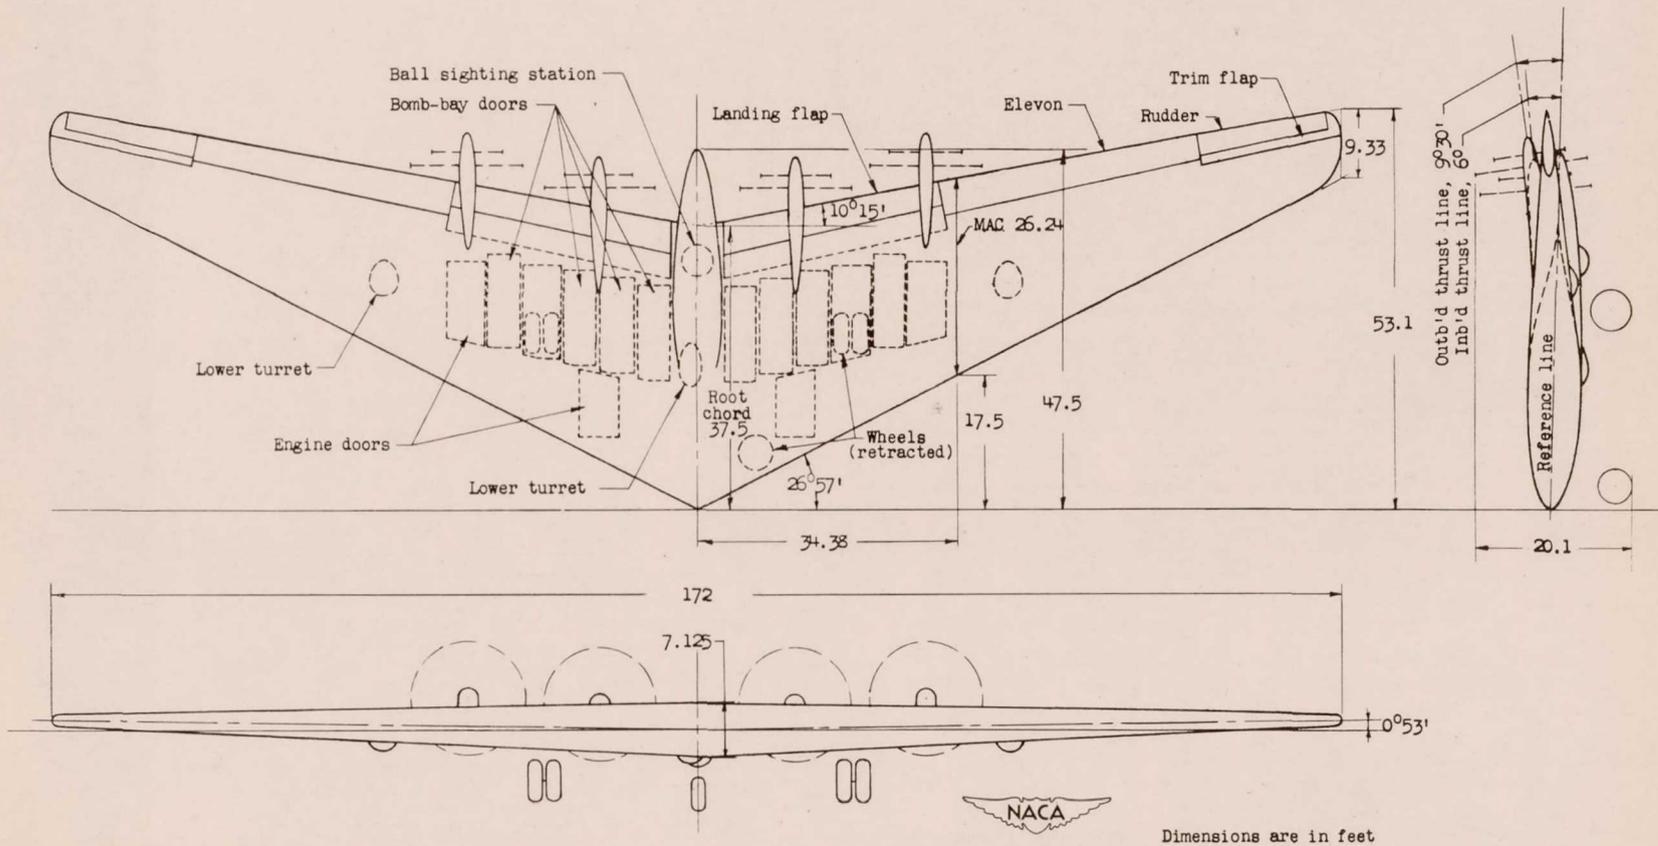
Figure 1.- Three-view drawing of the Northrop B-35 airplane.

Data on the full-scale airplane were obtained from Northrop Aircraft, Inc. A three-view drawing of the B-35 is shown in figure 1.

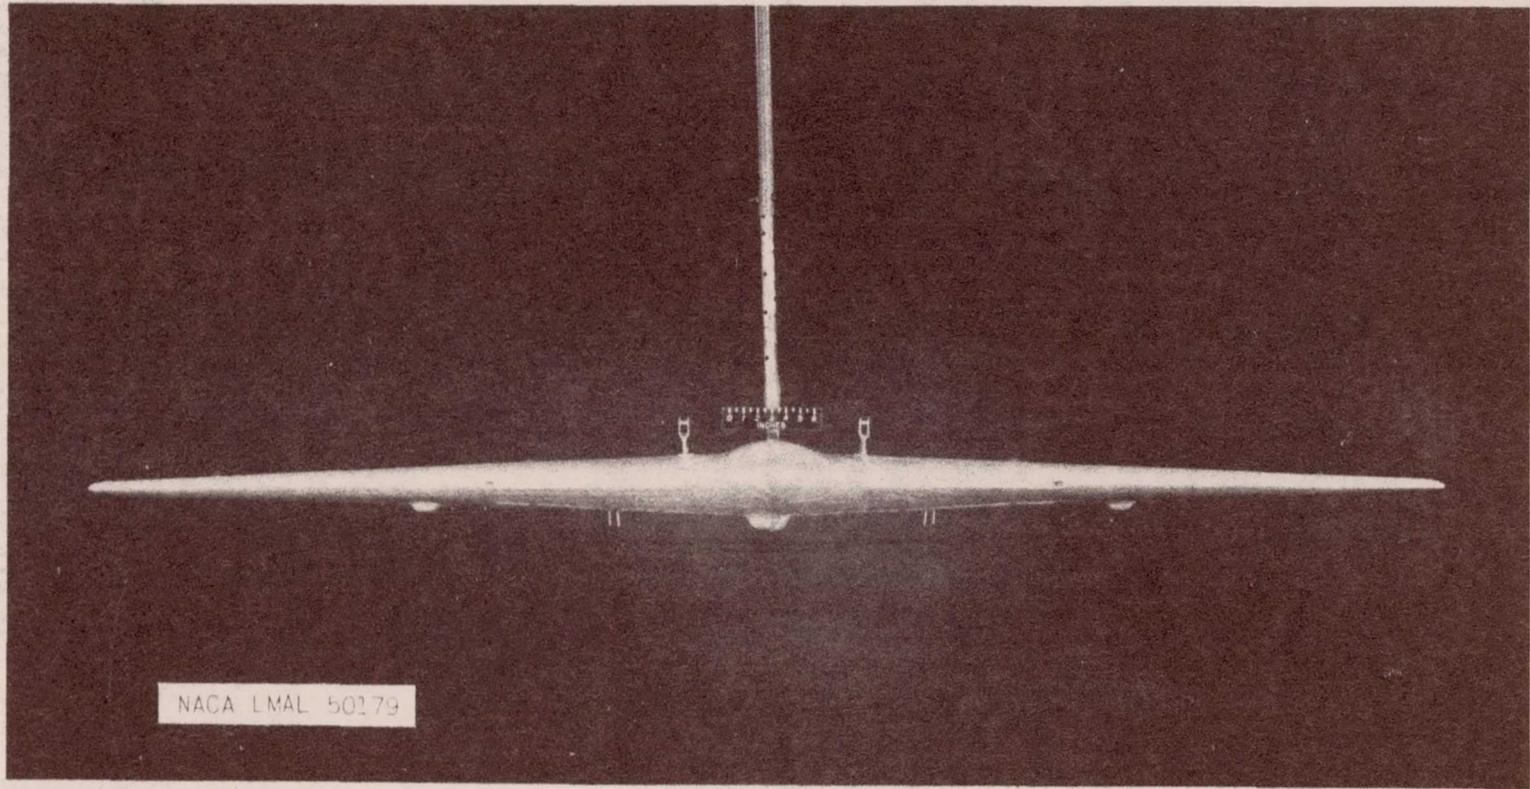
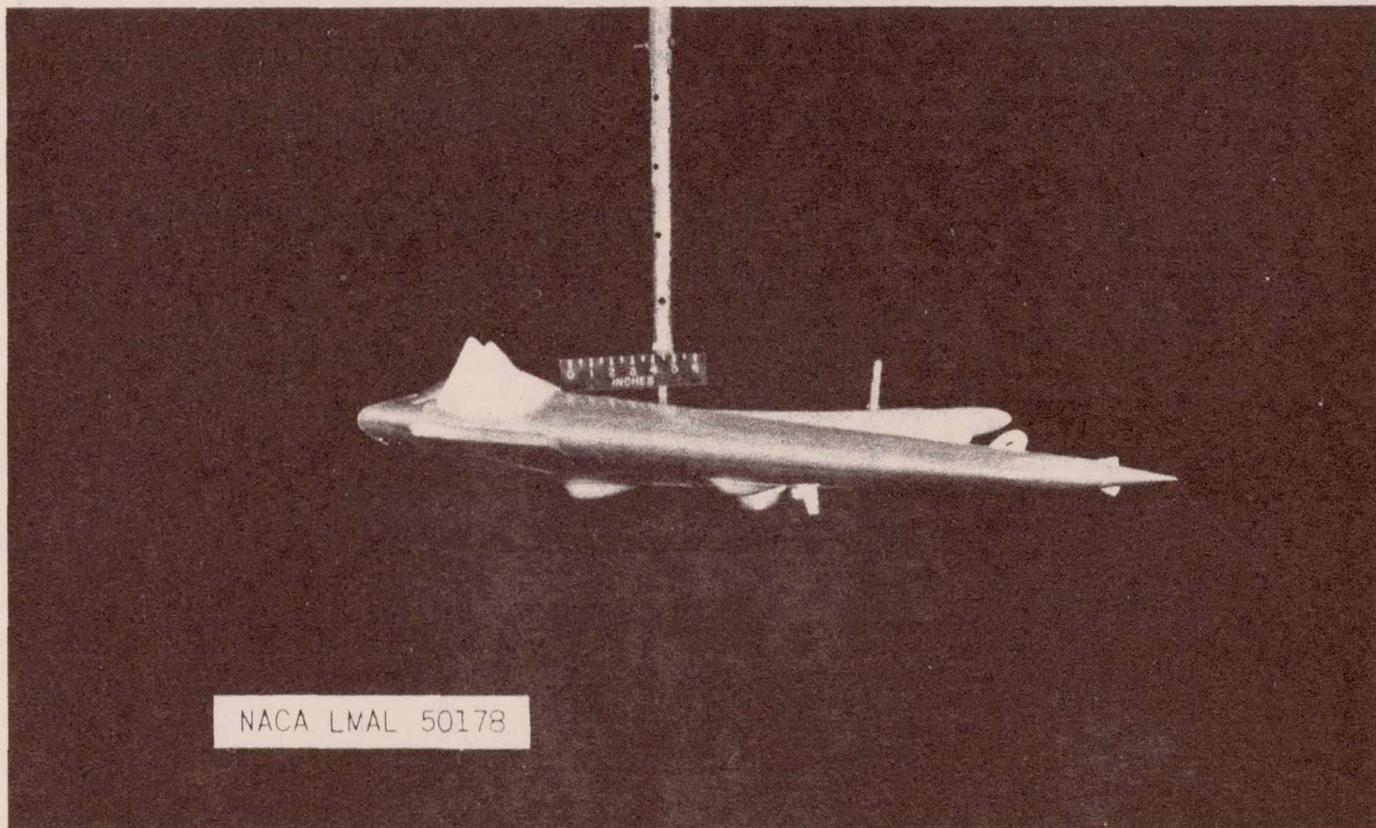
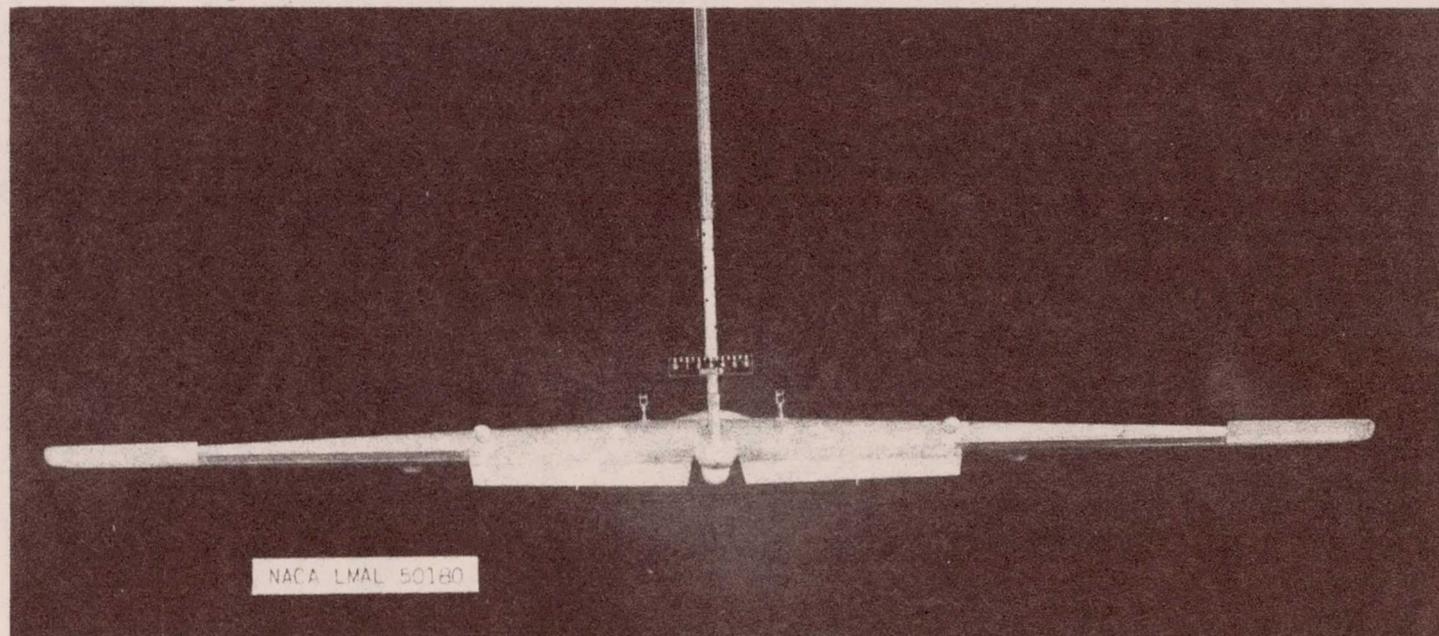
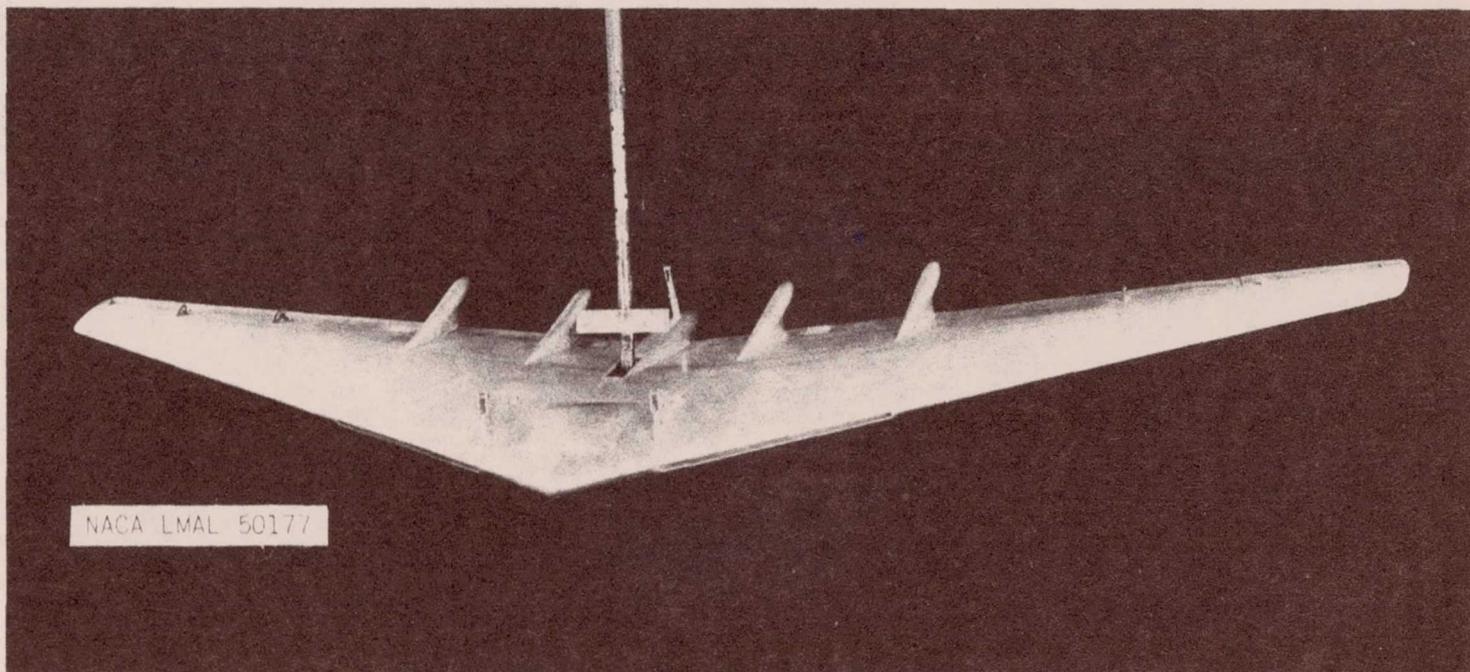
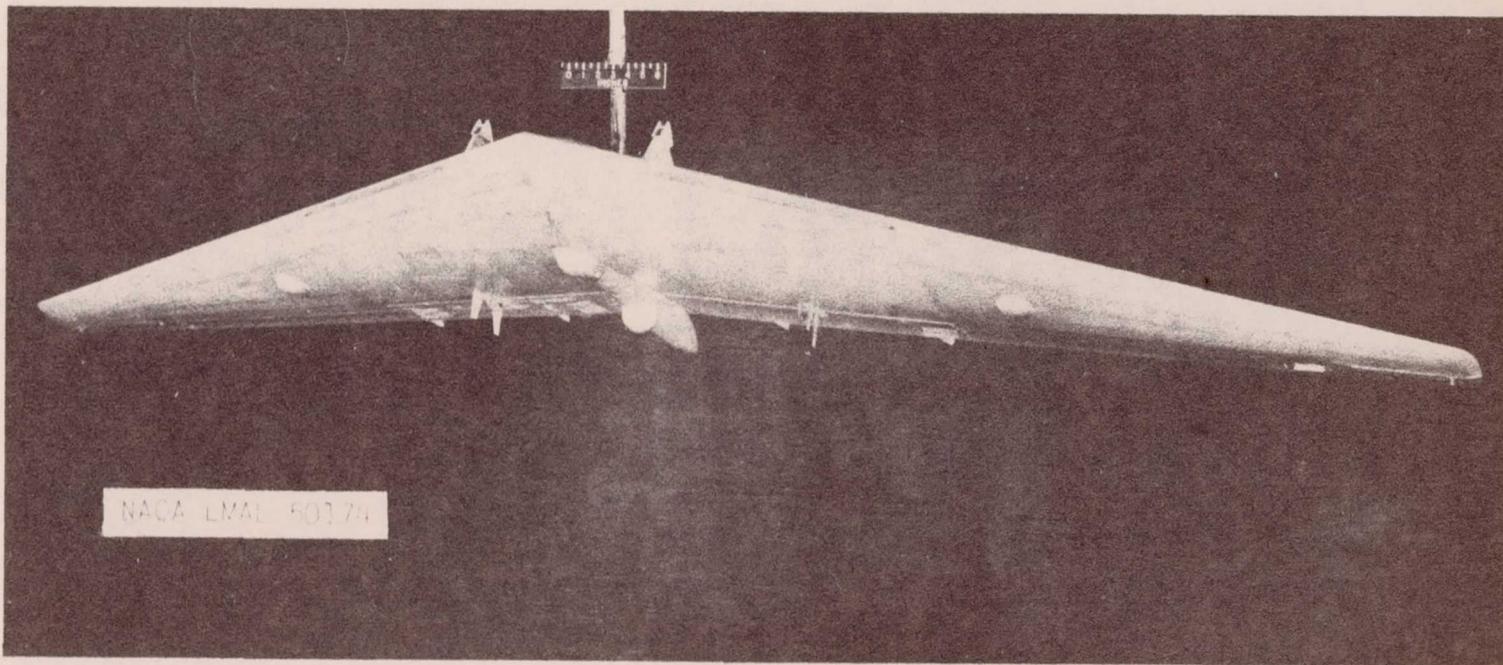
(a) Front view.

Figure 2.- Northrop B-35 airplane, $\frac{1}{20}$ -scale dynamic model.

(b) Side view.

(c) Rear view.

(d) Three-quarter top view.

(e) Three-quarter bottom view.

A $\frac{1}{20}$ -scale dynamically similar model of the Northrop B-35 airplane having a wing span of 8.6 feet was used in the tests. Photographs of the model are given in figure 2. The model was constructed of balsa ribs and planking with pieces of spruce at points of concentrated stress and with hardwood spars. The flaps, elevons, and rudders were constructed of pine ribs and spars covered with silk. Metal parts used for quadrants, hinges, and other fittings were made of brass or duralumin.

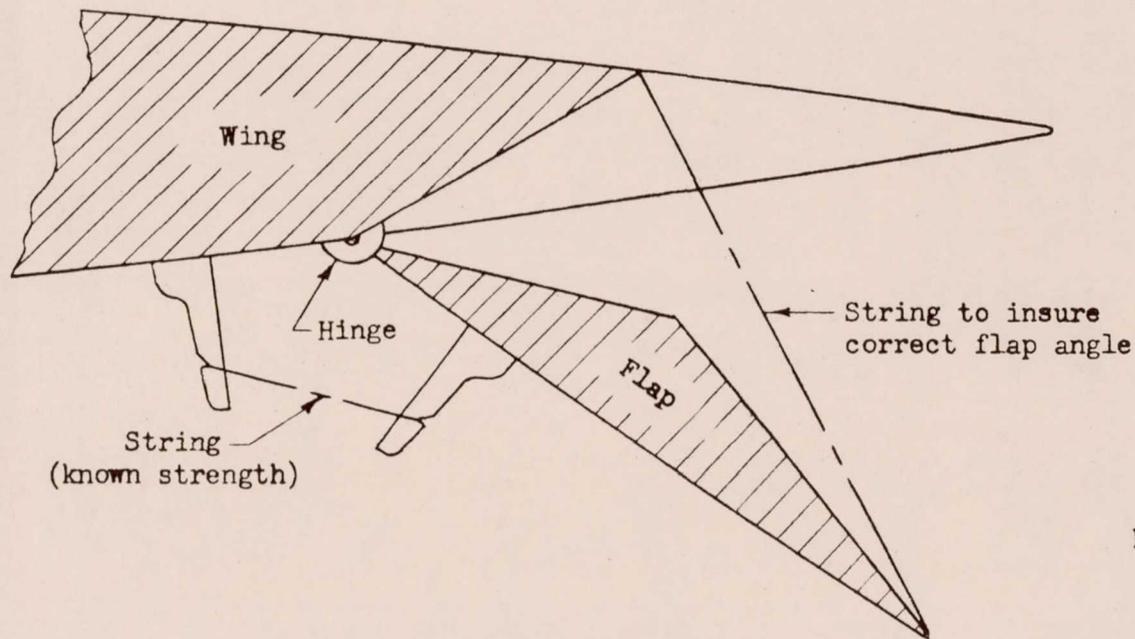
Note: The fitting is located at mid-span of each flap.

Figure 3.- Method used to obtain scale-strength landing flaps.

The landing flaps were installed on the model in such a manner that they could be held in the down position by a calibrated string that would fail when a load equal to the scale strength of the flap was applied. (See fig. 3.) Failure of a flap was simulated by the string breaking and the flap rotating on its hinges to the up position. The trim flaps, elevons, and rudders were also hinged and could be adjusted to balance the model aerodynamically.

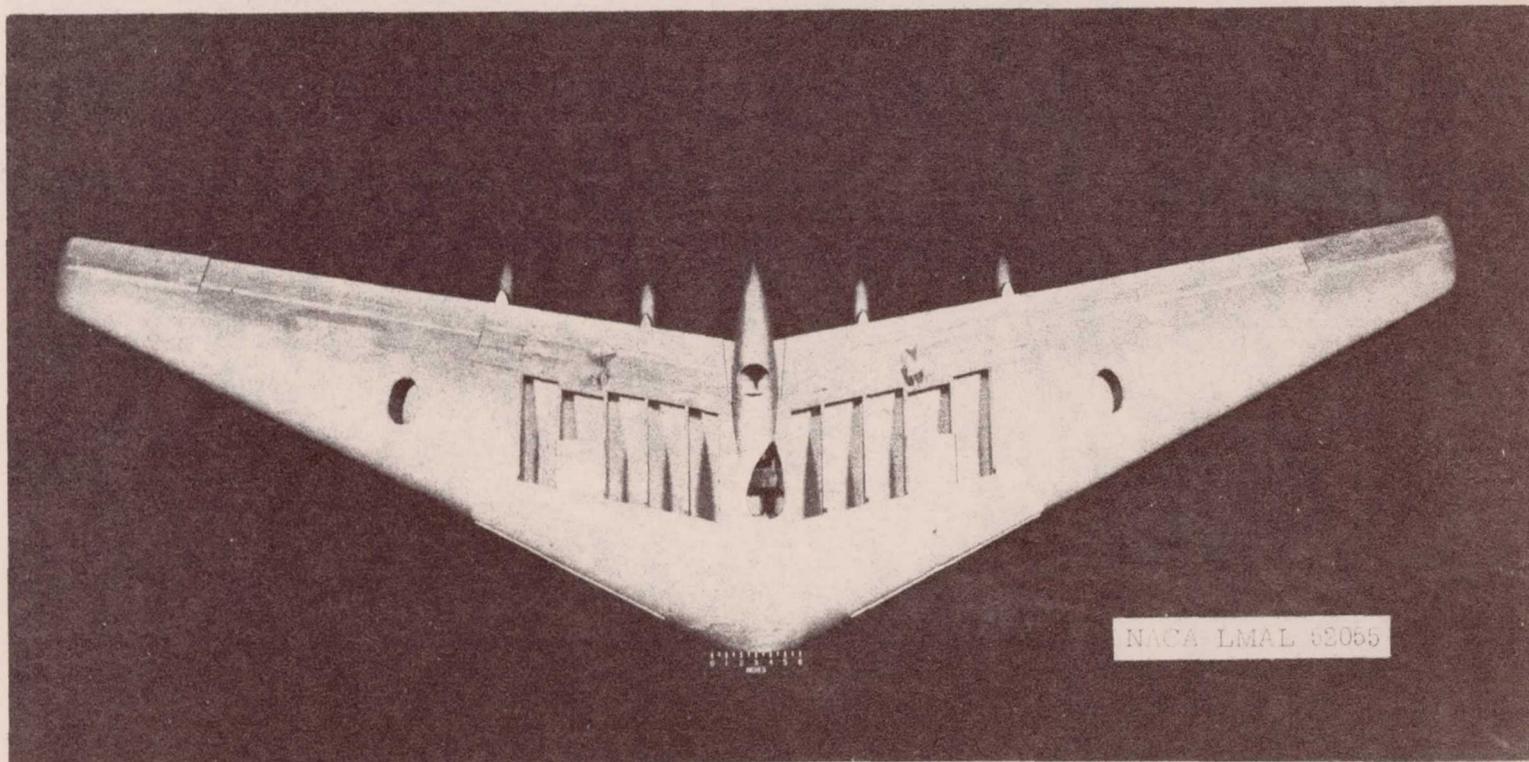
Figure 4.- Bottom view of model with bomb-bay doors, lower turrets, lower ball sighting station, and aft part of main-wheel doors removed.

- (a) No damage (See fig. 2.)
- (b) Simulated failure of bomb-bay doors, lower turrets, lower ball sighting station, and aft part of main-wheel doors (fig. 4)
- (c) Simulated failure of bomb-bay doors, lower turrets, lower ball sighting station, aft part of main-wheel doors, engine doors, and bombardier's window (fig. 5)

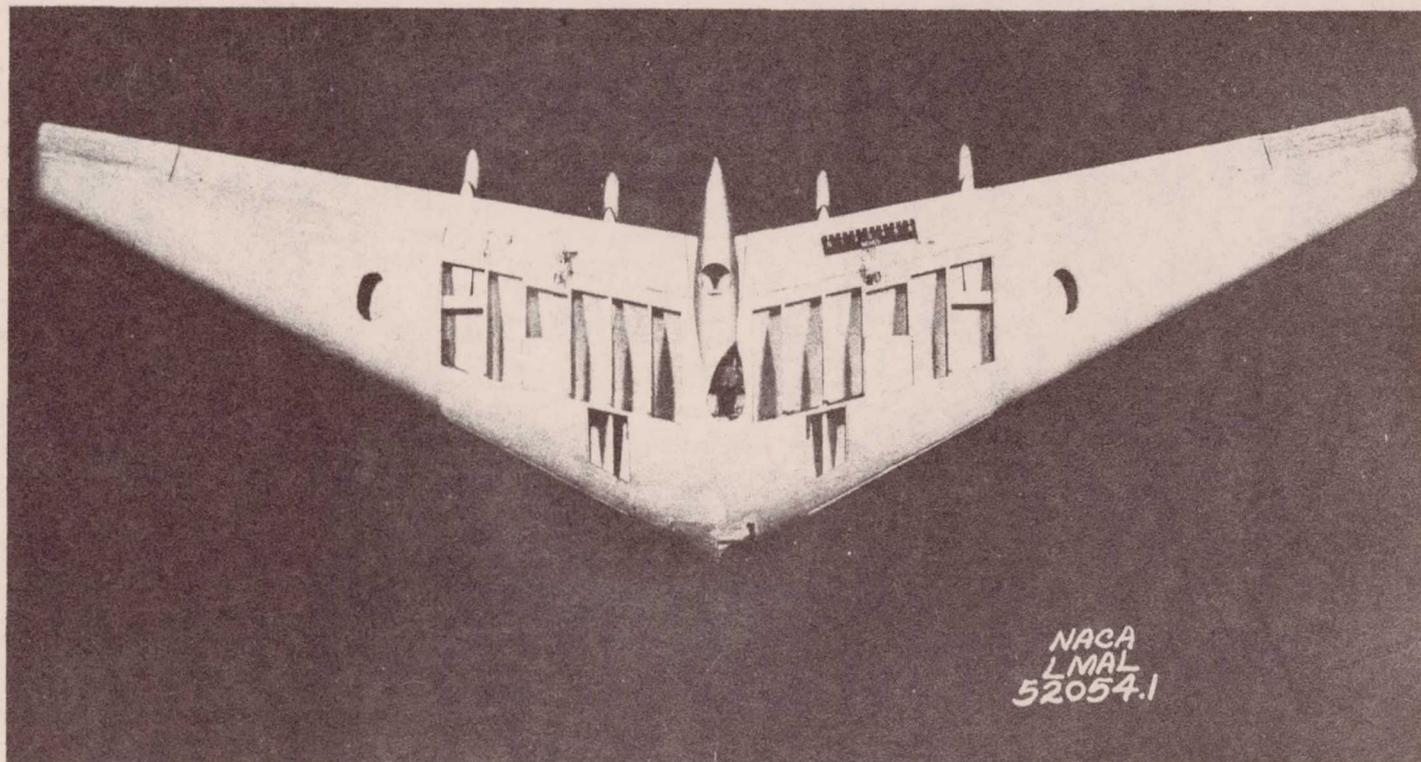
Figure 5.- Bottom view of model with bomb-bay doors, lower turrets, lower ball sighting station, aft part of main-wheel doors, engine doors, and bombardier's window removed.

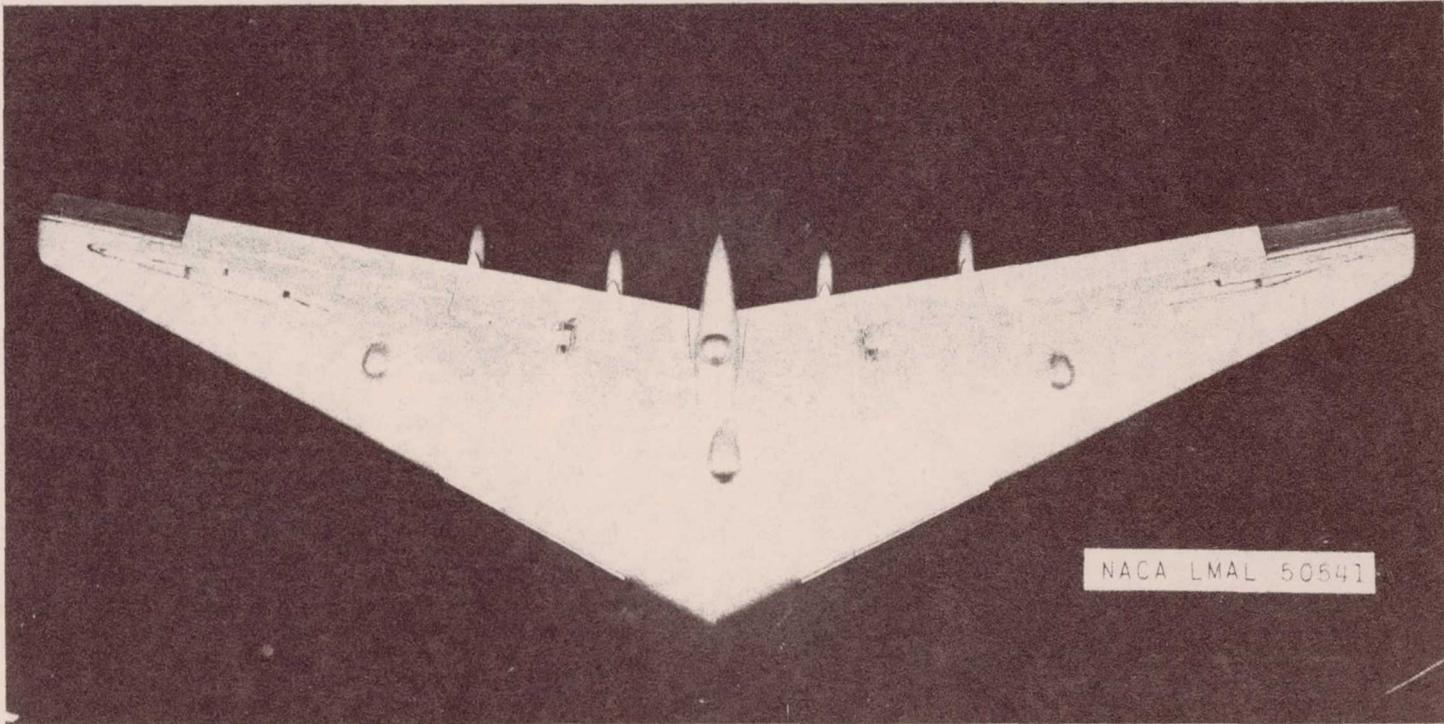
Figure 6.- Bottom view of model with planking torn from wing near tips.

In addition to the damage mentioned above as test conditions, the model was frequently damaged during the tests by contact with the water; the landing flaps, elevons, or trim flaps were broken off or the planking on the underside of the wing near the tips was torn away (fig. 6).

There always seemed to be a rather strong suction under the wing toward the trailing edge. This down force probably caused the model to trim up when landed at the 9° and 4° attitudes and caused the planking on the wing near the tips to be torn away. In tests of the undamaged model, there was a tendency for the bomb-bay doors to be forced out.

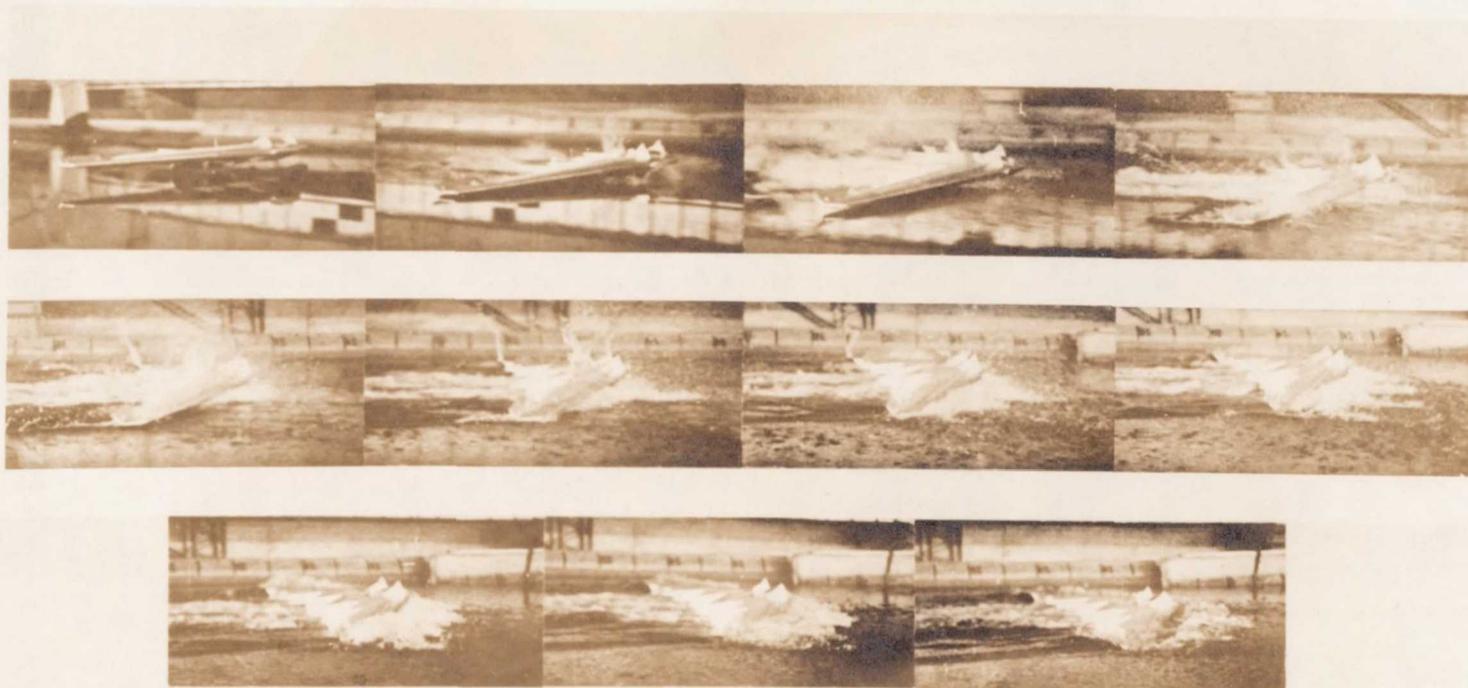
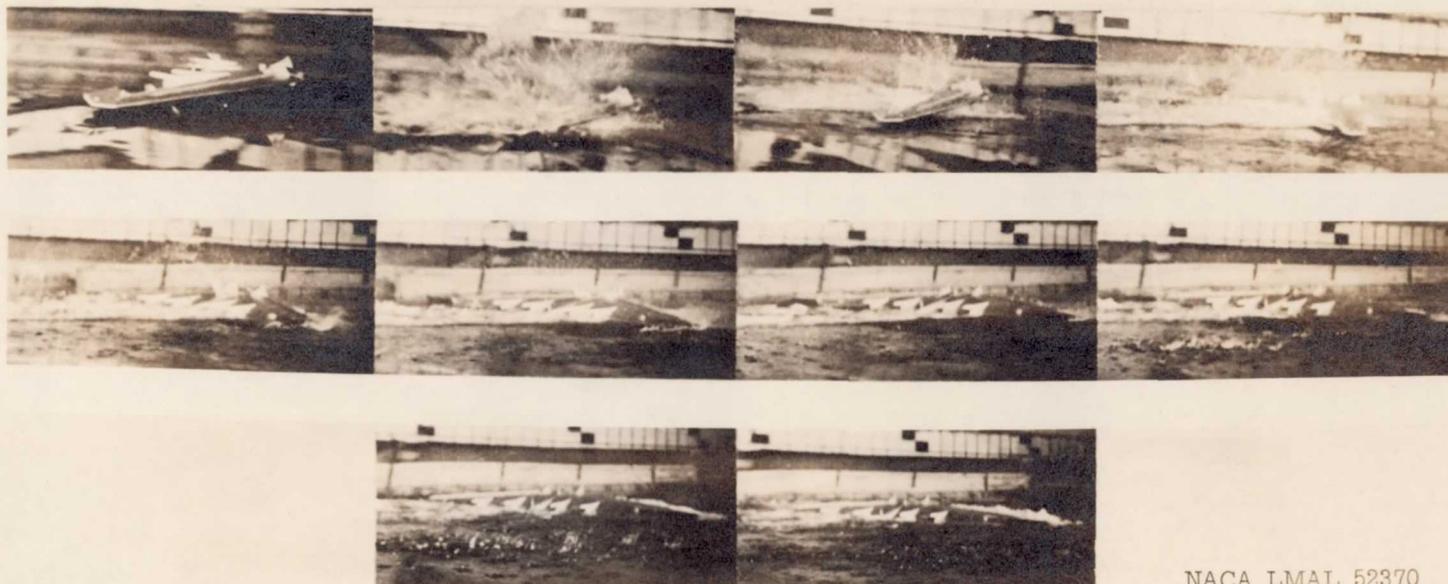
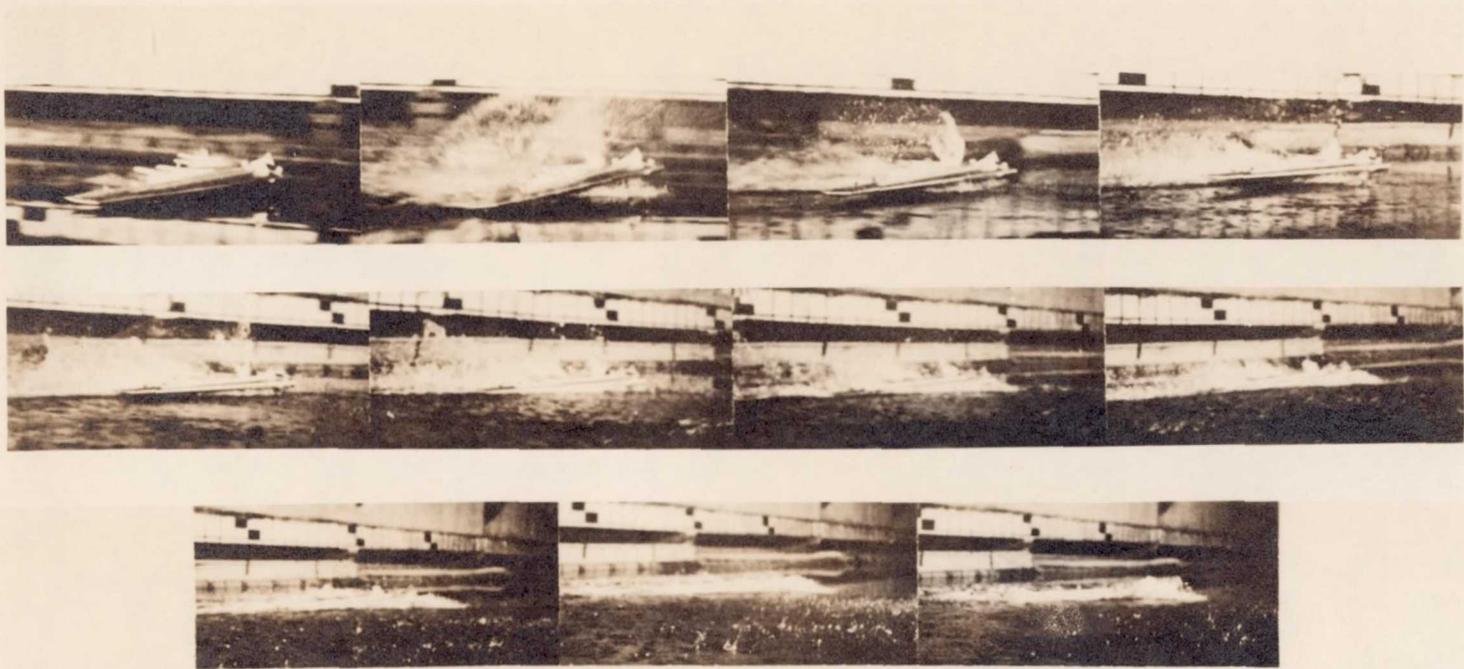
(a) Landing attitude, 14° ; landing speed, 113 mph.

Figure 7.- Sequence photographs at 0.56-second intervals of model ditchings with simulated failure of bomb-bay doors, lower turrets, lower ball sighting station, aft part of main-wheel doors, and bombardier's window. (All values are full scale.)

(b) Landing attitude, 9° ; landing speed, 128 mph.

(c) Landing attitude, 4° ; landing speed, 143 mph.

Photographs showing the characteristic behavior of the model are given in figure 7. Typical time histories of longitudinal and lateral accelerations are given in figures 8 and 9.

The landing attitude had no effect on the tendency of the model to yaw. The following effects of attitude are for tests in which straight runs were made or in which a turn did not occur until near the end of the run. At the 14° attitude, the model made smooth runs, running somewhat deeper in the water as the amount of damage was increased. At the 9° attitude, the model trimmed up soon after landing and then either porpoised slightly or made a smooth run, depending on the damage. At the 4° attitude, the model trimmed up soon after landing and then porpoised. The shortest runs and highest decelerations were made at 14° . The longest runs and lowest decelerations were made at 4° . (See table I.)

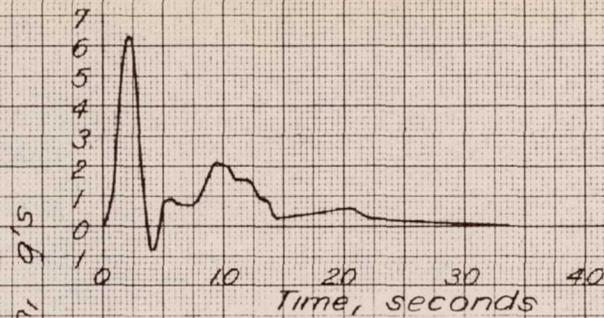
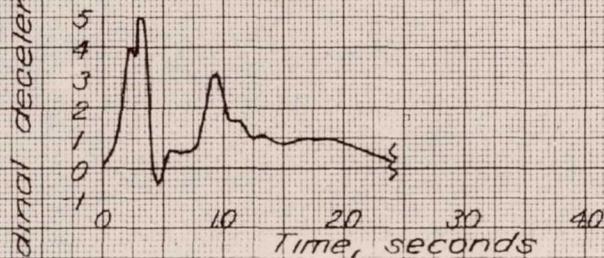
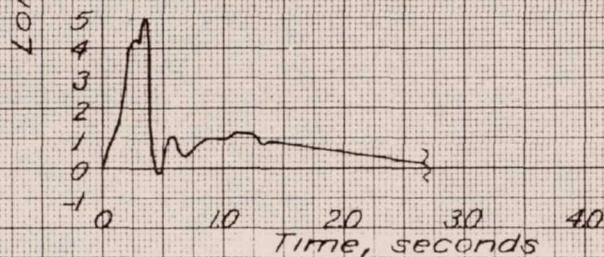
(a) Landing attitude, 14°;
landing speed, 113 mph.

(b) Landing attitude, 9°;
landing speed, 128 mph.

(c) Landing attitude, 4°;
landing speed, 143 mph.

Figure 8. - Typical time-histories of longitudinal decelerations for ditching tests of the model with flaps full-down and with simulated failure of the bomb-bay doors, lower turrets, lower ball sighting station, aft part of main-wheel doors, engine doors, and bombardier's window.

The model tests showed that the most pronounced ditching characteristic of the B-35 was its tendency to turn or yaw. Turning occurred much more frequently than did yawing. A turn or yaw developed if either wing tip was only slightly low on landing or dropped during the run. A turn was usually gradual and might occur either immediately after landing or near the end of the run. A yaw usually occurred near the beginning of the run; the model skidded along in the yawed position and near the end of the run usually turned off in the direction of yaw. Neither a turn nor a yaw seemed to be very dangerous, but personnel that ditch in a B-35 should be braced to withstand both longitudinal and lateral accelerations. The maximum longitudinal decelerations obtained in the tests were about 6g or 7g. (See table I and fig. 8.) The maximum lateral accelerations were about 2g (fig. 9). The positive values of lateral acceleration are in the direction toward which the model turned or yawed. The duration of the accelerations is shown in figures 8 and 9 but is not very great for the higher values of acceleration.

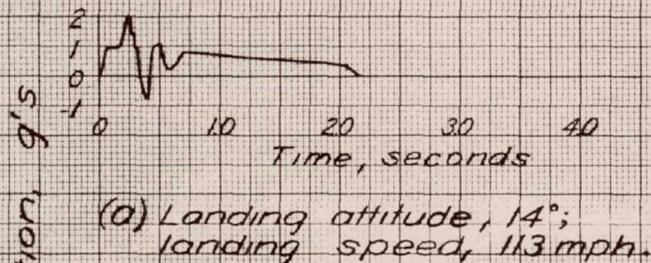
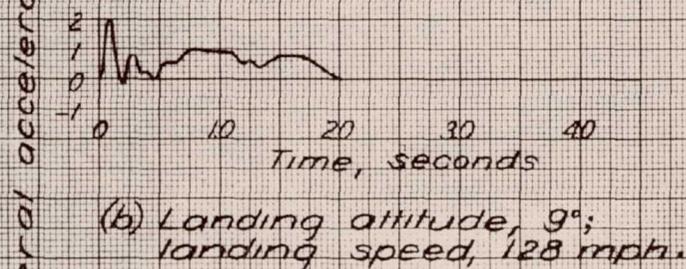
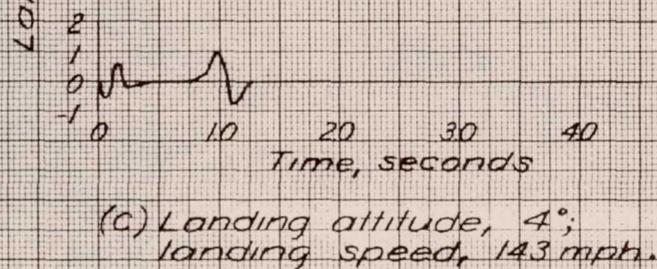
Figure 9. - Typical time-histories of lateral accelerations for ditching tests of the model with flaps full-down and with simulated failure of the bomb-bay doors, lower turrets, lower ball sighting station, aft part of main-wheel doors, engine doors, and bombardier's window.
