RESEARCH MEMORANDUM

PRELIMINARY RESULTS OBTAINED FROM FLIGHT TEST OF A $\frac{1}{7}$ - SCALE

ROCKET-POWERED MODEL OF THE GRUMMAN XF10F AIRPLANE

CONFIGURATION IN THE SWEPT-WING CONDITION

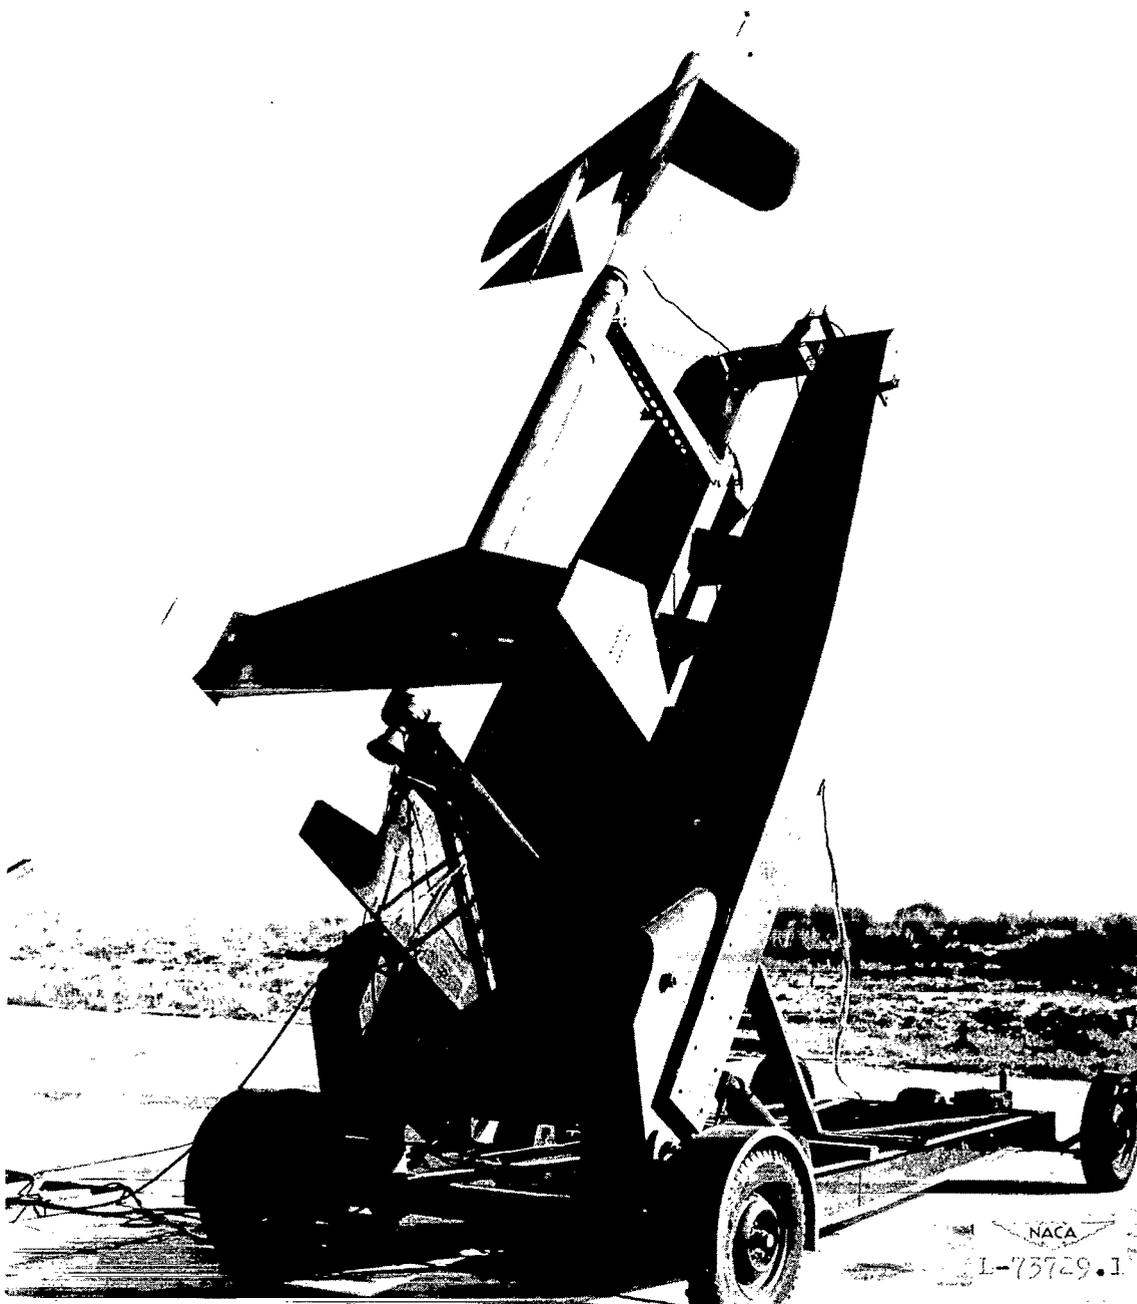
Figure 3.- Model booster combination on launcher.

Figure 3 is a photograph of the model booster combination on the launching platform. The model was boosted to a Mach number of 0.9 by a 6-inch ABL Deacon rocket motor. Approximately 0.7 second after booster burnout the modified ABL Deacon sustainer rocket motor fired and was intended to increase the speed of the model to about $M = 1.4$. The model was flown at the Langley Pilotless Aircraft Research Station at Wallops Island, Va.
