ENGAGEMENT OF METAL DEBRIS INTO A GEAR MESH

*Robert F. HANDSCHUH and Timothy L. KRANTZ

*Army Research Laboratory
NASA Glenn Research Center
Cleveland, Ohio*

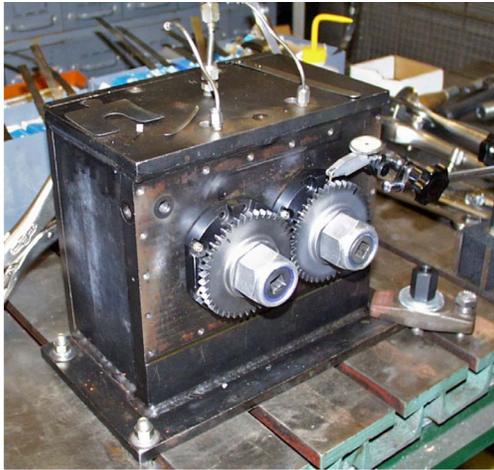
Figure 1.—Bench setup for gear chip engagement testing using the NASA Glenn Fatigue Rig.

The gear testing was done using a Glenn Research Center Spur Gear Fatigue test rig. This rig uses two identical spur gears engaged with one another. The shaft mounting is an overhung arrangement for the test gears, and the nearby bearings are roller bearings. The overhung distance from the bearing supports is approximately 32 mm (1.25 in.). Because the test machine was designed for experiments of gear fatigue, the shaft and bearing supports are relatively large and stiff. Figure 1 shows the test gearbox with a pair of test gears mounted.

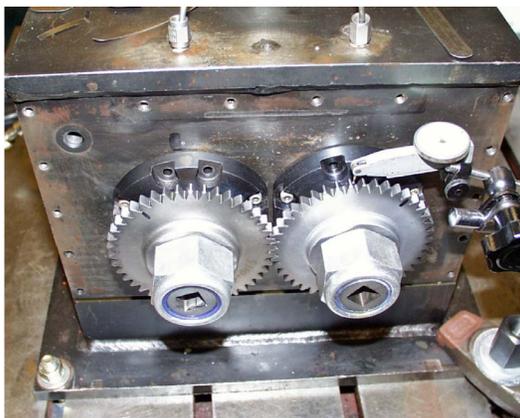
Figure 2.—Setup for backlash measurement using dial indicator.

The gear design specifications and the actual mounted center distance determine the root clearance and backlash of a pair of gears. The backlash and root clearances were determined for the first pair of test gear mounted on the test fixture. The backlash was measured as 0.15 mm (0.006 in.) using a standard measurement setup (Fig. 2). The root clearance was measured as 0.94 mm (0.037 in.). The root clearance was determined by running a piece of soft material (solder) through the mesh and measuring the deformed material with a caliper.

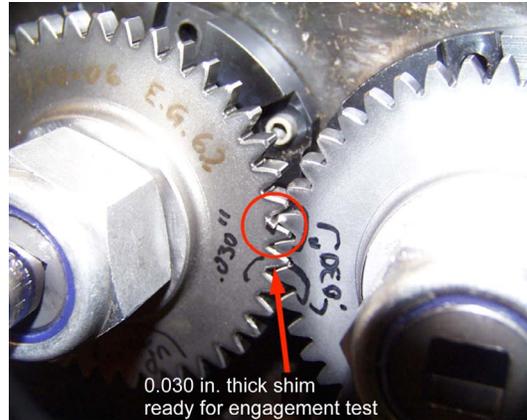
Figure 3.—Example of shim and placement used for engagement testing.

Three types of “debris” were placed into the meshing gear teeth for testing, namely steel shim stock, drill bit shanks, and pieces or “chips” from gear teeth. The shim stock materials used were steel and stainless steel. The shim thickness ranged from 0.13 to 1.88 mm (0.005 to 0.074 in.). The shims were cut to a length of approximately 2.5 to 3.8 mm (0.100 to 0.150 in.), representing approximately half of the tooth height. The shim lengths were wider than the faces of the gears and were placed to engage the full-face width of the gear teeth (Fig. 3). The drill bit shanks used for these experiments had shank diameters ranging from 1.07 to 1.96 mm (0.042 to 0.077 in.).

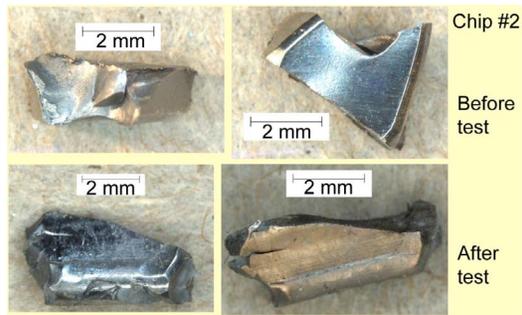
Figure 9.—Chip #1, mass of chip 0.090 grams.

Figure 10.—Chip #2, mass of chip 0.100 grams.

Figure 11.—Chip #3, mass of chip 0.106 grams.

Figure 12.—Chip #4, mass of chip 0.116 grams.

Figure 13.—Chip #5, mass of chip 0.139 grams.

Figure 14.—Chip #6, mass of chip 0.252 grams.

Images of the chips both before and after engagement testing are provided in Figures 9 to 18. The images show that the main effects on the chips were deformation of the chips to conform to the available tooth root spaces. In general, the chips remained intact. For the case of chips #5 and #8, small pieces were liberated from the main piece as can be seen in the figures. Chip #10 especially shows that the case-carburized material, even though generally described as brittle, can be significantly deformed and exhibit some toughness. Although the chip experienced some “tearing”, the chip did not “shatter” or otherwise exhibit extreme brittleness.
