(Preprint) AAS 10-085

## LAUNCH AND COMMISSIONING OF THE LUNAR RECONNAISSANCE ORBITER (LRO)

The Lunar Reconnaissance Orbiter (LRO) launched on June 18, 2009 from the Cape Canaveral Air Force Station. LRO, designed, built, and operated by the National Aeronautics and Space Administration (NASA) Goddard Space Flight Center in Greenbelt, MD, is gathering crucial data on the lunar environment that will help astronauts prepare for long-duration lunar expeditions. To date, the Guidance, Navigation and Control (GN&C) subsystem has operated nominally and met all requirements. However, during the early phase of the mission, the GN&C Team encountered some anomalies. For example, during the Solar Array and High Gain Antenna deployments, one of the safing action points tripped, which was not expected. Also, the spacecraft transitioned to its safe hold mode, SunSafe, due to encountering an end of file for an ephemeris table. During the five-day lunar acquisition, one of the star trackers triggered the spacecraft to transition into a safe hold configuration, the cause of which was determined. These events offered invaluable insight to better understand the performance of the system they design

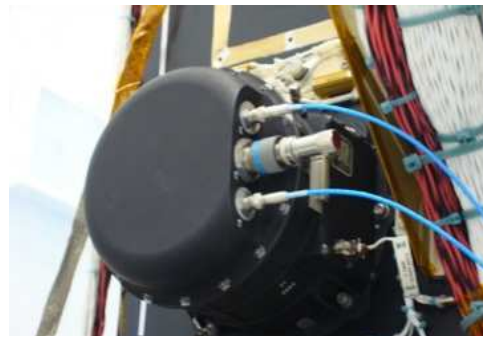
Honeywell's Miniature Inertial Measurement Unit (MIMU) serves as a single IRU. It contains 3 ring-laser gyros (one gyro per axis) that are used to produce spacecraft inertial body rates.

This unit outputs an accumulated angle, which is sampled by the onboard system at 10 Hz and differenced to produce the body rates. These 10 Hz rate estimates are averaged over two samples to provide a rate for use in the feedback loop at the ACS cycle time of 5 Hz. Due to accumulated angle roll-over ambiguity, the MIMU gyros provide only direction of spin but not the magnitude of the attitude rate for rates above a saturation level. For LRO the IRU saturation level is 18 deg/sec. The MIMU was turned on prior to launch and, has performed flawlessly in continuous operation during the LRO mission.

**Figure 4. MIMU mounted on LRO**

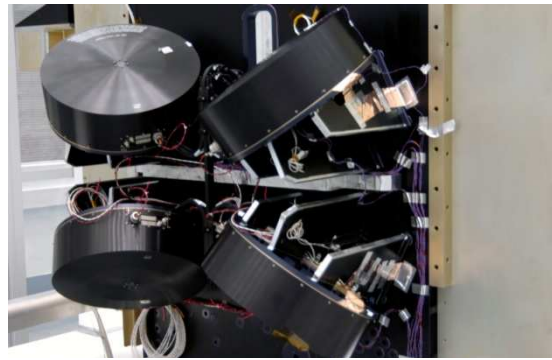
Fine pointing control of the LRO spacecraft is accomplished through the use of four Reaction Wheels (RWs). These actuators were developed, built, tested, and delivered in-house by the NASA Goddard GN&C Hardware Branch. Each RW uses an 18-inch aluminum flywheel, providing inertia for momentum exchange. The RWs are mounted in a pyramid configuration with a reaction wheel assembly system momentum storage capacity of 130 Nms.

**Figure 5. Reaction Wheel Assembly mounted on LRO in a tetrahedron configuration**

The LRO RW contains several design features. Each wheel has software and firmware for controlling either wheel speed or wheel torque as well as the reporting of telemetry. Each wheel also has a separate 1553 Remote Terminal address. The internal software and firmware can be reprogrammed from the ground if desired during the mission. Although not used for this lunar mission, the wheel design has the added feature of nearly complete burn-up if it were to plummet into the Earth's atmosphere at the end of its life.

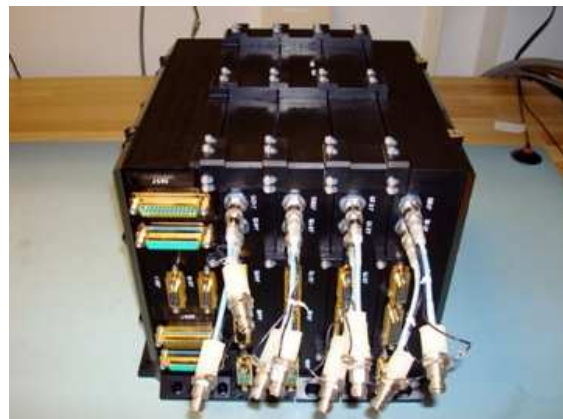
**Figure 6. PDE**

The Propulsion Deployment Electronics (PDE) has a number of functions used to complete the LRO mission. First, the PDE commands the firing of the thrusters when desired as well as firing of the Propulsion NASA Standard Initiators (NSI) for opening of the propulsion pressurization tank. During the Solar Array (SA) and High Gain Antenna (HGA) deployment, the PDE is used to turn on the Non Explosive Actuators (NEA). Additionally, the PDE prevents the radio frequency transmitters from functioning until launch vehicle fairing separation, and provides extra switch capabilities for science payload heaters. This component was designed to allow the propulsion system to have redundant drive electronics to support the redundant set of thrusters. The PDE is designed

have redundant drive electronics to support the redundant set of thrusters. The PDE is designed

with four identical electronic boards and one module for the prevention of certain spacecraft functions at the desired times.

The design of the four PDE electronic boards allows for the critical Lunar Orbit Insertion (LOI) maneuvers to be completed, even if one of the four identical electronic boards is declared suspect. Each of the four electronic boards has their own 1553 remote terminal address. The thrusters are connected to electronic boards in a manner that allows LRO to complete its desired orbit adjustment despite a thruster failure.
