**Joint Test Report**

**For Validation of Alternative Low-Emission Surface  
Preparation/Depainting Technologies for Structural  
Steel**

**FINAL**  
NAP2.PROJ.JTR.DEP.PL.02.16.07.F

**February 16, 2007**

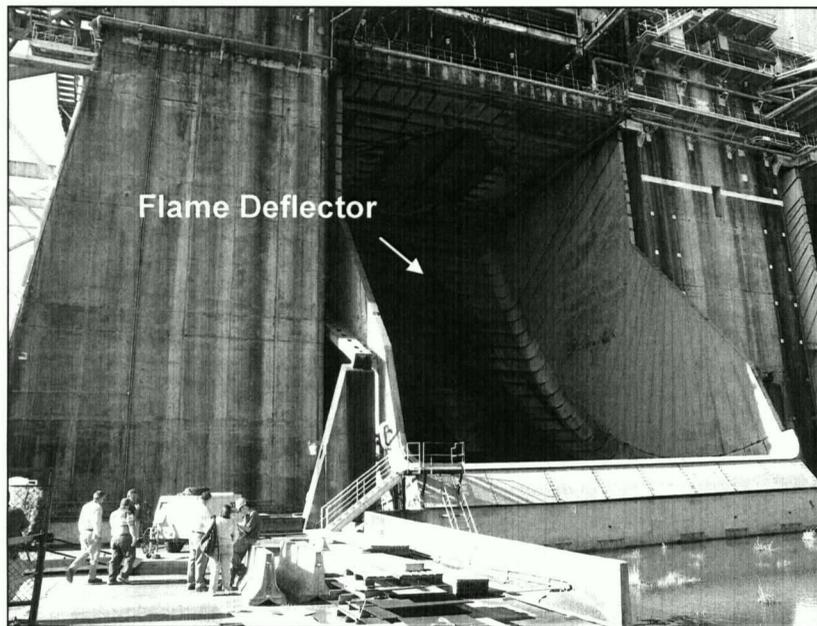
**Figure 5-1 Stennis Space Center Rocket Motor Test Stand**

Each depainting technology was evaluated in the field for ease of use, strip rate, surface cleanliness, surface profile/roughness, and substrate damage. The coating removal processes were evaluated in the field using the above criteria and the results are as follows. Blasting operations were evaluated on 12"x12" test panels and on a Stennis Space Center rocket motor test stand flame deflector (Figure 5-1). Documentation for each test can be found on the "Depainting System Field Evaluation and Inspection Report" in Appendix B.

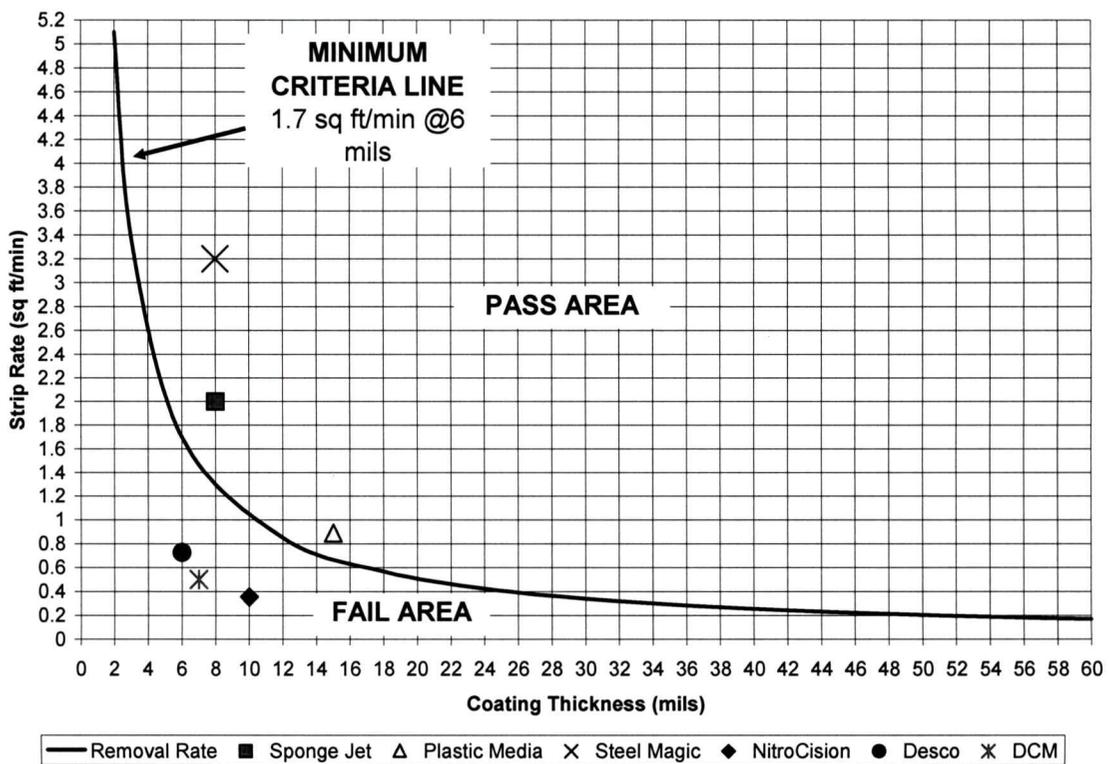
Figure 5-2 Flame Deflector Coating Removal Strip Rate

This procedure was used to determine the rate of coating removal for candidate coating removal technologies. Paint strip rate test data was based on a minimum test area on the structure equal to 16 ft<sup>2</sup> and on the 12"x12" test panels. All coatings were removed down to the substrate and achieved a minimum of SSPC-VIS1 SP-10/NACE-No. 2, near-white condition. The coating strip rate of the coating removal technology must meet or exceed strip rates established by NASA participants. Acceptance criteria for the coated substrates are 1.7 ft<sup>2</sup> per minute at 6 mils nominal thickness (Figure 5-2). The data points graphed in Figure 5-2 are from the coating removal rates on a typical 16 square foot section of the flame deflector steel structure. The area depicted equal to or above the criteria line is acceptable. The results are summarized below in Tables 5-2 through 5-5.

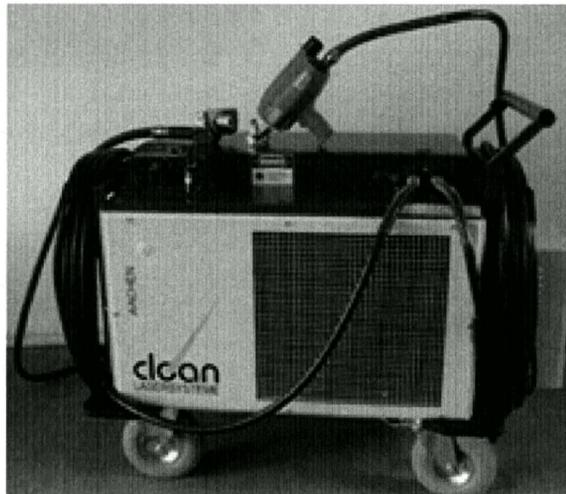
**Figure 6-1 CL 120Q Nd:YAG Laser System**

A vendor presentation of the PLCRS was performed the week of October 24-28, 2005, at NASA Glenn Research Center, Ohio, using a CL 120Q Nd:YAG Laser system with fiber optic cable (Figure 6-1). The PLCRS system was evaluated with the goal of determining if the process is effective in removing typical coatings used on facility and ground support equipment and whether it is detrimental to the underlying substrate.

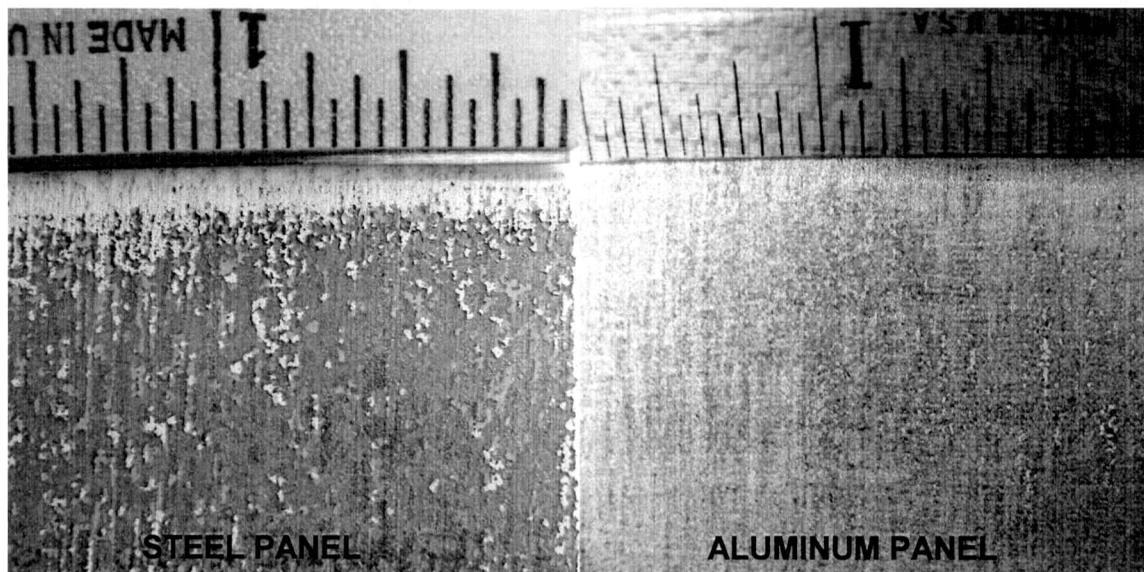
As seen in the following photographs, the PLCRS system did not achieve the minimum requirements of surface cleaning established in the JTP Section 3.2.3 during the demonstration (Figure 6-2). The laser depainting showed better performance on the aluminum coated substrate, but trace amounts of coating still remain on the surface.

Figure 6-2 Laser Depainted Surfaces

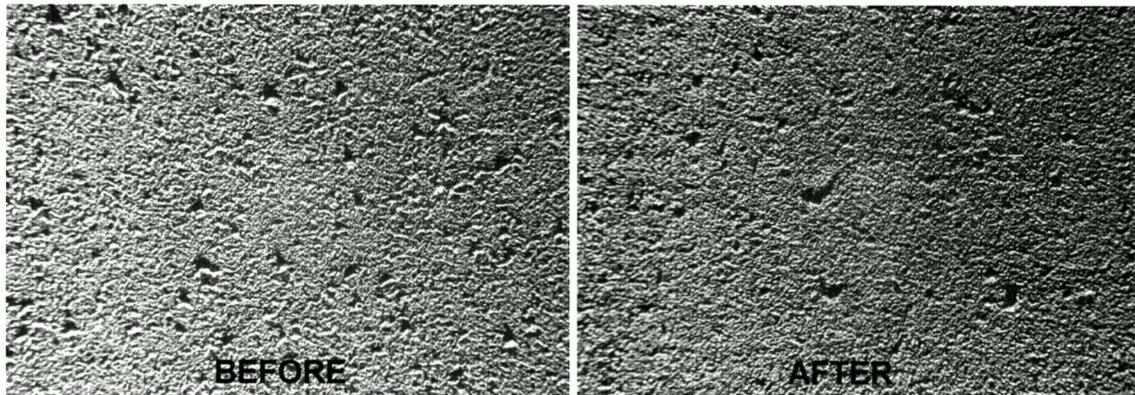
There were no measurable changes to the before and after surface profile measurements. Before and after magnified photographs show similar surface roughness (Figure 6-3).

**Figure 6-3 Surface Roughness on Aluminum Panel**

Measurements of surface profile on the coated steel panels were not performed due to the PLCRS system not removing 100% of the coating. However, the laser was applied to the surface of an uncoated aluminum coupon for a period of time to see if the surface profile was altered.

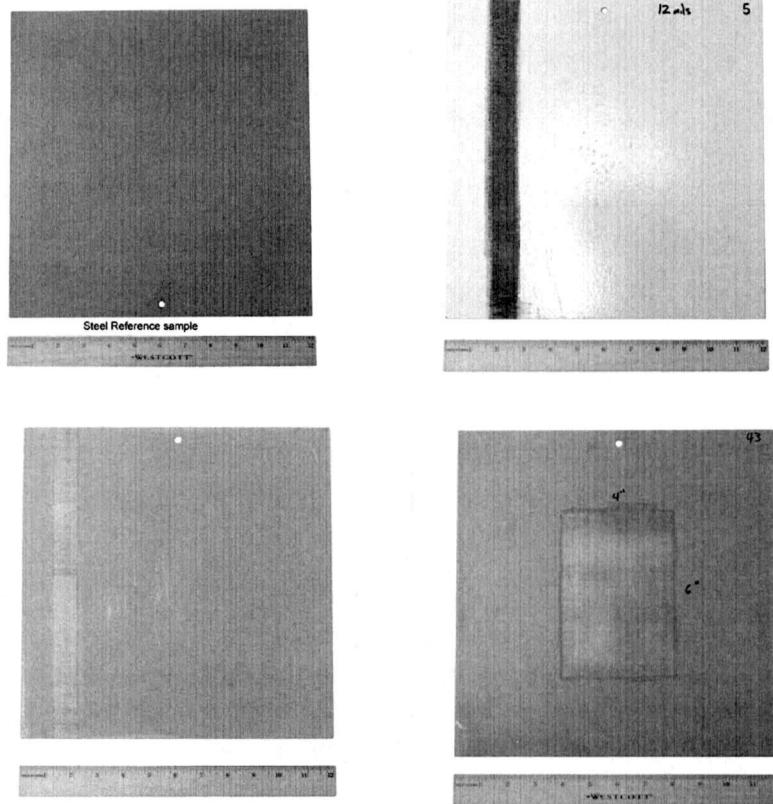
Figure 1

- 3.1 The panels were photographed as-received (Figure 1), showing the bare steel reference surface along with the epoxy primer, primer only, and bare aluminum samples. The two coated steel panels have a linear strip where the coating was removed with the laser. The bare aluminum sample has a square section that was exposed to the laser, but no coating was removed.

As-received panels showing the steel reference (upper left), white epoxy painted (upper right; includes primer underneath), green primer only (lower left), and bare aluminum (lower right). Scale is standard (inches).

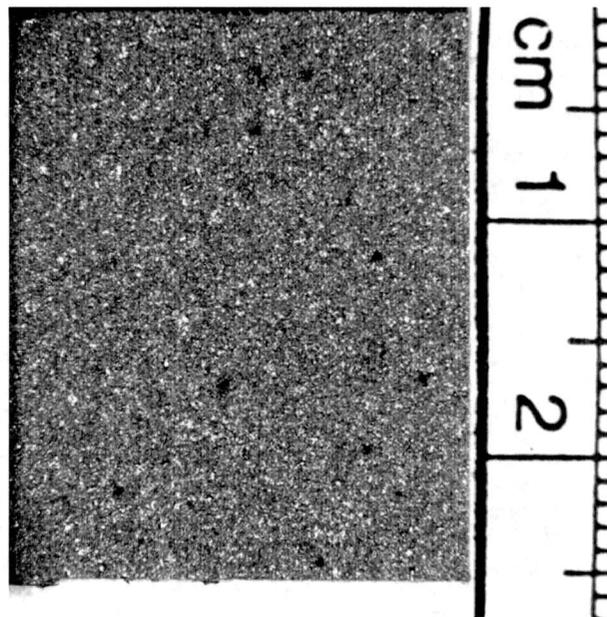
Figure 2  
Surface morphology of the steel reference sample. Magnification: 5X

- 3.2 Optical stereomicroscopic examination showed that the laser treated surfaces of both the painted and primed steel samples had islands of residual coating still embedded in the course contours of the surface, and the exposed base metal appeared slightly coarser than the steel reference. The aluminum sample surface exposed to the laser showed macroscopic delineations along the length of the treated area that appear to correspond to the width of each laser pass. Higher magnification optical inspection revealed subtle changes in color, but little difference in the surface morphology. The original matte grey finish of the untreated area was brighter in the areas exposed to the laser, likely due to removal of prolonged oxidation on the surface (Figures 2-5).

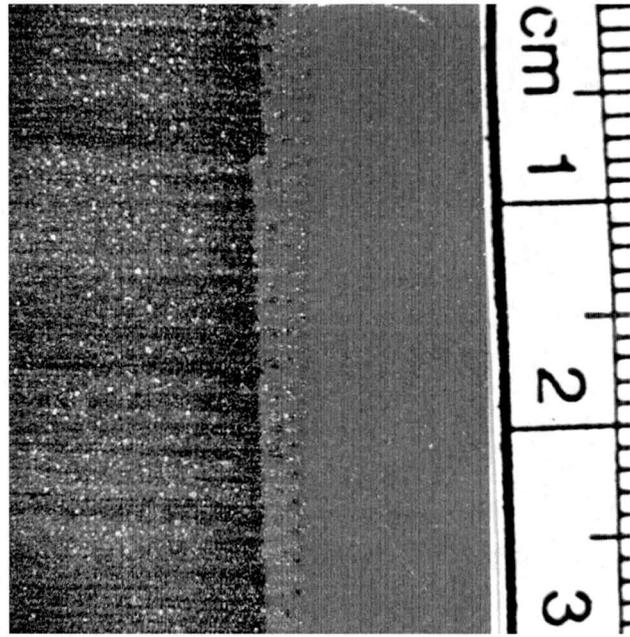
Figure 4

Surface morphology of the primed steel sample. Magnification: 5X

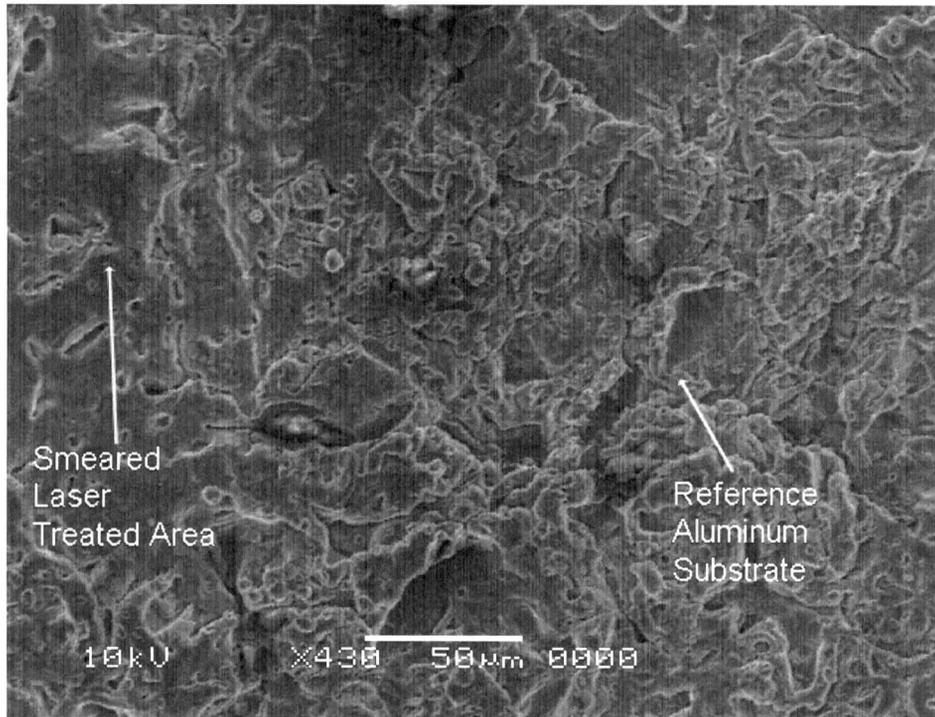
Figure 6

SEM micrograph of aluminum sample, showing the laser treated substrate on the left and the virgin base metal on the right. Magnification: 430X

- 3.3 The surfaces were cleaned and analyzed via SEM. The surfaces of both the aluminum and steel exposed to the laser showed slight mechanical deformation (smearing) compared to the reference samples (Figure 6-9). The steel specimens also showed the smeared regions containing islands of residual coating not removed by the laser.

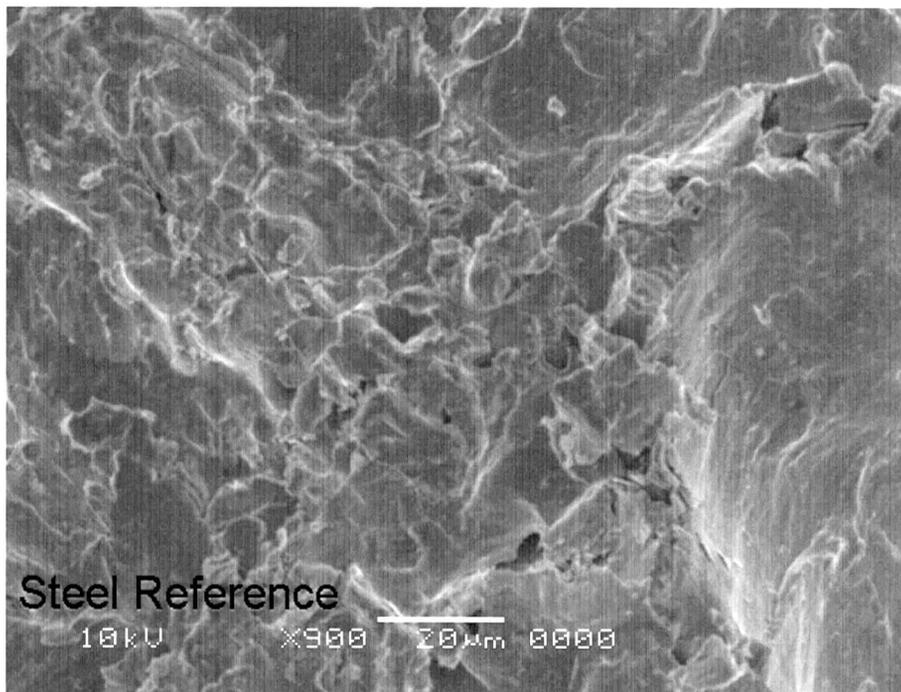
Figure 7

SEM micrograph of steel substrate reference, not exposed to the laser. Magnification: 900X

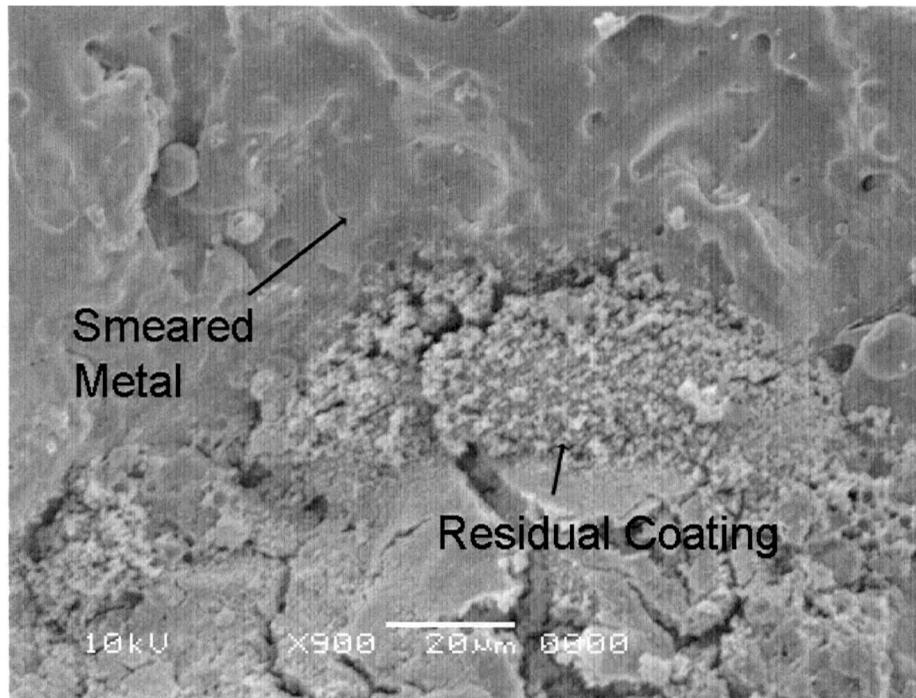
Figure 8

SEM micrograph showing the smeared surface and residual coating of the primed and painted sample exposed to the laser de-paint process. Magnification: 900X

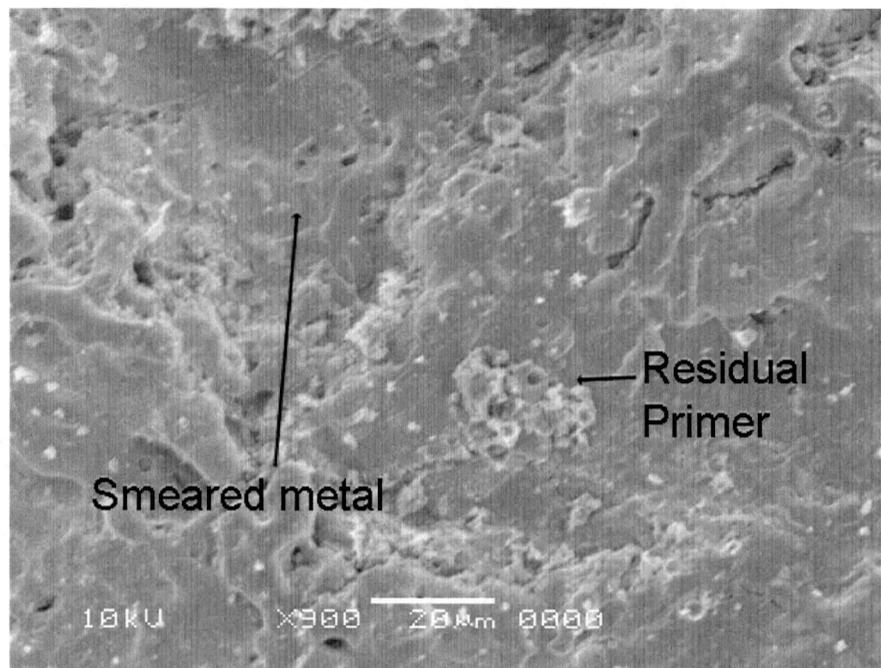
Figure 9

SEM micrograph showing the smeared surface and residual coating of the steel sample with only the green primer applied. Magnification: 900X
