Re-Engineering the ISS Payload Operations Control Center During Increased Utilization and Critical Onboard Events

Stephanie R. B. Dudley¹ and Angela L. Marsh²
National Aeronautics and Space Administration, Huntsville, AL, 35812

With an increase in utilization and hours of payload operations being executed onboard the International Space Station (ISS), upgrading the NASA Marshall Space Flight Center (MSFC) Huntsville Operations Support Center (HOSC) ISS Payload Control Area (PCA) was essential to gaining efficiencies and assurance of current and future payload health and science return. PCA houses the Payload Operations Integration Center (POIC) responsible for the execution of all NASA payloads onboard the ISS. POIC Flight Controllers are responsible for the operation of voice, stowage, command, telemetry, video, power, thermal, and environmental control in support of ISS science experiments. The methodologies and execution of the PCA refurbishment were planned and performed within a four-month period in order to assure uninterrupted operation of ISS payloads and minimal impacts to payload operations teams. To vacate the PCA, three additional HOSC control rooms were reconfigured

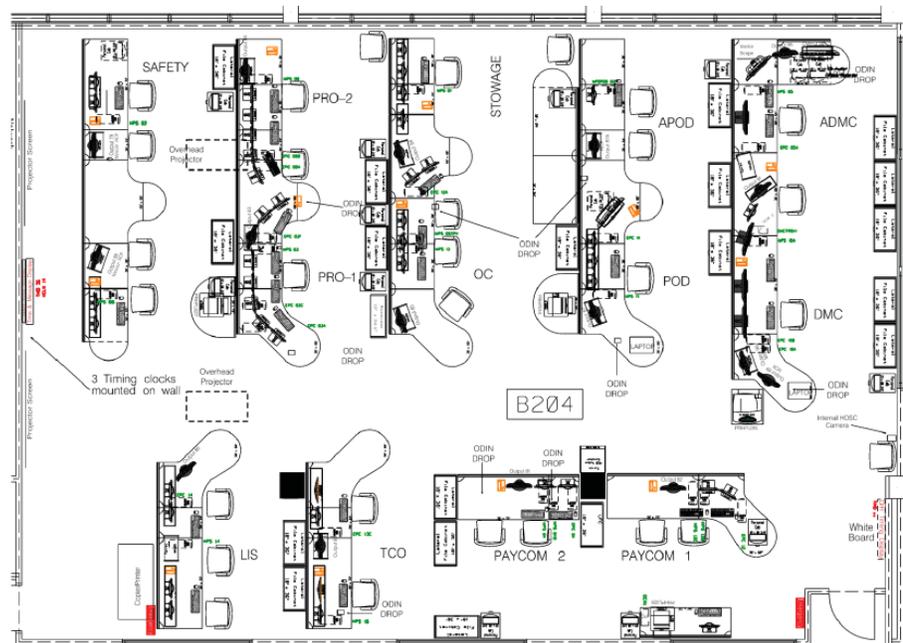
The existing PCA-1 consoles were 12 years old and not designed to expand to meet ISS payload flight controller increasing operations concepts. Console tops were overcrowded. Two projectors were being used to display information that was not being utilized by the console operators because the quality of the projectors and arrangement of the consoles did not allow ease of use. Video wall technologies had been investigated and it was a big desire to have a video wall installed as part of the upgrade. Larger screen monitors had been mounted around the walls of the room in an ad hoc manner, so it only made sense to seriously consider a video wall implementation. Other constraints that had to be considered were two structural columns in the room that were not removable, and whether to remove the flags

Figure 2. Drawing of PCA-1 before redesign.

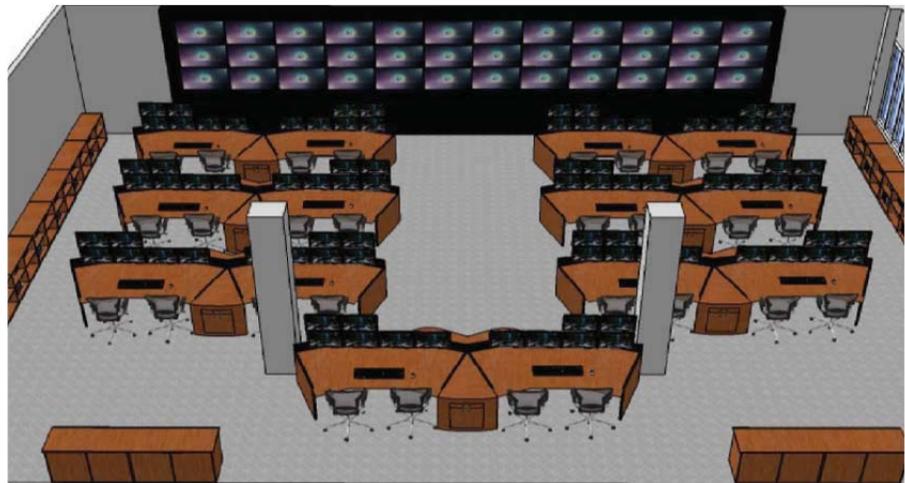
A 3D Computer Aided Drawing (CAD) tool was used to analyze orientation of the room, possible console widths and depths, storage, and amenities. With all the options to consider, the team realized that turning the room 90 degrees clockwise, facing the north wall, would give more area for a video wall, meaning more information could be displayed and shared among the cadre. It also meant that the operators in the back row were much closer than they would be if the video wall were on the west wall. Lastly, turning the layout 90 degrees provided a better view from the viewing room because the consoles were arranged perpendicular to the glass, giving a tour group a view down the entire length of each row.

Figure 3. Initial 3D conceptual rendering of PCA-1.

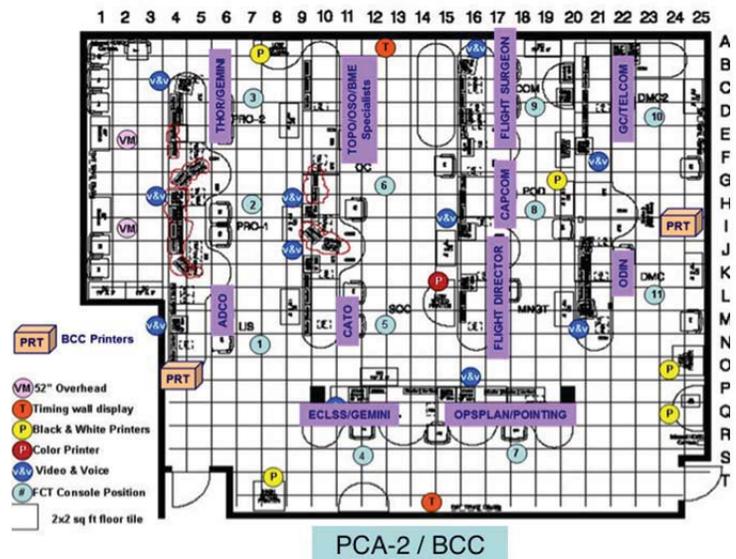
Figure 4. PCA-2 configuration for BCC.

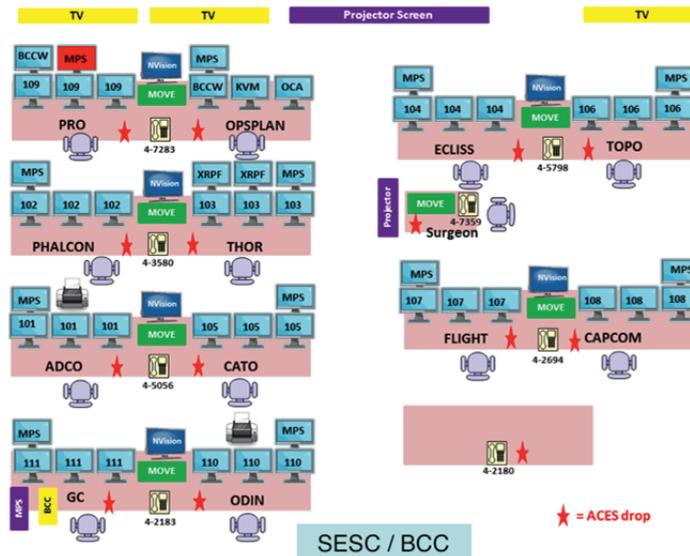
In 2013, JSC was engineering the delivery of a new Mission Critical Environment (MCE) that consolidated MCC-H mission critical systems which included the BCC system. New BCC MCE hardware had been designed, engineered, and installed at the HOSC. With the delivery schedule of the MCC-H BCE shifting, BCC training and certification for 2013 Hurricane system was required to be completed for both the BCC operational system and the BCC MCE re-engineering deliveries.

Figure 5. SESC configuration for BCC.

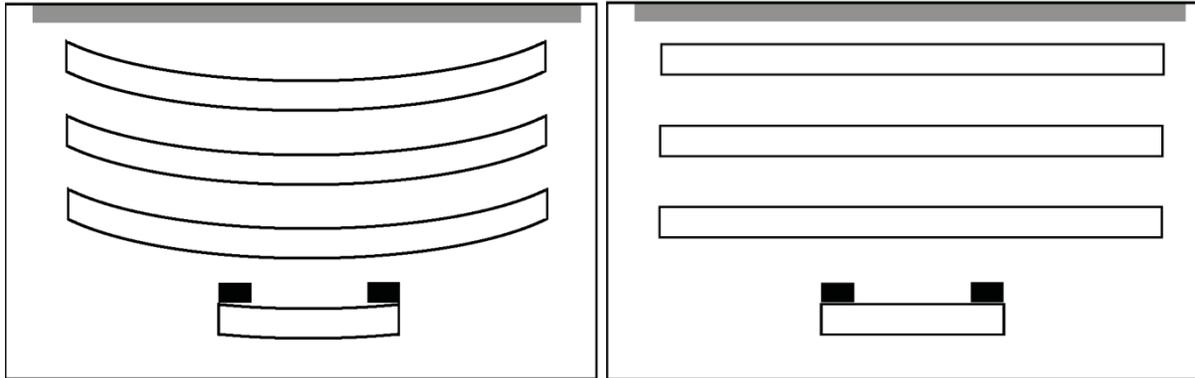
Once the decision was made to turn the room to face north, different console layouts were considered. One option was an arc design: 3 full-length rows of consoles on a slight arc, plus one shorter arc in the back, Figure 6, left. This concept left too little room between the third row and the columns, making areas unusable. Another option was essentially the same, but without the arc, simply 4 straight rows of consoles, Figure 6, right. The flight control team requested a walkway down the center of the room, so that console operators could walk to different rows without walking all the way around the room. There was no need to break the first row since no one would need to

Figure 6. Initial PCA-1 layout concepts.

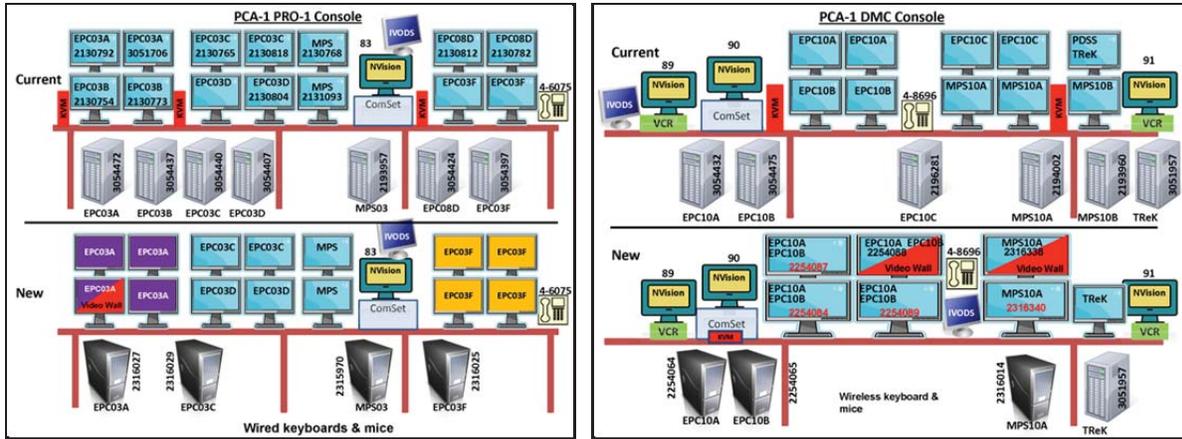
The old PCA-1 console layouts were studied with each console operator position team. New layouts were developed based on the new design of the room. For example, the Payload Communicators (PAYCOMs) decided to unstack their monitors so they have a better view of the video wall. The DMCs, with stacked 30” monitors, shifted their communication set placement to create a gap for face-to-face communication with the Payload Operations Director (POD), who sits in front of them, as shown in Figure 7.

Figure 7. Equipment Configuration of PRO and DMC consoles in PCA-1.

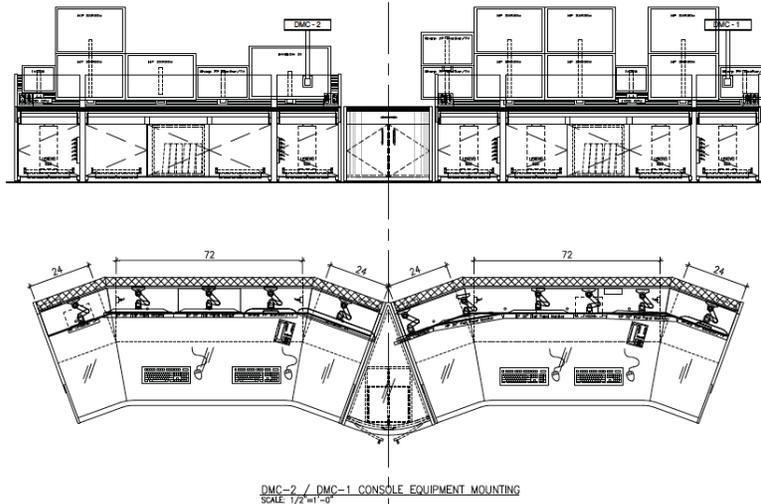
Figure 8. DMC-2 and DMC-1 console drawings.

Flight controllers typically keep a vast amount of reference material at their fingertips for use in both emergency situations and nominal operations. Accommodations for storage, either in the consoles themselves, or in nearby bookcases was required. The Strategy™ consoles have bays underneath the desktop, which open from both front and back, for slide-out processor trays, storage, or rack mounted equipment. The PCA-1 consoles have 5 bays each. One bay was configured for operator storage and the other 4 bays were configured with slide-out processor trays.

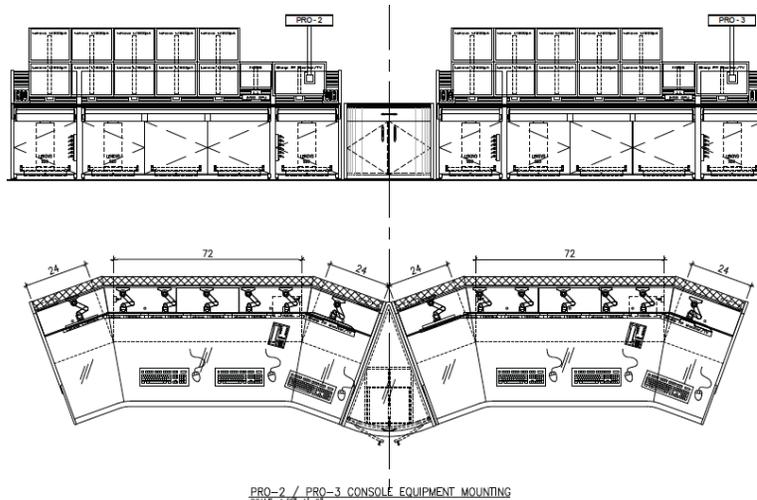
Figure 9. PRO-2 and PRO-3 console drawings.

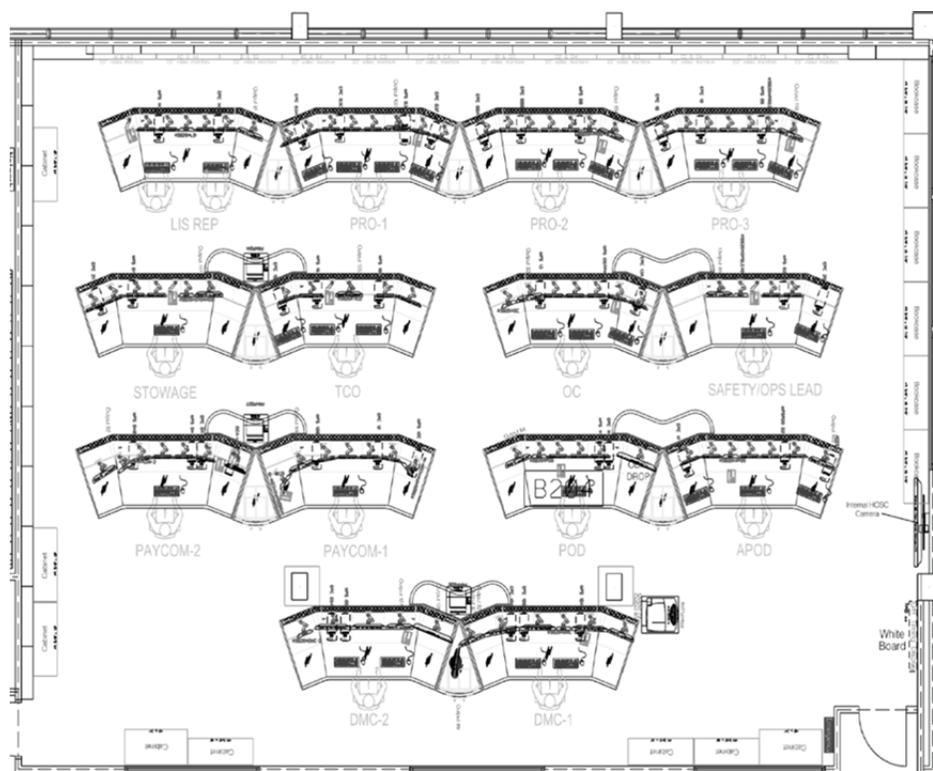
In addition to the consoles, several amenities were also purchased to round out the room design with matching furniture. There are six bookcases of 2-shelf height designed to fit 3-ring binders. There are six similar bookcases with doors. The open bookcases are positioned along the wall underneath the viewing room windows since tour groups or the television cameras cannot see them. Three of the closed bookcases are along the mural wall and three are on the back wall. There are two extended depth cabinets designed for printers. The nook on the backside between

Figure 10. PCA-1 room layout, with bookcases pictured.

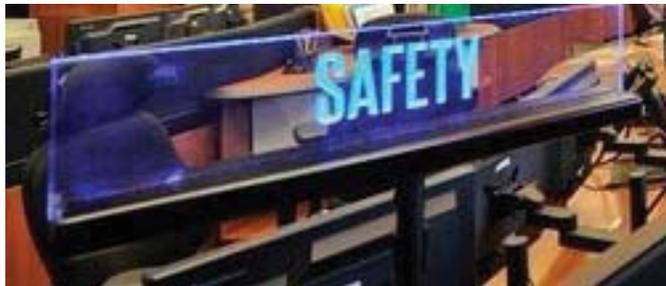
Each console has a lighted position call sign fabricated from engraved glass that is mounted to the slat wall. Each sign has a remote that allows the operator to change the color of the sign. PCA-1 flight controllers use them as another means of communication. For example, the POD will ask the team to change to a specific color when they are ready for a certain operation or have finished a certain task.

Figure 11. Lighted position call sign.

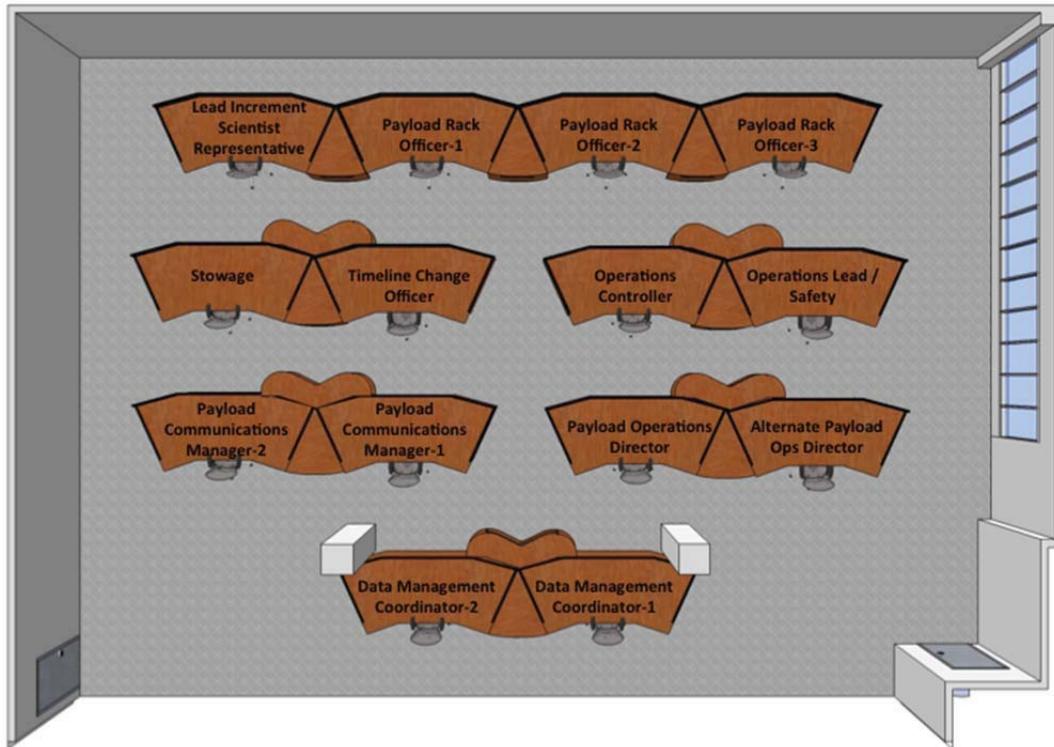
The 3 PROs were arranged on the front row in the right three spots. Currently POIC staffs 2 PROs on most shifts and only brings in a third PRO when there are complex ops and an expert is required. Since PRO-3 is not always staffed, we decided to put them furthest from POD (front row, all the way to the right). So if POD wants to have an over the wall conversation with the PROs, most of the time they just walk up the center aisle and need not transverse the row. The Lead Increment Scientist Representative (LIS Rep) attends a lot of meetings with the science community, so the spot remaining works well for them as they are on an outside aisle near the door. Figure 13 shows the final arrangement of PCA-1.

Figure 13. Layout of PCA-1 console positions.

Once the room orientation, consoles, and basic layout were determined, a great deal of thought went into deciding where each position would sit in the room. The huge monitors of the DMCs would be an obstacle to any flight controller's view of the video wall, so they needed to be either in the first or last row. Likewise the PROs have 10-14 normal sized monitors stacked, creating a wall. The old PCA-1 had 2 PRO consoles and 2 DMC consoles and we were looking to create a third PRO console for future capability increase in the new design. Splitting the PROs between different rows did not make sense, so the 2 DMC consoles went on the back row and the 3 PRO consoles went to the front row.

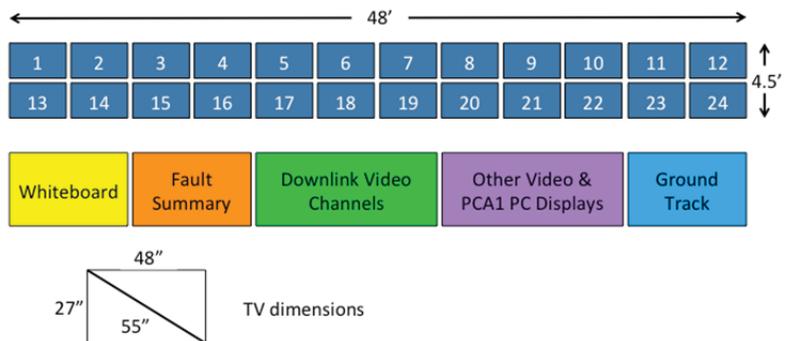
With more than 200 experiments being conducted on the ISS, the need for information sharing among ground controllers led to the need for a video wall. RGB Spectrum¹ was selected as the vendor for the video wall. Composed of a 2x12 configuration of monitors using a display processor to route and display up to 32 input signals, ground controllers are now enabled to share information in real-time, such as live video feeds, diagrams, photographs,

Figure 14. PCA-1 Video Wall, including dimensions and video sources.
