NASA/TP-2015-218674  
NESC-RP-13-00884

# Spin Forming Aluminum Crew Module (CM) Metallic Aft Pressure Vessel Bulkhead (APVBH) – Phase II

*Eric K. Hoffman and Marcia S. Domack  
Langley Research Center, Hampton, Virginia*

January 2015

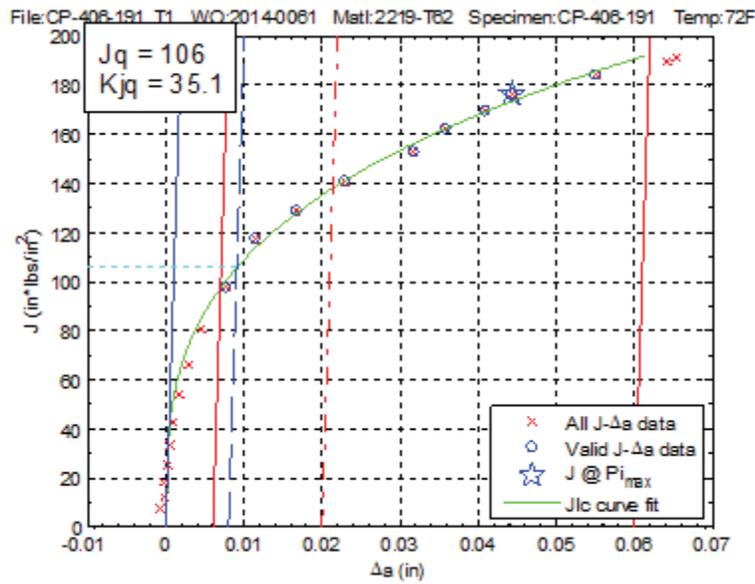
Figure 8.4-6. Typical  $J_c$  Fracture Toughness R-Curve Plot

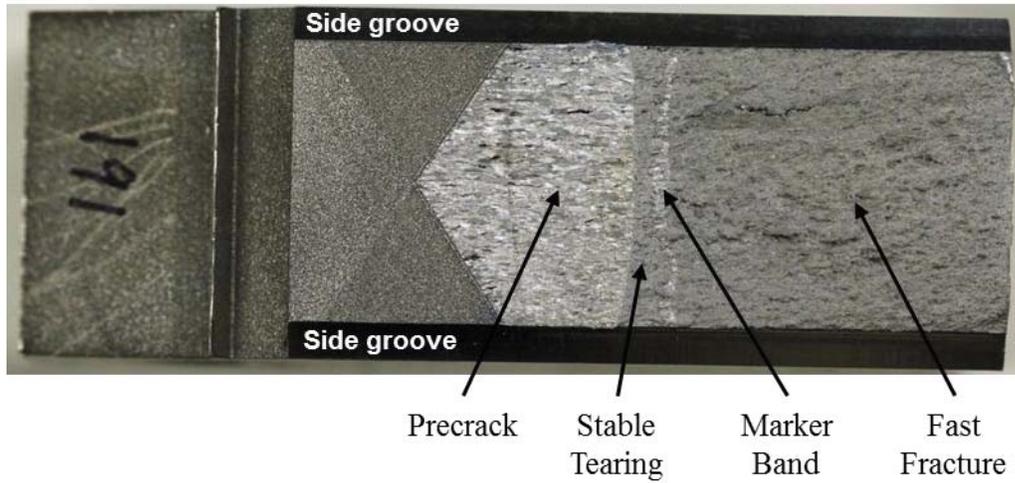
**Figure 8.4-7. Typical Cross-Sectional Fracture Surface of a  $J_{1C}$  Fracture Toughness Specimen (specimen shown is CP-406-191 from coupon blank M1 in the L-T orientation)**

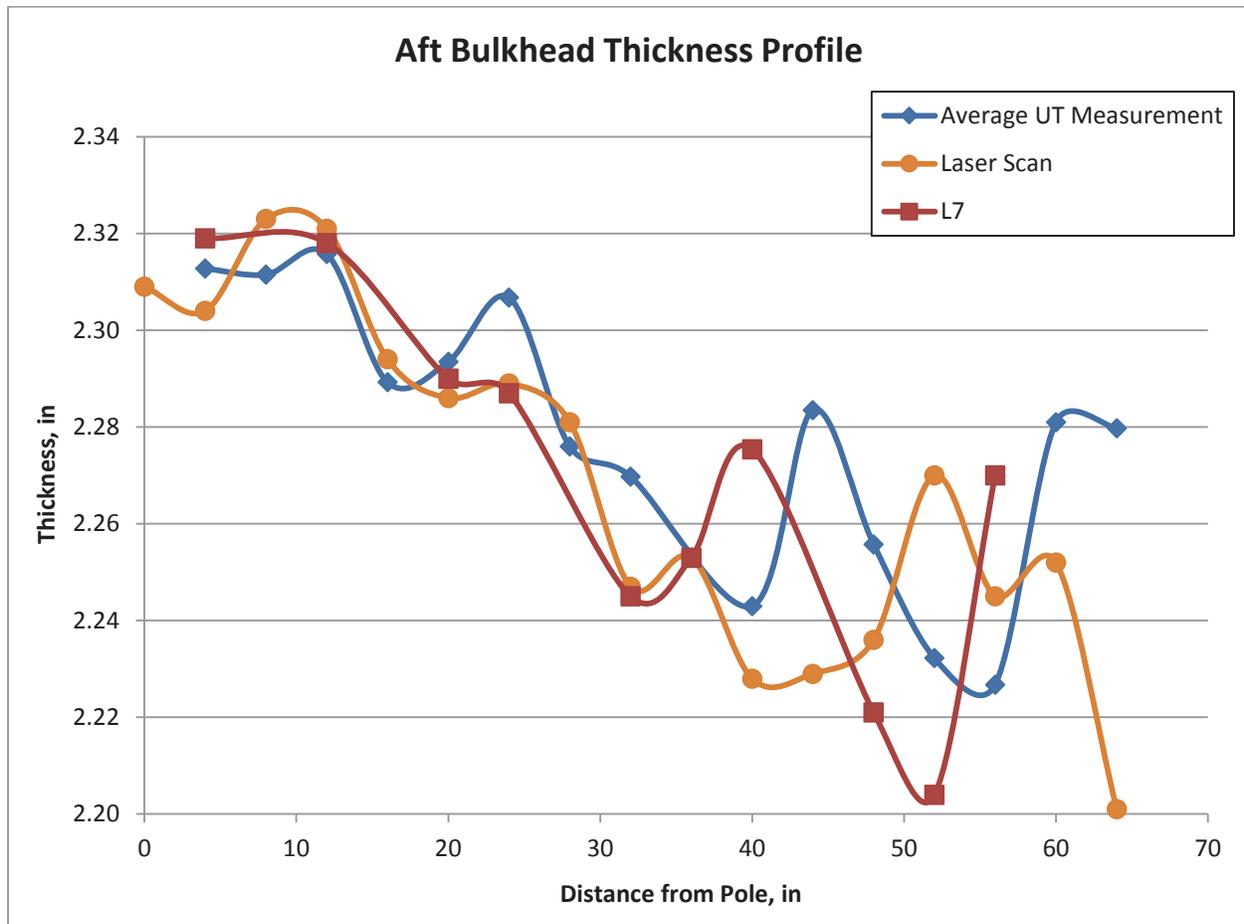
Figure 10.1-1. Thickness Profile of Coupon Blank L7 Compared with the UT and Laser Scan Data

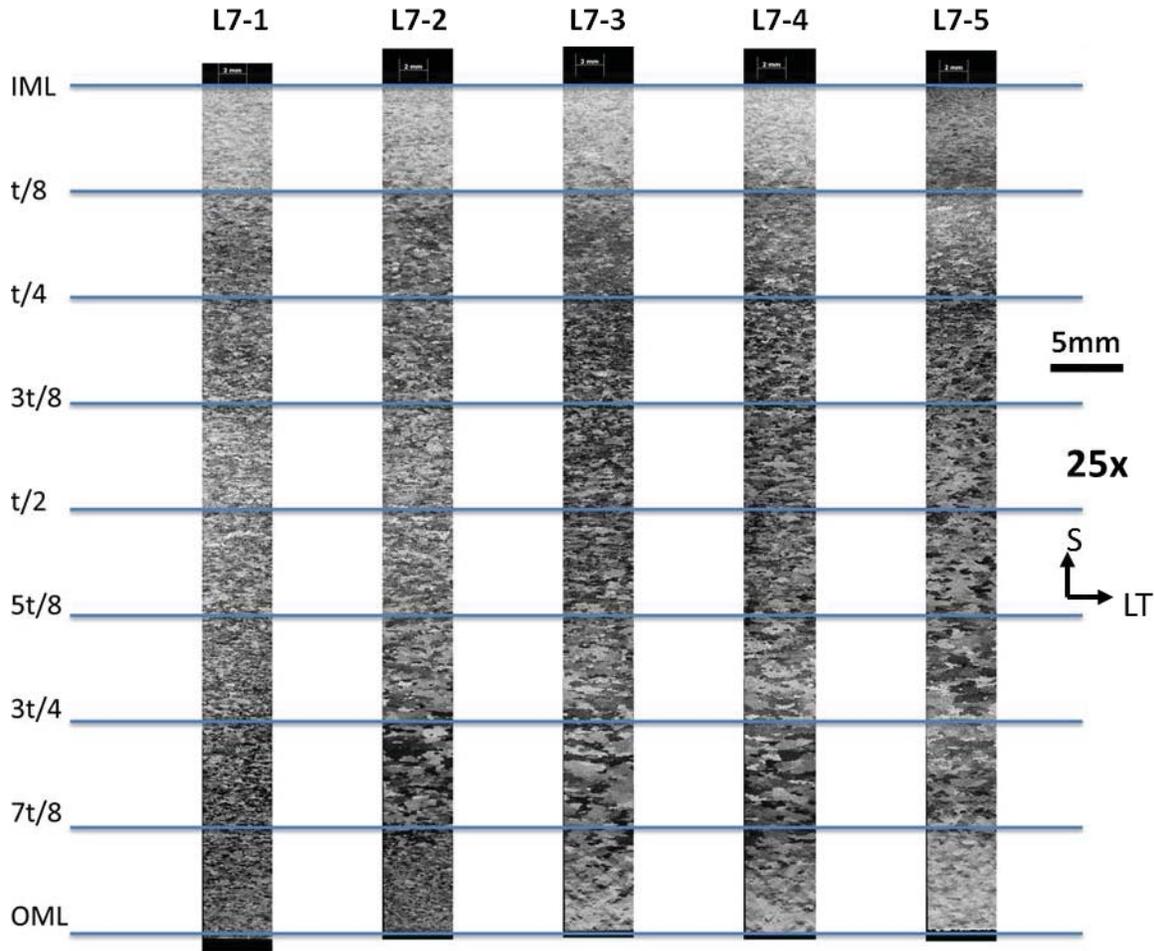
**Figure 10.1-2. Through-thickness Microstructures of the Aft Bulkhead at Locations Along the  $0^\circ$  Meridian**

exhibits regions of larger grain size, most likely due to strain induced recrystallization, primarily towards the OML surface where the forming tool contacts the plate. Notably larger grain size is observed between  $3t/4$  and  $7t/8$  starting with L7-2 and more pronounced in L7-3 and L7-4. Macroscopic deformation bands are observed near the OML, particularly in samples L7-3, L7-4, and L7-5.

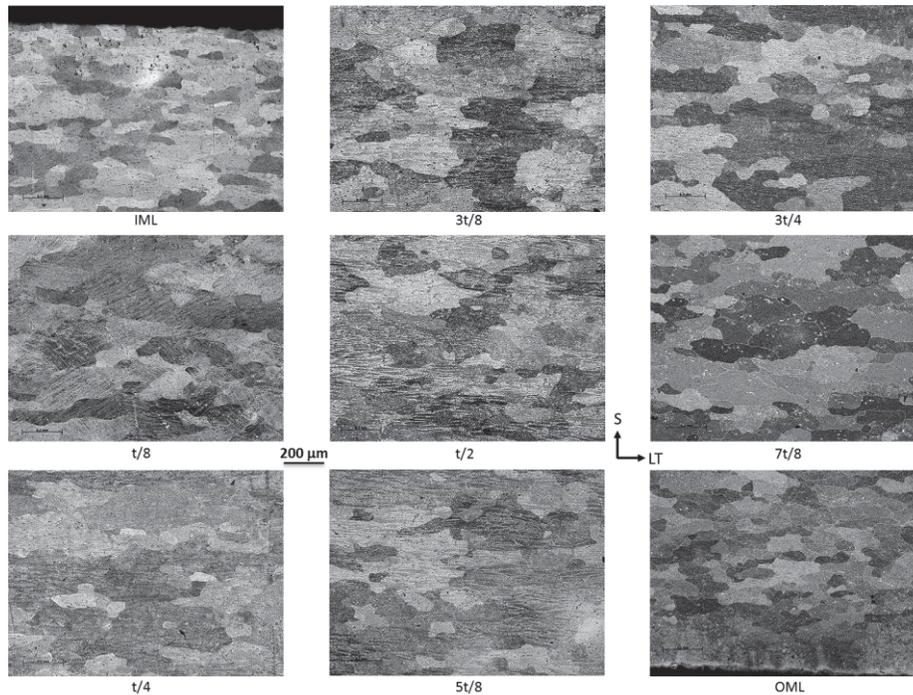
**(a) Microstructure at L7-1 (L/8, 8 inches from the pole)**

bands, more heavily in the unrecrystallized regions. Aligned precipitation in the recrystallized regions may indicate that the prior deformation history associated with both plate rolling and spin forming is not completely erased during SHT. Alternatively, the alignment may indicate precipitation on slip planes (14), (15), (16).

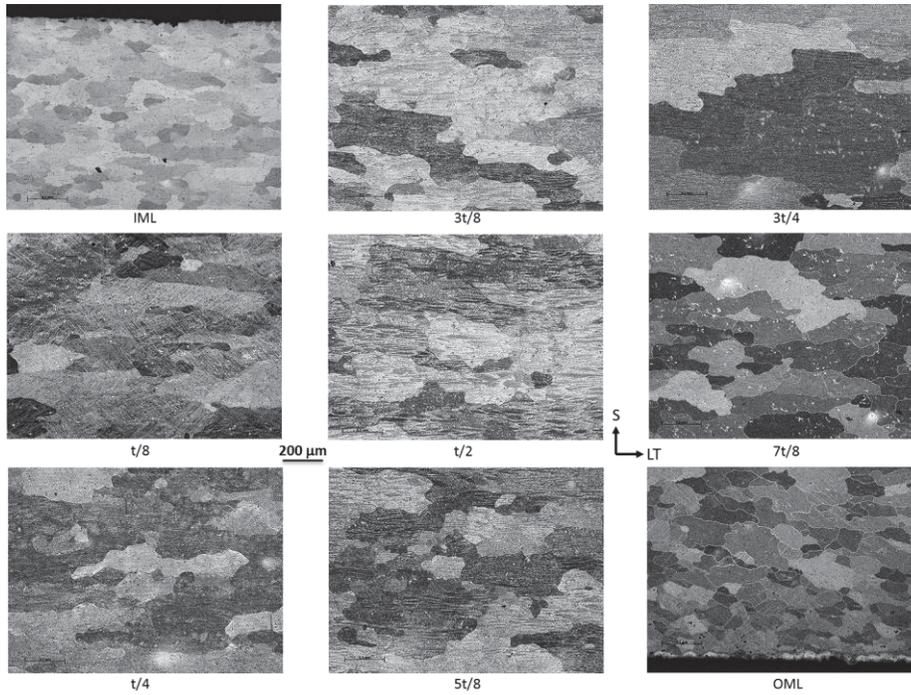
**(b) Microstructure at L7-2 (L/4, 16 inches from the pole)**

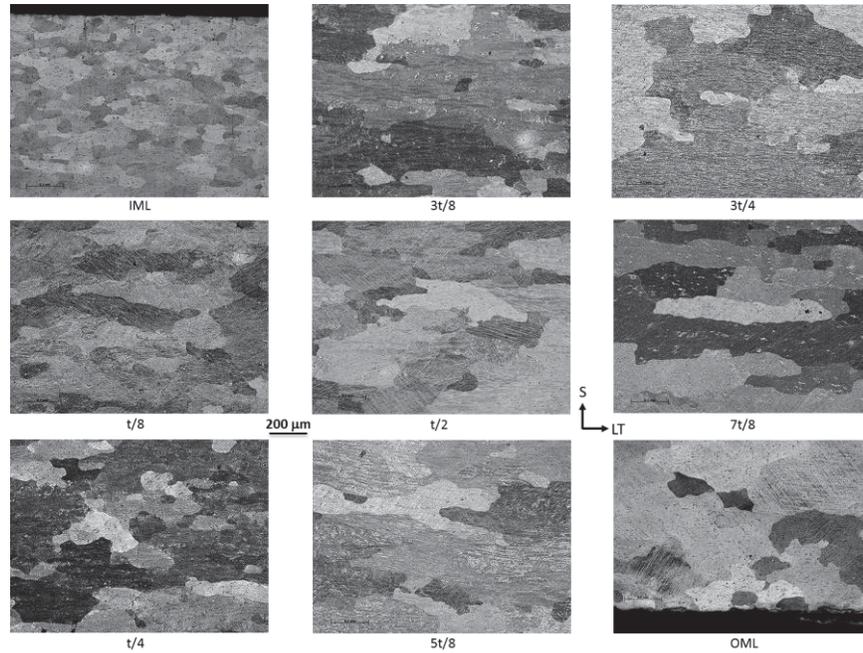
**(d) Microstructure at L7-4 (3L/4, 43 inches from the pole)**

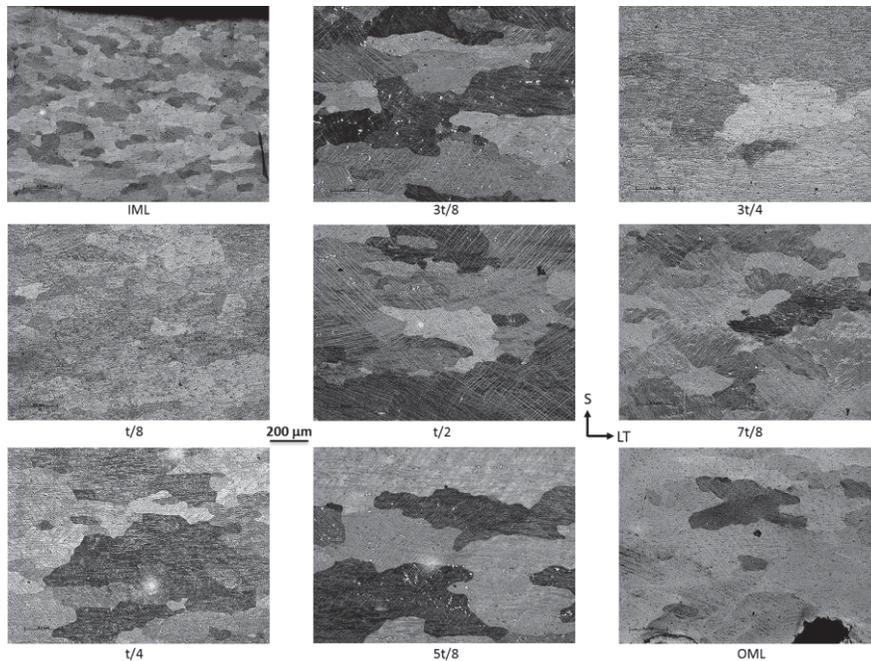
**(e) Microstructure at L7-5 (L, 61 inches from the pole)**

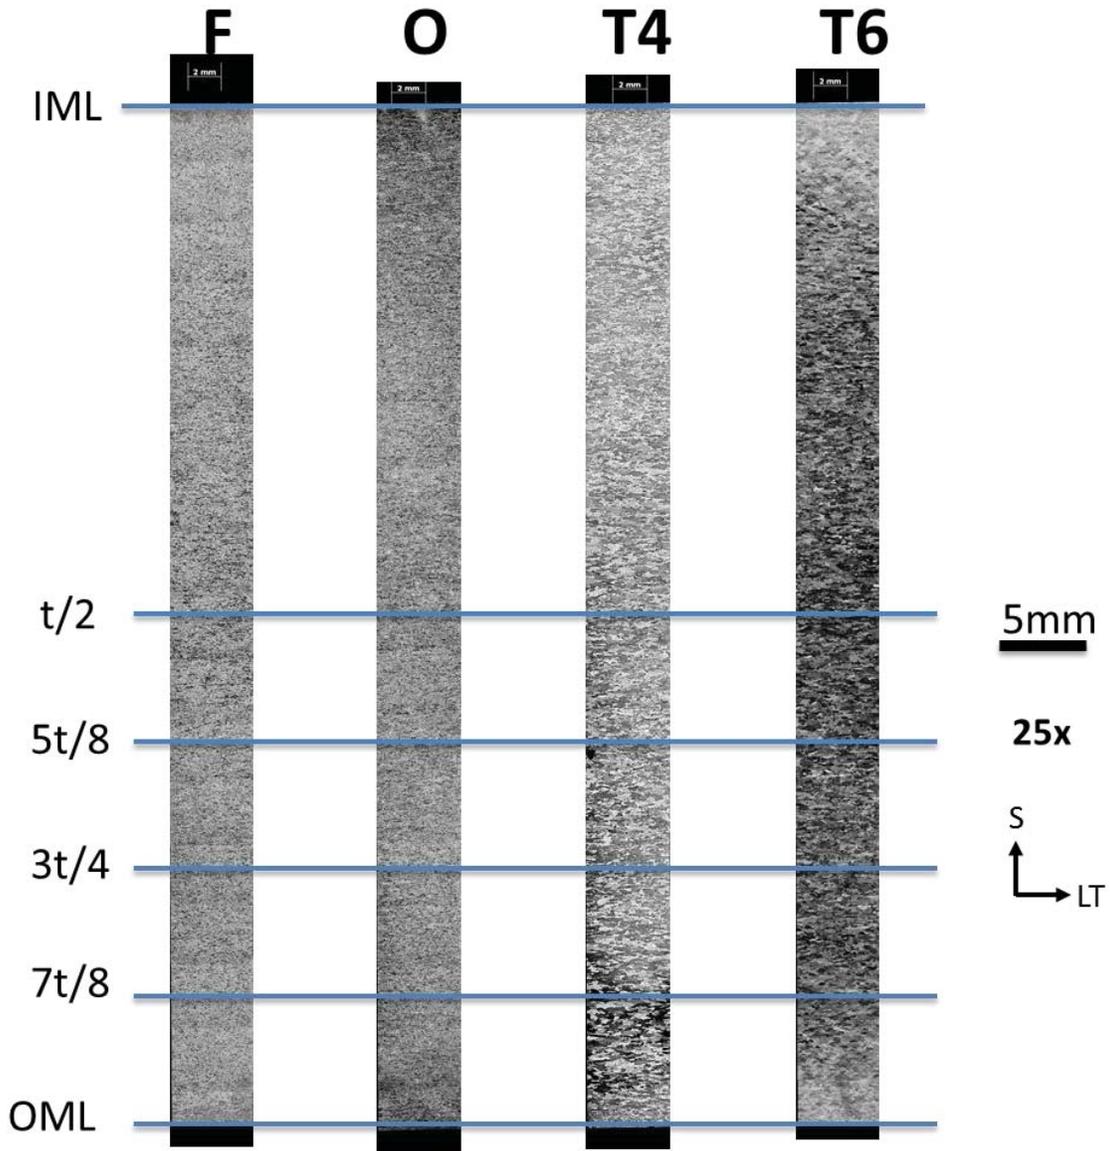
*Figure 10.1-4. Through-Thickness Microstructures of the Thermally Processed Test Blocks*

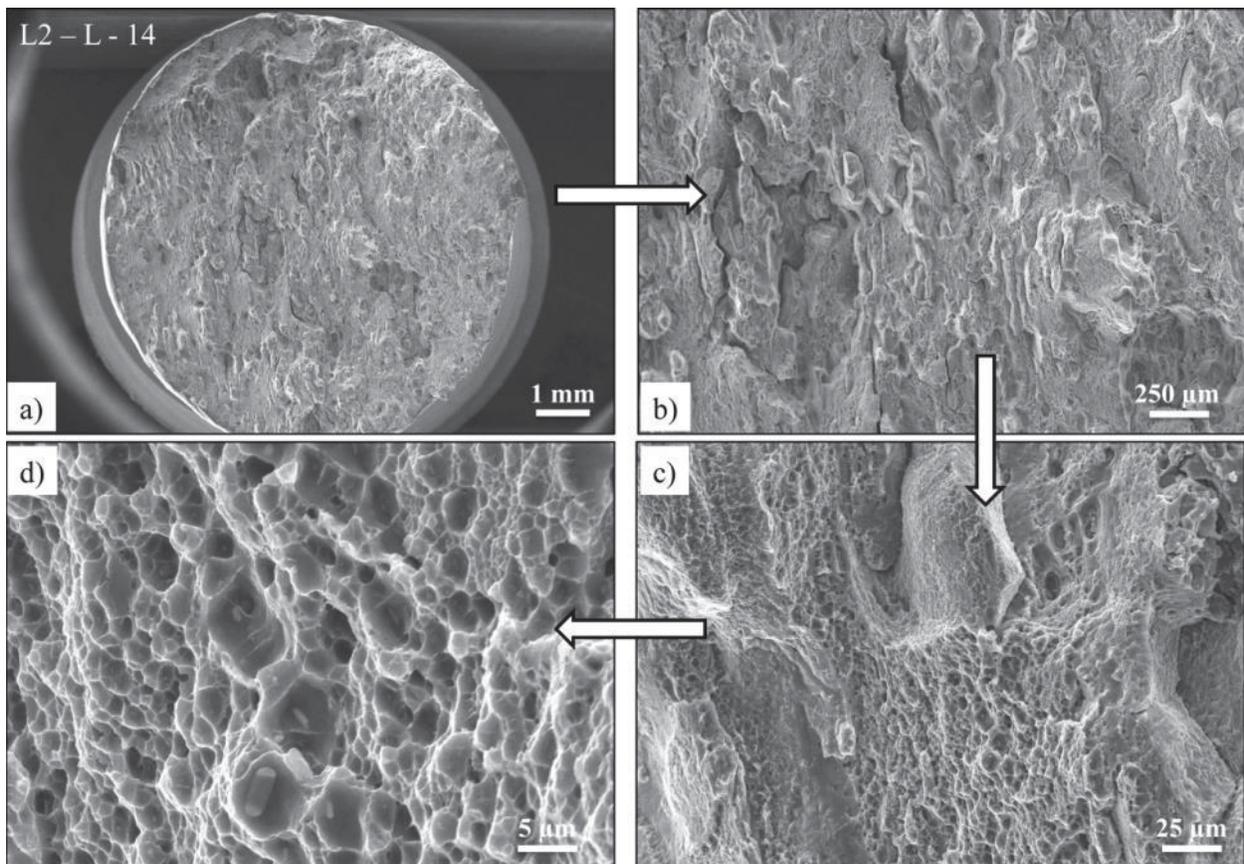
**Figure 10.2-19. SEM Images of the Fracture Surface of Tensile Specimen L2-L-14 at a) 14x; b) 50x; c) 500x and d) 2,000x Magnifications**

revealing a fibrous appearance with noticeable ridges and valleys, which is typical of fracture in Al alloy plate. The fibrous features are associated with transgranular fracture of elongated grains in rolled plate and the ridges with transition between grains. At 50x (Figure 10.2-19b), regions of transgranular microvoid coalescence are observed along with regions of lower ductility fracture and small delaminations, features that generally correlated with grain size. Higher magnification (500x, Figure 10.2-19c) confirms that all regions exhibit microvoid coalescence consistent with ductile fracture, with dimple sizes larger in the regions of transgranular fracture. At 2,000x (Figure 10.2-19d), dimples ranging from sub-micron size to approximately 5  $\mu\text{m}$  are observed. Overall, fractography indicates the L and LT tensile specimens failed in a typical, ductile manner, which correlates well with the elongation values measured during the tensile tests.

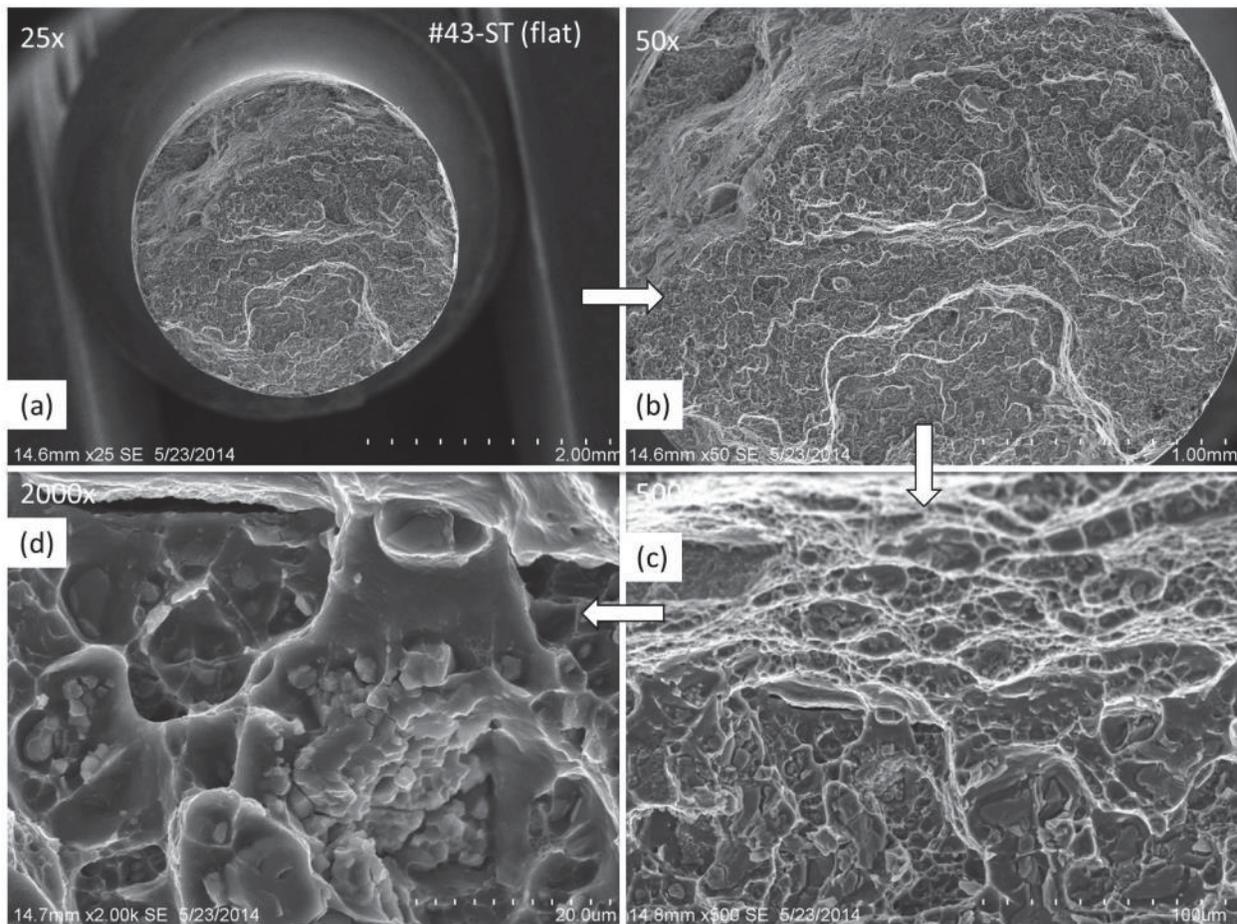
**Figure 10.2-20. SEM Images of the Fracture Surface of Tensile Specimen ST-43 at (a) 25x; (b) 50x; (c) 500x; and (d) 2,000x Magnifications**

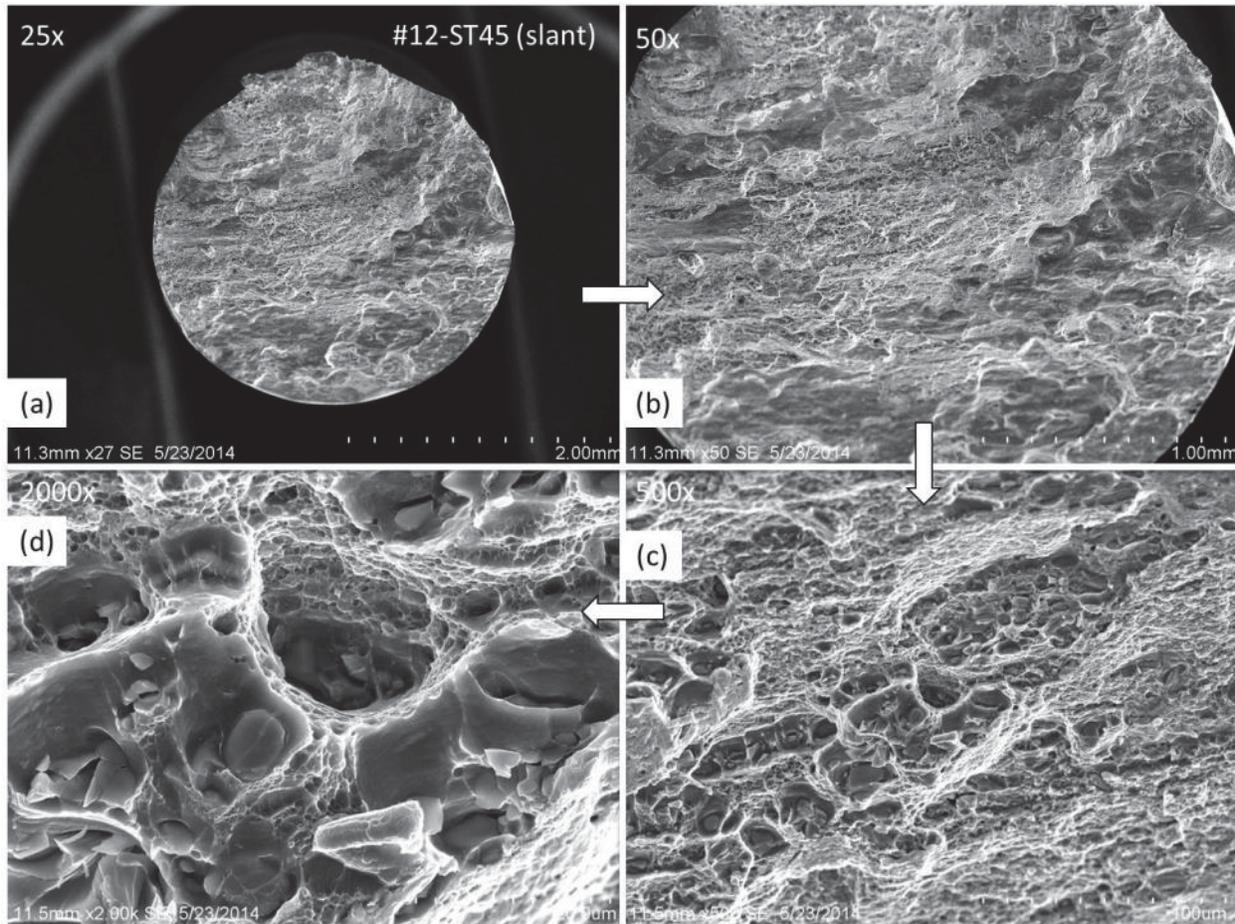
**Figure 10.2-21. SEM Images of the Fracture Surface of Tensile Specimen ST45-12 at (a) 25x; (b) 50x; (c) 500x; and (d) 2,000x Magnifications**

stringers of smaller particles (view (d)). The ST45 fracture surface shown in Figure 10.2-21 exhibits some fibrous texture associated with transgranular crack propagation, but without the pronounced ridges and valleys noted on the L and LT fracture surfaces. Large microvoids are noted, again forming at constituent particle populations; however, more colonies of small microvoids are noted than in the ST fracture. The features noted in the ST and ST45 fractures are consistent with the lower ductility levels measured during tensile tests when compared with the L and LT orientations.

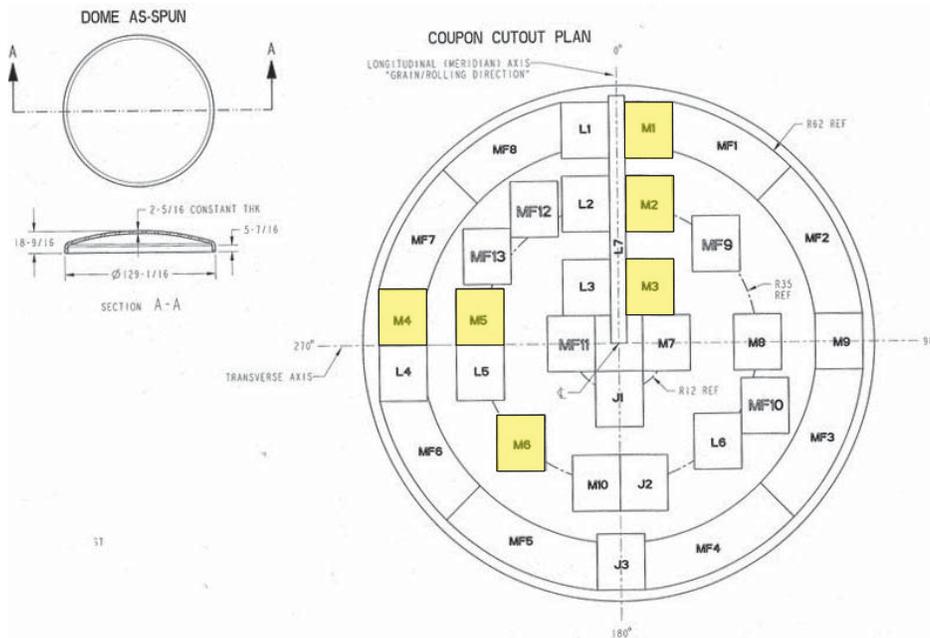
Figure 10.3-1. Aft Bulkhead Cut Plan showing the Location of the Fracture Coupon Blanks highlighted in Yellow

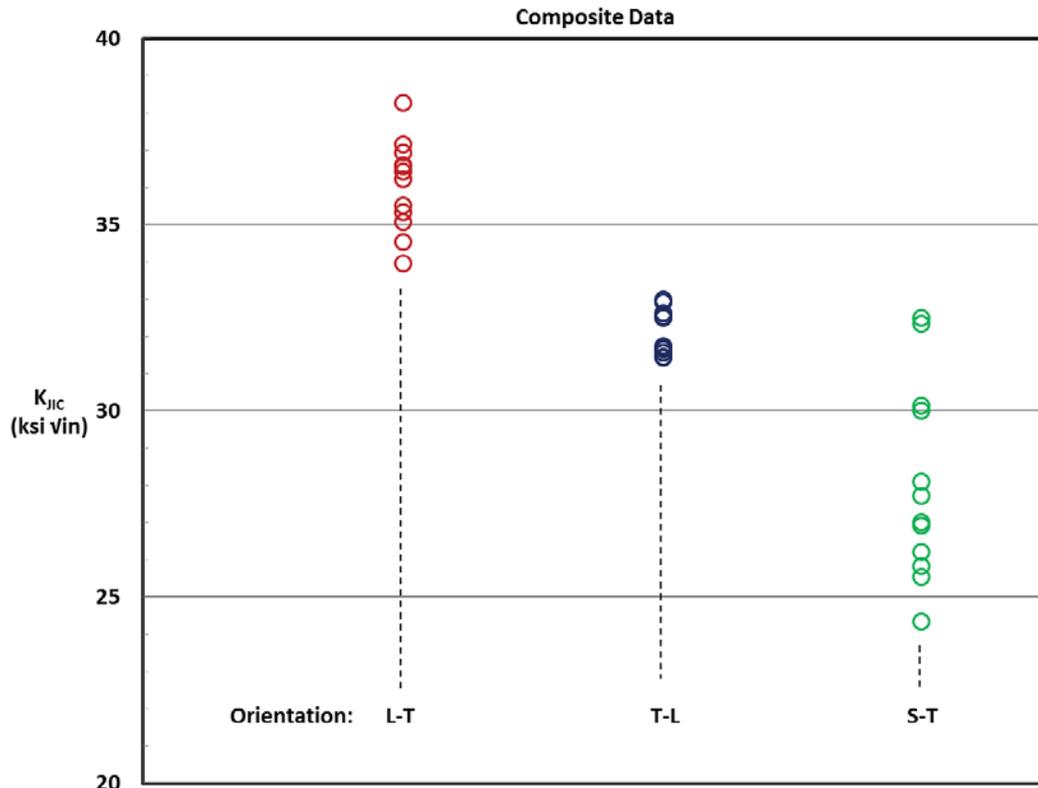
**Figure 10.3-2. Fracture Toughness Data as a Function of Orientation**

The composite fracture data is shown in Figure 10.3-2. This figure reflects all data taken from various locations across the aft bulkhead and is plotted for each orientation. Fracture toughness values vary with orientation as expected. Specifically, toughness in the L-T orientation is higher than toughness in the T-L orientation, which in turn is higher than toughness in the S-T orientation.

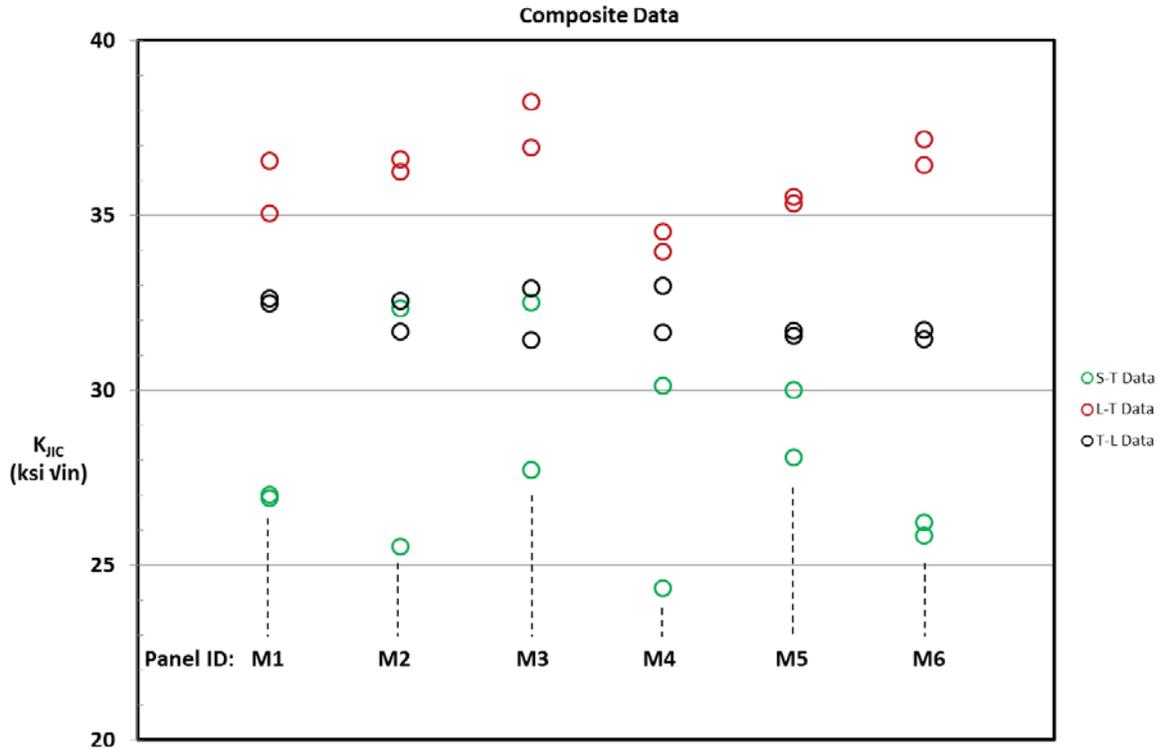
*Figure 10.3-3. Fracture Toughness Data as a Function of Coupon Blank Location and Grain Orientation*

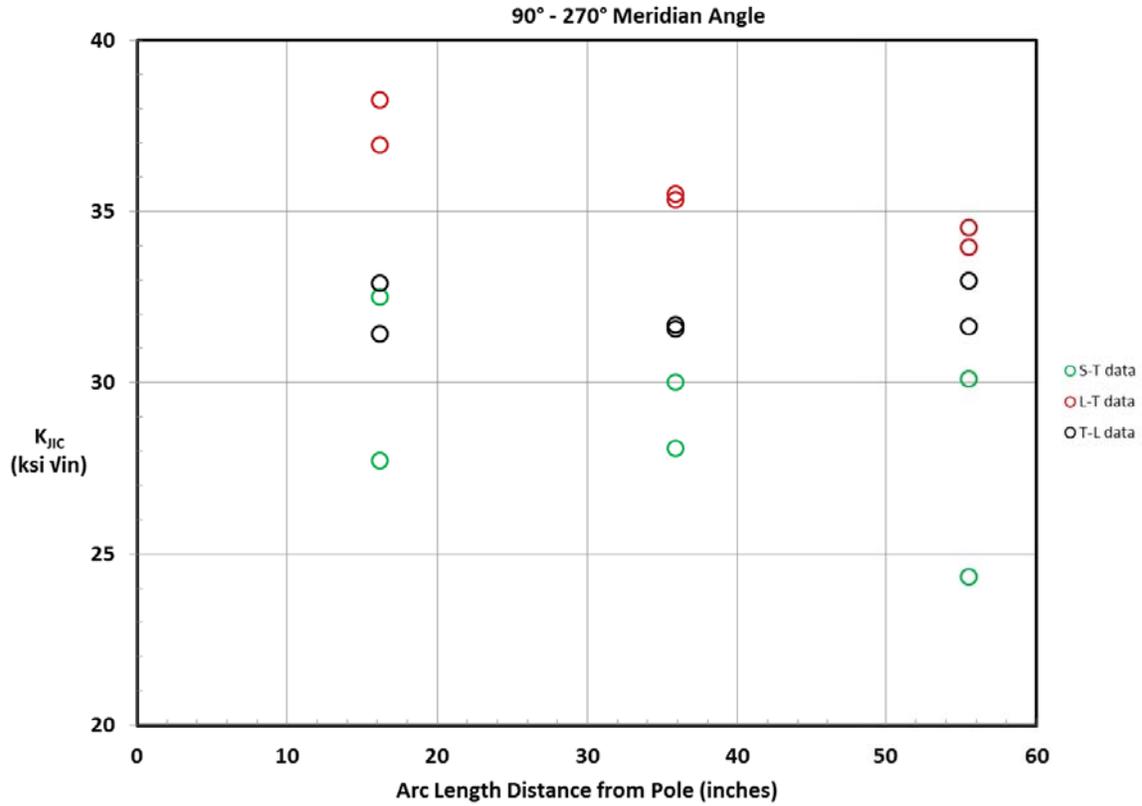
*Figure 10.3-5. Fracture Toughness Data as a Function of Arc Length Distance from Pole for the 90° to 270° Meridian*

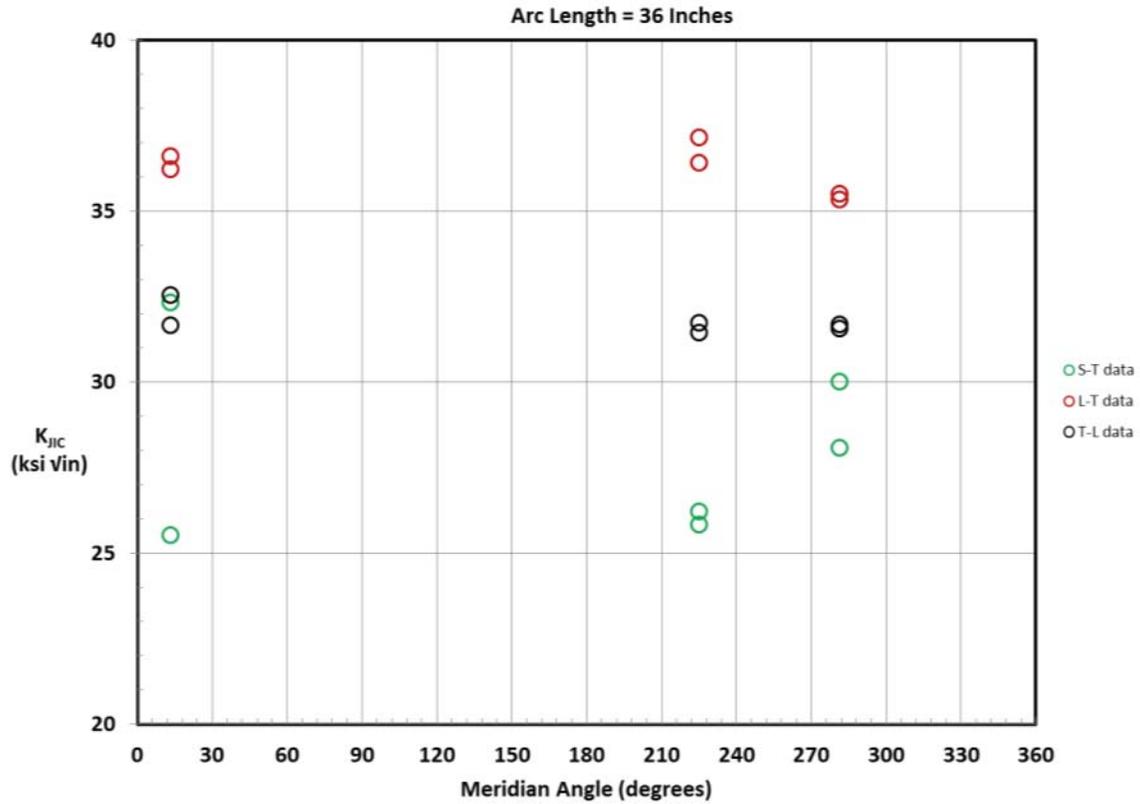
*Figure 10.3-6. Fracture Toughness Data as a Function of Meridian Angle for Arc Length Distance of 36 Inches*

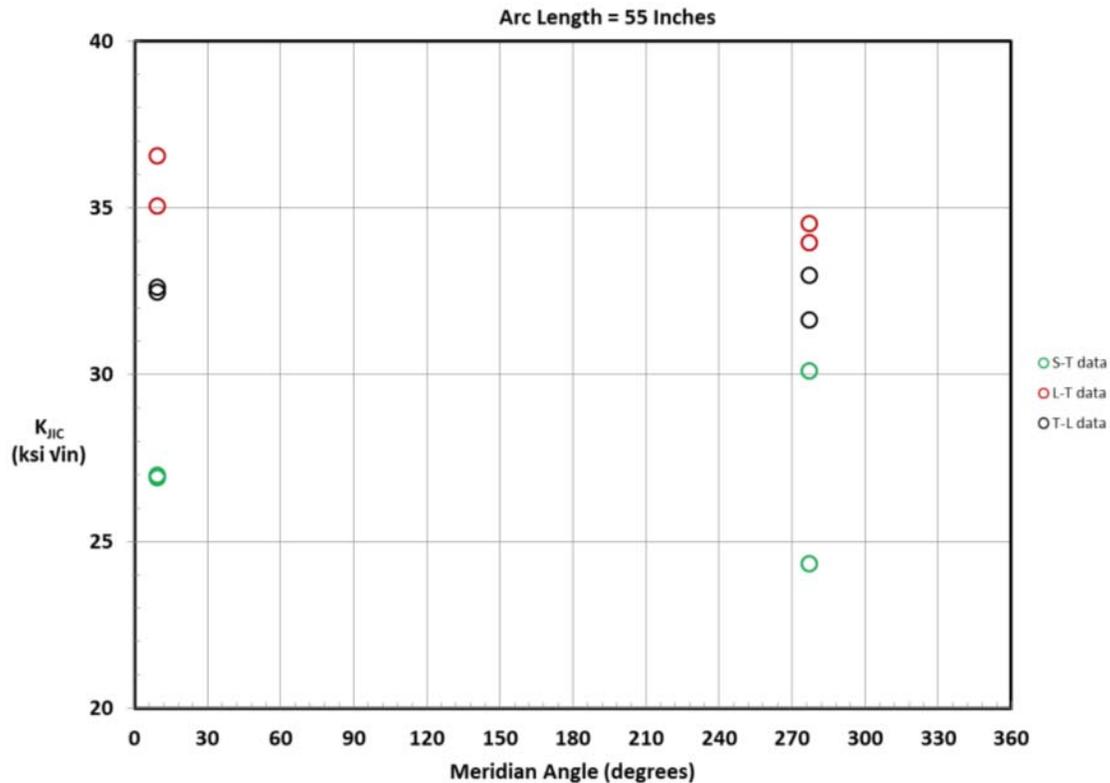
**Figure 10.3-7. Fracture Toughness Data as a Function of Meridian Angle for Arc Length Distance of 55 Inches**

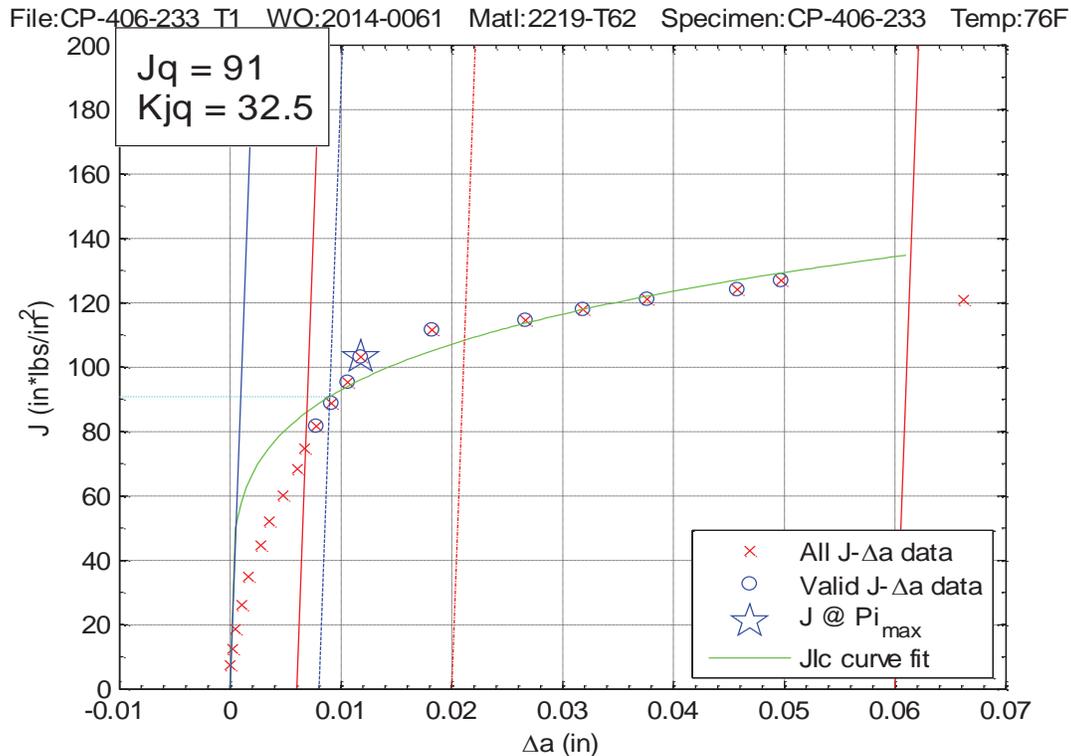
**Figure 10.3-10. J-R Curve for Spin Formed Al 2219-T62 Aft Bulkhead Material in the S-T Orientation; Coupon Blank M3, Specimen CP-406-233**

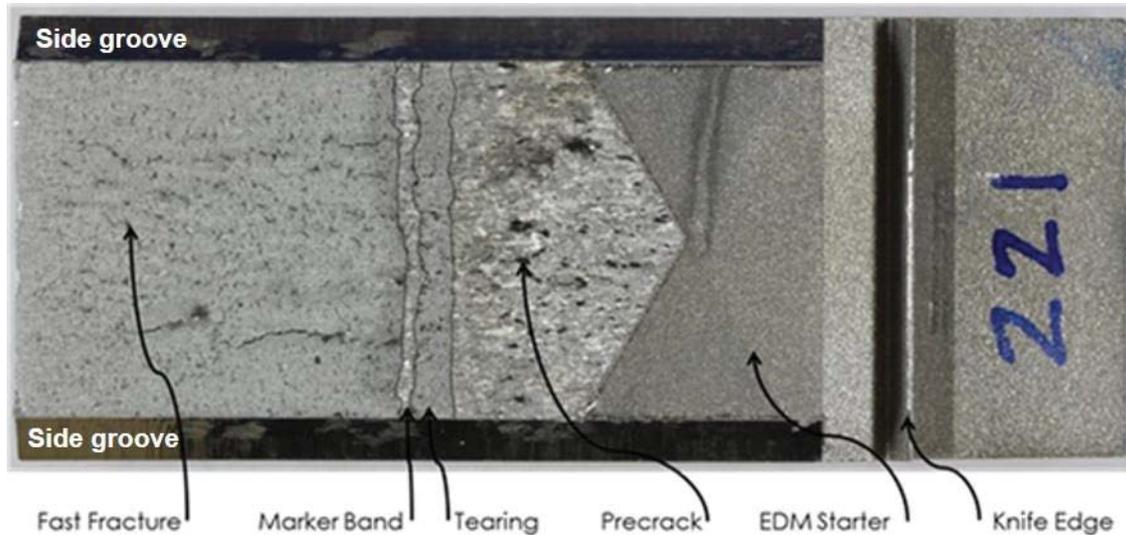
**Figure 10.3-12. Photomicrograph of Fracture Surface of L-T Fracture Specimen from Coupon Blank M2**

uniform. Conversely, the tearing region for the S-T specimen (Figure 10.3-13) is more irregular and exhibited more topography than the T-L and L-T regions.

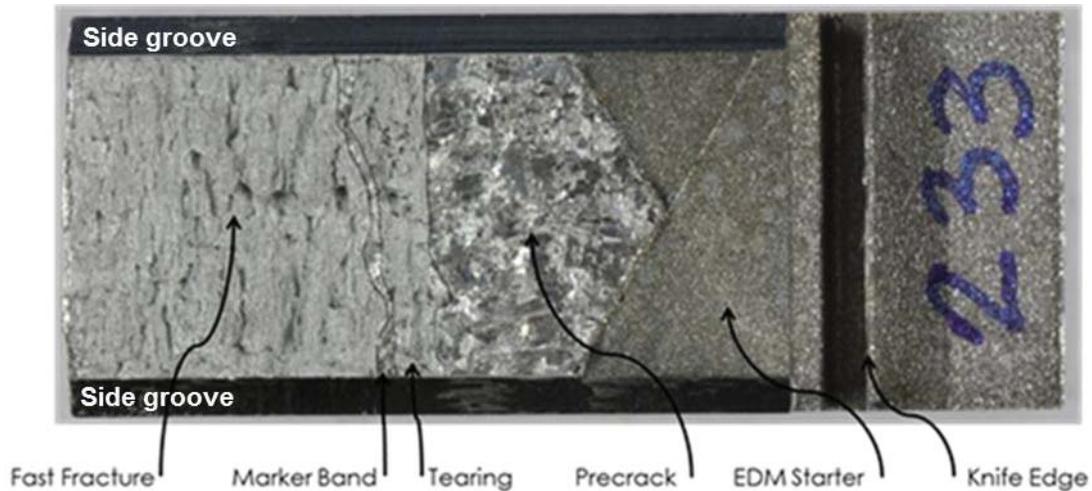
**Figure 10.3-13. Photomicrograph of Fracture Surface of S-T Fracture Specimen from Coupon Blank M2**

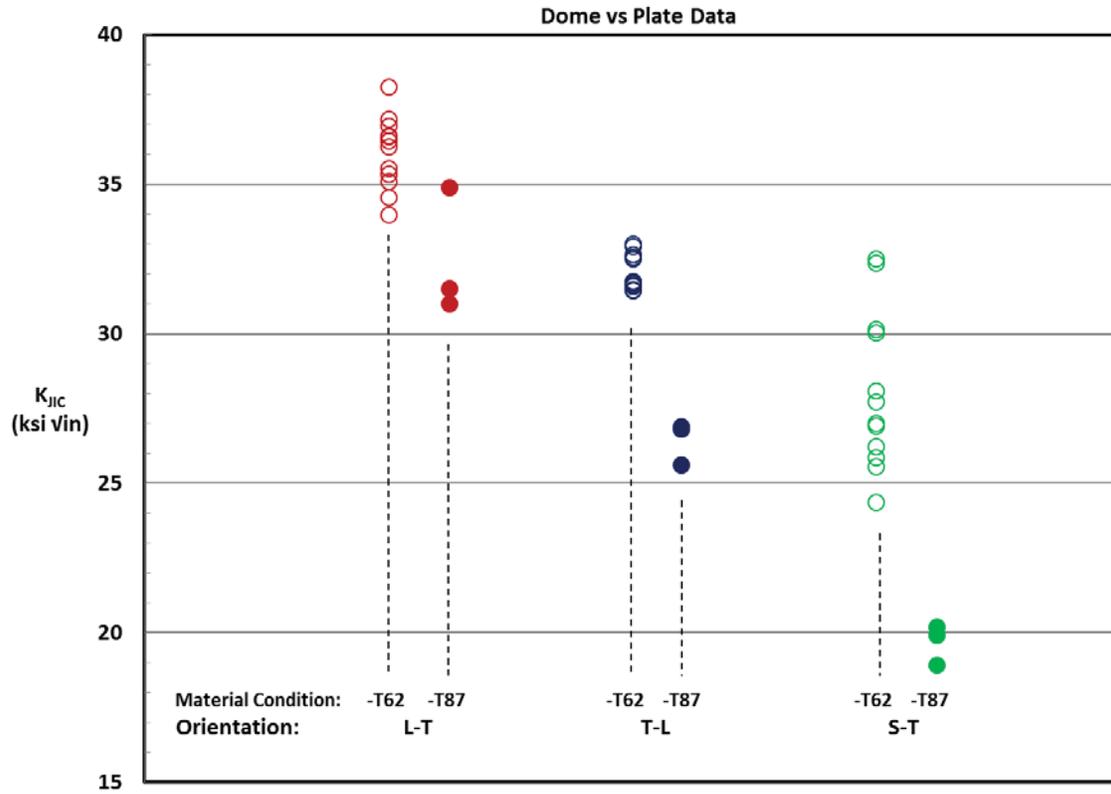
**Figure 10.3-14. Fracture Toughness Comparison between Spin Formed Al 2219-T62 Aft Bulkhead Material and Al 2219-T87 Plate (25)**

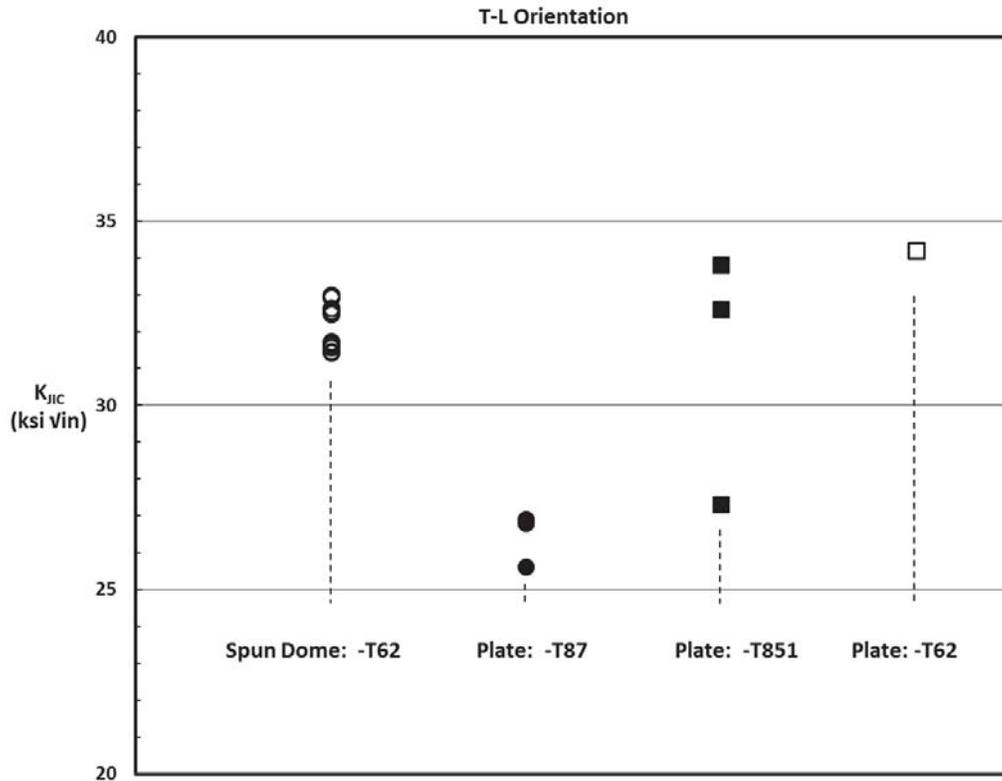
Figure 10.3-15. Fracture Toughness Comparison between Spin Formed Al 2219-T62 Aft Bulkhead Material and other Al 2219 Tempers in the T-L Orientation (25)
