Aerodynamic Characterization of a Thin, High-Performance Airfoil for Use in Ground Fluids Testing

NASA John H. Glenn Research Center, Cleveland, Ohio 44135 USA

National Research Council Canada, Ottawa, Ontario K1A 0R6 CANADA

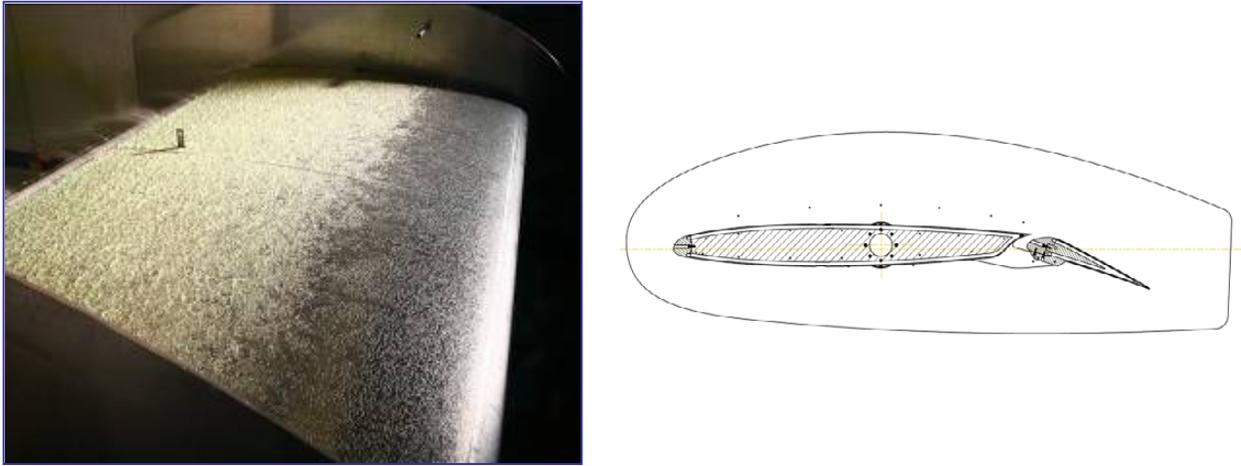
Figure 1. Photograph of thin, high-performance wing section installed in the NRC PIWT facility and end-view drawing of endplate configuration.

All of the experiments were carried out using the thin, high-performance wing section in the NRC PIWT facility located on the Montreal Road campus in Ottawa. The PIWT is an open-return wind tunnel that draws air from the outdoors and is therefore naturally cooled. The fan is located in the wind-tunnel inlet and was driven by a gas turbine engine for the test campaign. The test section measures 10 ft (3 m) across and 20 ft (6 m) in height. An insert was used that reduced the height to 16.4 ft (5 m) resulting in an increase in maximum test-section speed. The wing was mounted horizontally in the test section as shown in Fig. 1. The model had a span of 7.9 ft (2.4 m) and was isolated from the wind-tunnel walls with endplates. There were large gaps between the endplates and the test-section walls (≈ 1 ft (0.3 m) on each side). The size of the endplates was minimized to facilitate visual access to the wing surface which was very important for the experiments with anti-icing fluids and contamination. An additional motivation of this work was to determine any adverse effect of these gaps coupled with the relatively small size of the endplates. Figure 2 shows the 6 ft (1.8 m) chord, thin, high-performance wing section with a single-slotted flap

The model was supported by two-component external force balances at each end, located outside of the test-section walls. Each balance rotated with the wing section, and consisted of two load cells in the normal direction and one load cell in the axial direction. A drive motor and gearbox connected to the left-side force balance provided rotation for setting the wing geometric pitch angle. Lift, drag and pitching moment data were measured from the balance during angle of attack sweeps. These data were corrected for wind-tunnel wall effects using the 2-D airfoil methods described in Rae and Pope.¹⁹ Performance data were acquired over a small range of Reynolds and Mach number depending upon the outside air temperature and the speed. These conditions are summarized in Table 1. This experimental set-up is very similar to that used to evaluate the performance of fluids in their uncontaminated state and with ice-pellet contamination and has been described elsewhere.^{20,21}

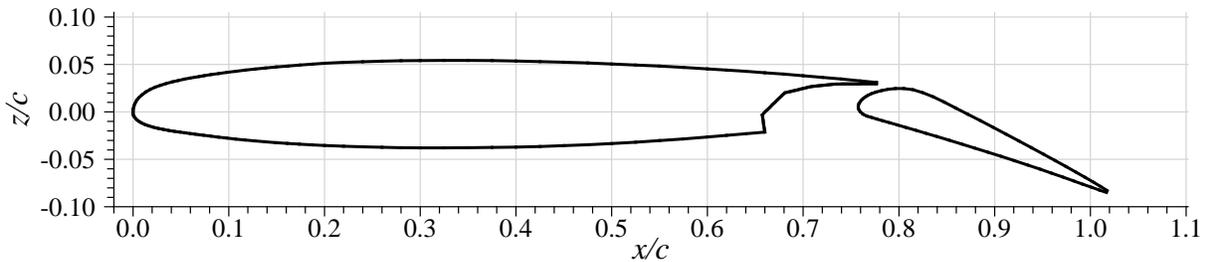
Figure 2. Thin, high-performance airfoil section used in the PIWT testing, reference chord = 6.0 ft (1.82 m).

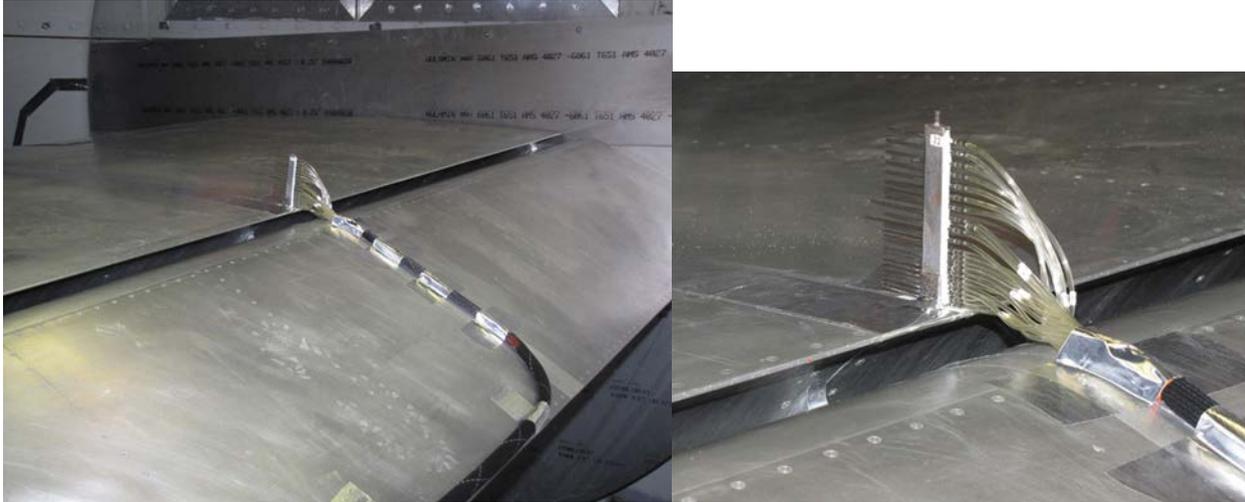
Figure 3. Pressure rake used to measure boundary-layer velocity profiles shown at midspan station near trailing edge of main element.

The boundary-layer velocity profiles were measured using a rake with 21 total pressure tubes as shown in Fig. 3. This rake also contained a single tube used to measure the local static pressure that was used to compute the mean streamwise velocity from the total pressures. The rake was placed at three spanwise locations near the trailing edge of the main element. These locations were near the midspan station and approximately 2 ft. (0.6 m) to the right and left of the midspan station ($y/b = \pm 0.25$). Boundary-layer profiles were also measured near the trailing edge of the flap at the midspan station. The mean streamwise velocity profiles were subsequently integrated to obtain the boundary-layer displacement thickness, momentum thickness and shape factor using the following equations for incompressible flow:

Boundary-layer velocity profiles were measured near the trailing edge of the main element and flap using the pressure rake shown in Fig. 3. Additional measurements were conducted with the rake positioned at $y/b = \pm 0.25$ on the main element trailing edge to quantify potential spanwise variation over the middle 50% of the model span. Data were acquired over a large angle of attack range and a subset of the velocity profiles are depicted in Fig. 9 for $\alpha = 8, 14$ and 18 deg. These profiles illustrate the boundary-layer growth approaching stall. The profiles on the main element were characteristic of a turbulent boundary layer and exhibited minimal differences across the wing span. The velocity profiles on the flap show the classic confluence of the flap boundary-layer and the wake of the main element for a well-designed slotted flap system. Since the confluent boundary-layer thickness exceeded the vertical extent of the pressure rake, the flap velocity profiles could not be normalized by the true edge velocity. Instead the largest velocity measured in the profile (e.g., $z' = 80$ mm at $\alpha = 8$ and 14 deg, and $z' = 25$ mm at $\alpha = 18$ deg.) was used to normalize the profiles. The velocity profiles further support the flow visualization results that indicated an absence of boundary-layer separation on the main element and flap trailing edges approaching stall.

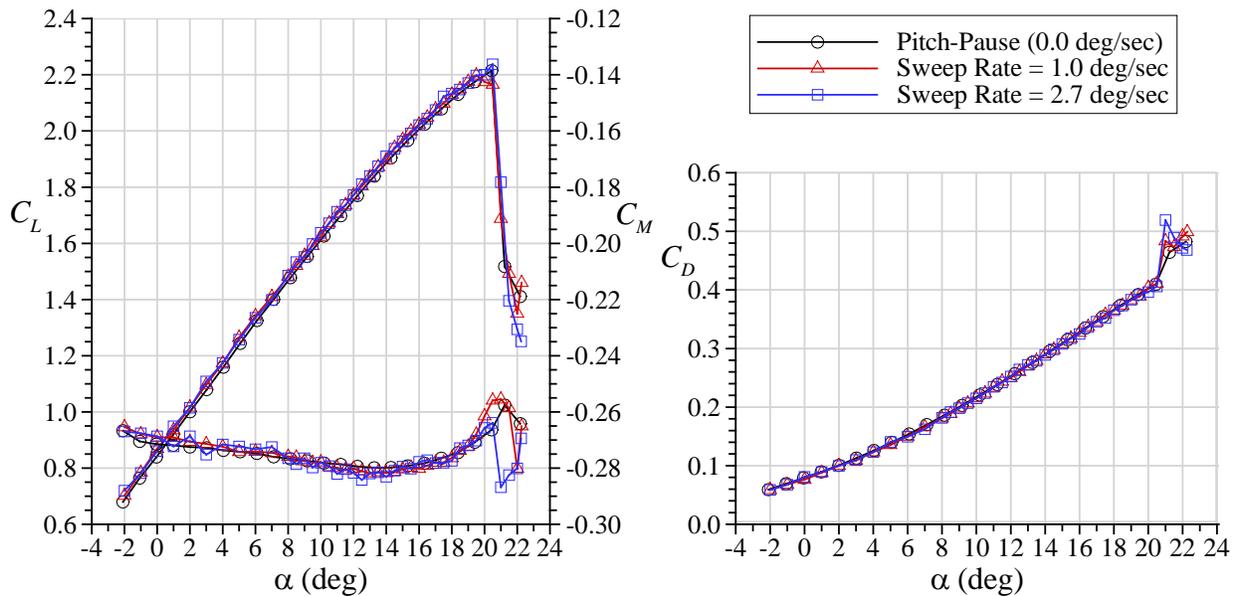
Figure 4. Effect of angle of attack sweep rate on airfoil aerodynamic performance.

One of the characteristics of the thin, high-performance wing section exhibited in Fig. 4 is the sharp decrease in lift coefficient at stall. This behavior is typical of leading-edge stall which has been defined as abrupt flow separation near the leading edge without subsequent reattachment.²² The “abrupt” separation usually results from a small leading-edge laminar separation bubble which “bursts” at stall and causes the sharp decrease in lift.²² Flow visualization was conducted to confirm the leading-edge stall type of the airfoil and to determine if there were any adverse effects due to the unique model installation with the relatively small endplates. Surface oil flow visualization indicated that there was a small, leading-edge laminar separation bubble located on the upper surface. This situation is depicted in Fig. 5 with the model at 8 deg. angle of attack. Figure 5 also shows a phenomenological sketch of the flow that was adapted from Tanner²³ but has been documented in numerous other references (e.g., Ref. 24-27). The separated flow region inside the bubble is clearly visible in the photograph as the thick black line of accumulated surface oil. The boundary-layer reattachment region was located immediately downstream at approximately $x/c = 0.05$. Increasing the angle of attack to 18 deg., which is about two degrees prior to stall, had the effect of moving the laminar separation bubble upstream as depicted in Fig. 6. Although very difficult to judge from this photograph the reattachment region is estimated to be at approximately $x/c = 0.03$. An additional observation from the flow visualization images in Fig. 5 and 6 is that the separation bubble had a very clear two-dimensional structure across the span of the model which indicates that two-dimensional flow was maintained on the leading-edge area approaching aerodynamic stall.

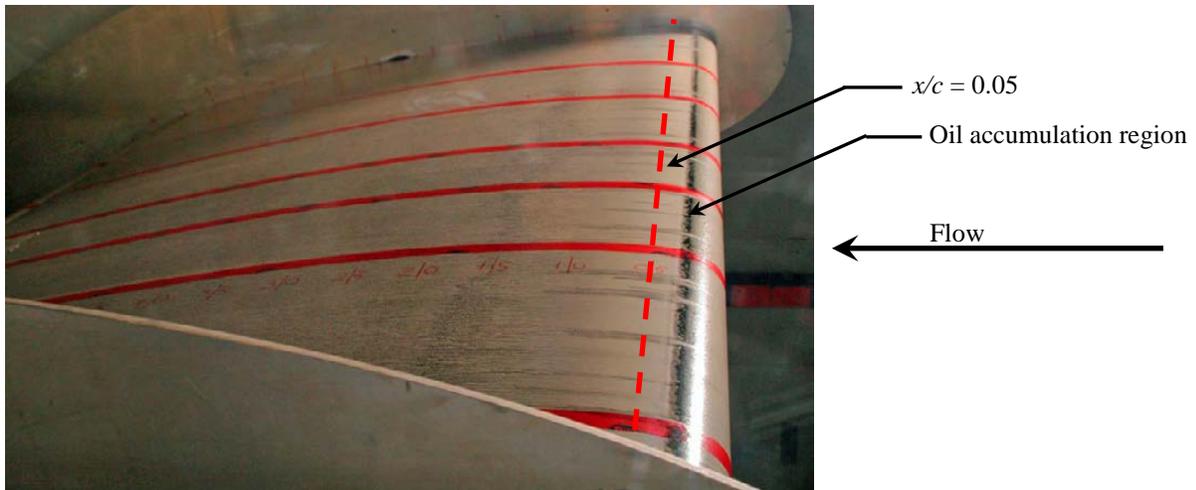
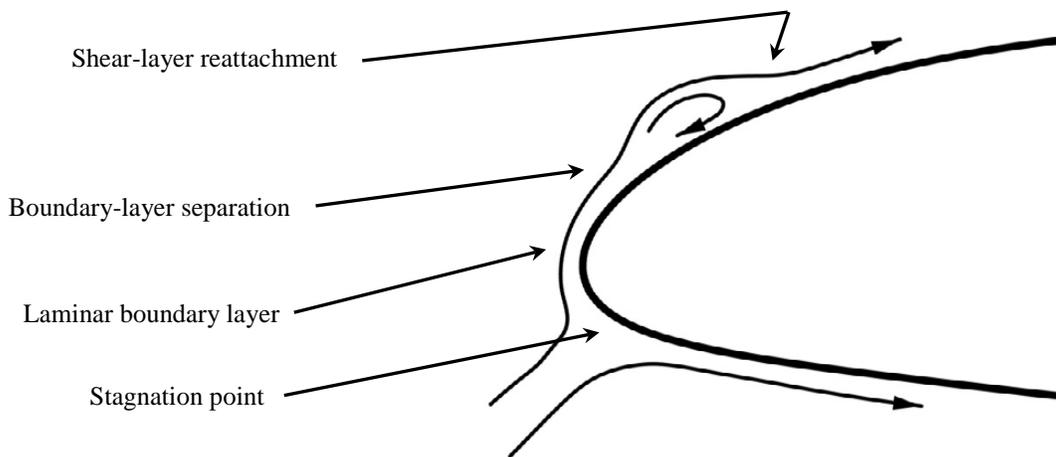
Figure 5. Photograph of surface-oil flow visualization (top) at $\alpha = 8$ deg. and phenomenological sketch of laminar separation bubble flowfield, adapted from Tanner.²³

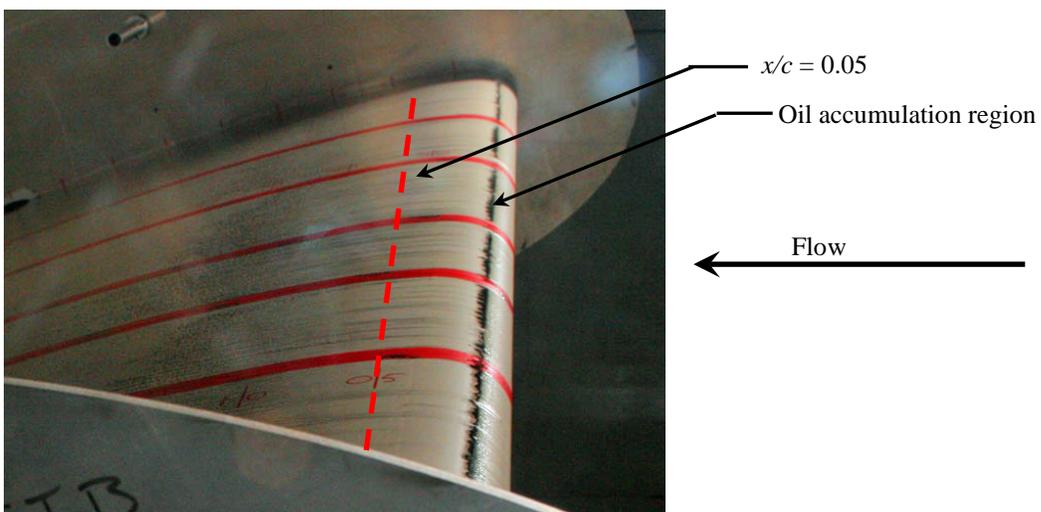
Figure 6. Photograph of surface-oil flow visualization at $\alpha = 18$ deg.

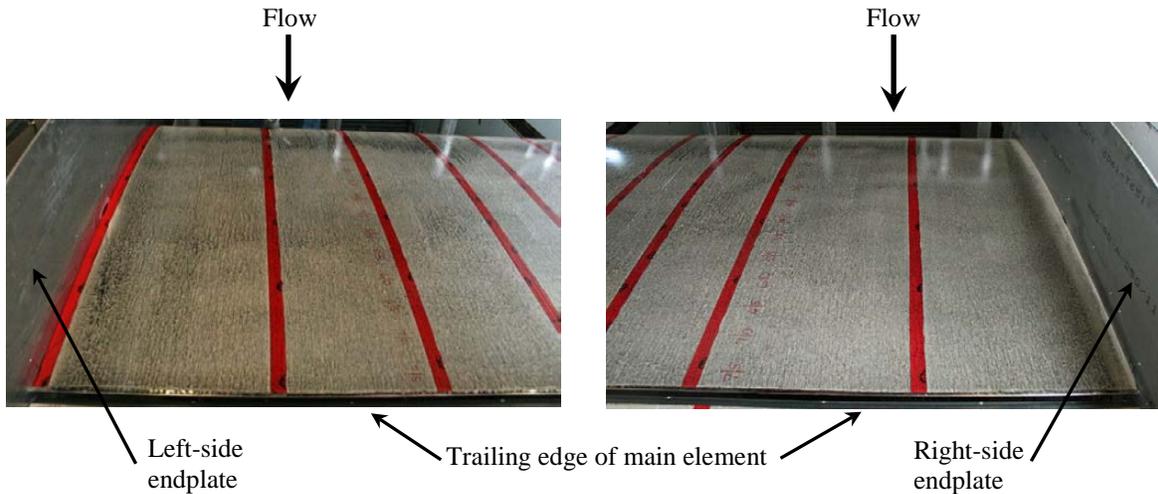
Figure 7. Photographs of surface-oil flow visualization the left and right sides of the model main element at $\alpha = 18$ deg.

Verifying the extent of two-dimensional flow approaching stall was an important part of this work because the influence of the small endplates and large gaps was unknown. Initially, it was expected that the combination of the small endplate size and relatively large gaps between the test-section walls and the model endplates would lead to significant three-dimensional effects near stall. Additional flow visualization images were acquired for the other portions of the wing model at $\alpha = 18$ deg. which was determined to be sufficiently close to the stalling angle to characterize the surface flow. Shown in Fig. 7 are surface-oil flow visualization images near the trailing edge of the wing main element extending to the left and right-side endplates. The images show that the boundary-layer remained attached and that the surface flow was highly two-dimensional, even in areas adjacent to the endplates. These images were also corroborated with images from the thread tufts extended to the left and right sides. The tuft images showed no indication of spanwise flow on the model. Similar results were obtained for flow visualization performed on the flap, depicted in Fig. 8. In this case, there were small regions of spanwise flow evident near the endplates. This was attributed to very narrow gaps between the endplates and the flap. These narrow gaps were not sealed as was the main element, to allow for adjustment of the flap angle. The surface-oil flow images near the trailing edge of the flap were somewhat ambiguous, indicating a low-shear flow on the surface. Flow visualization with thread tufts did not indicate flow separation in this region. This was corroborated with boundary-layer pressure rake measurements, discussed in the following paragraph. Overall, the flow visualization results confirmed the leading-edge stall type characterized by a leading-edge laminar separation bubble and very little or no turbulent boundary-layer separation on the main element or flap. Furthermore, the surface flow was remarkably two-dimensional given the small size of the endplates and large gaps between the endplates and test-section walls.

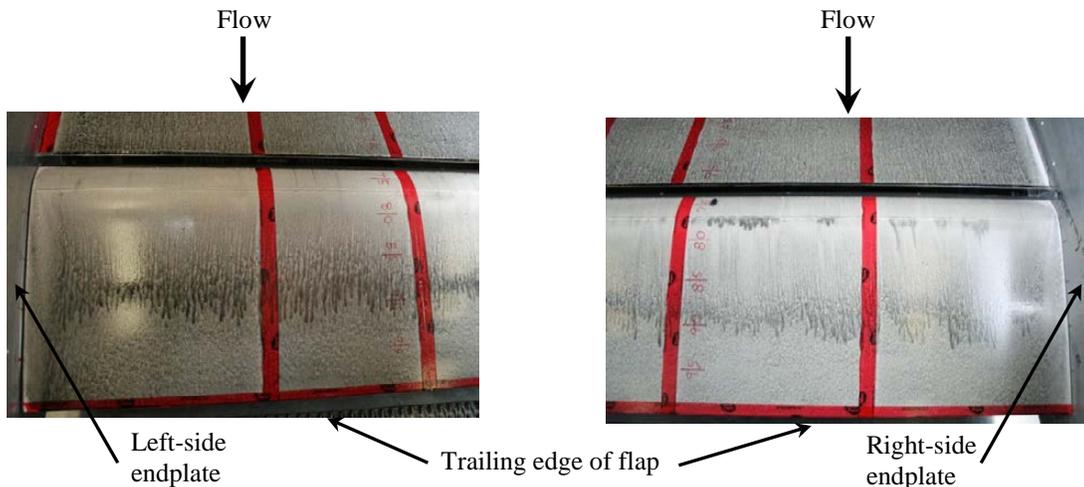
Figure 8. Photographs of surface-oil flow visualization the left and right sides of the model flap at $\alpha = 18$ deg.

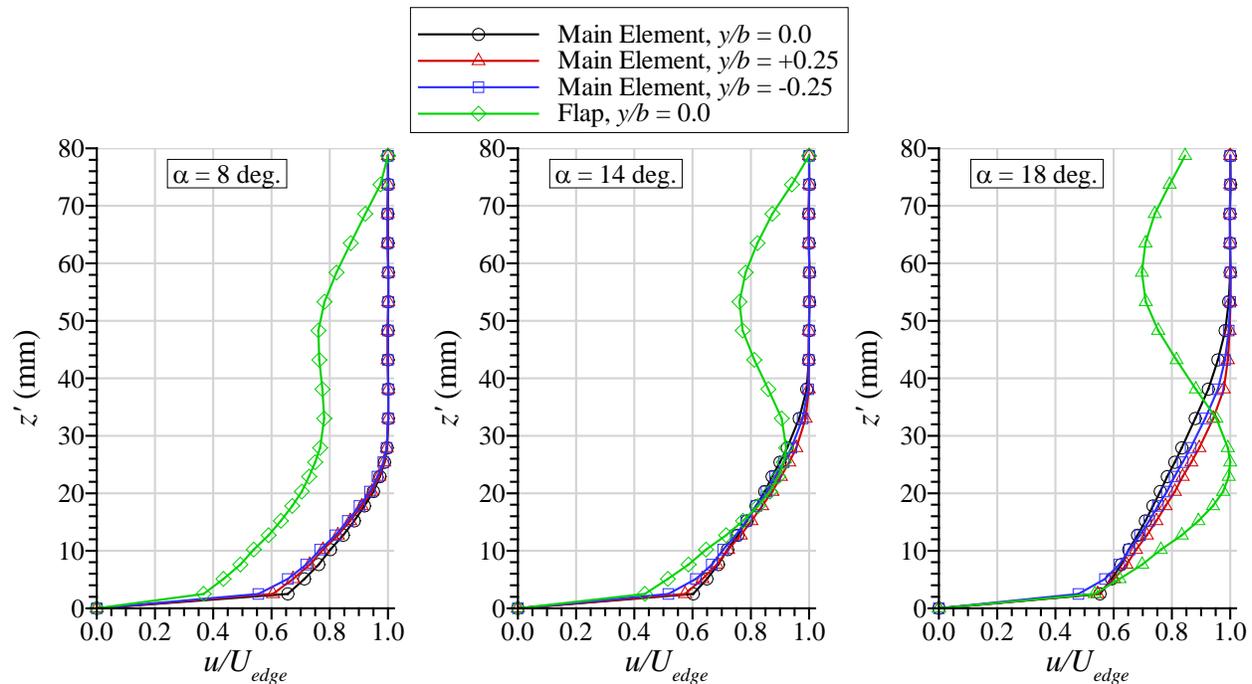
Figure 9. Comparison of boundary-layer velocity profiles taken at the trailing edge of the main element and flap for three angles of attack.

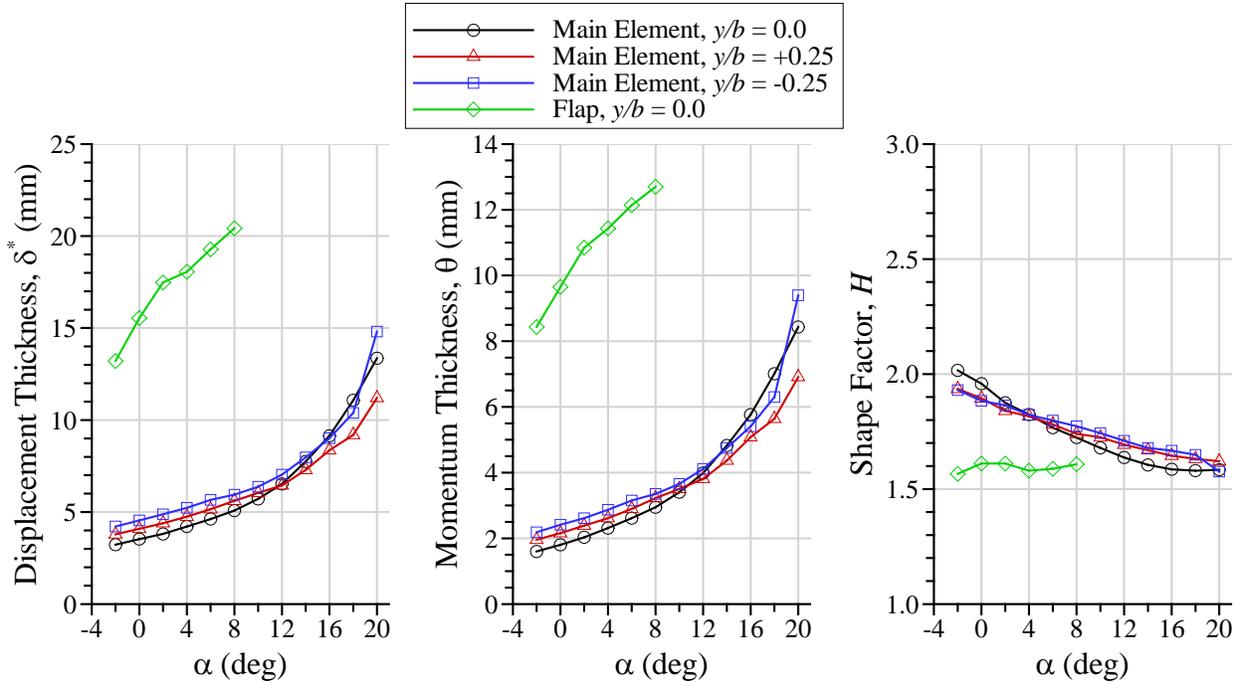
Figure 10. Variation of integrated boundary-layer parameters with angle of attack at the trailing edge of the main element and flap.

The velocity profiles were used to calculate the integrated boundary-layer parameters described in Eq. 1-3 and are plotted in Fig. 10. These values could not be calculated for the flap at angles of attack greater than 8 deg, because the thickness of the confluent boundary layer exceeded the height of the pressure rake as described in the previous paragraph. The displacement and momentum thickness on the main element increased with angle of attack as expected, reflecting the respective increases in boundary-layer thickness and skin-friction drag. These integrated values exhibited more spanwise variation than was observed in the velocity profiles, but this variation is not considered to be significant. The boundary-layer shape factor calculated for the main element decreases with angle of attack thus indicating an increasing resistance to boundary-layer separation at these locations.

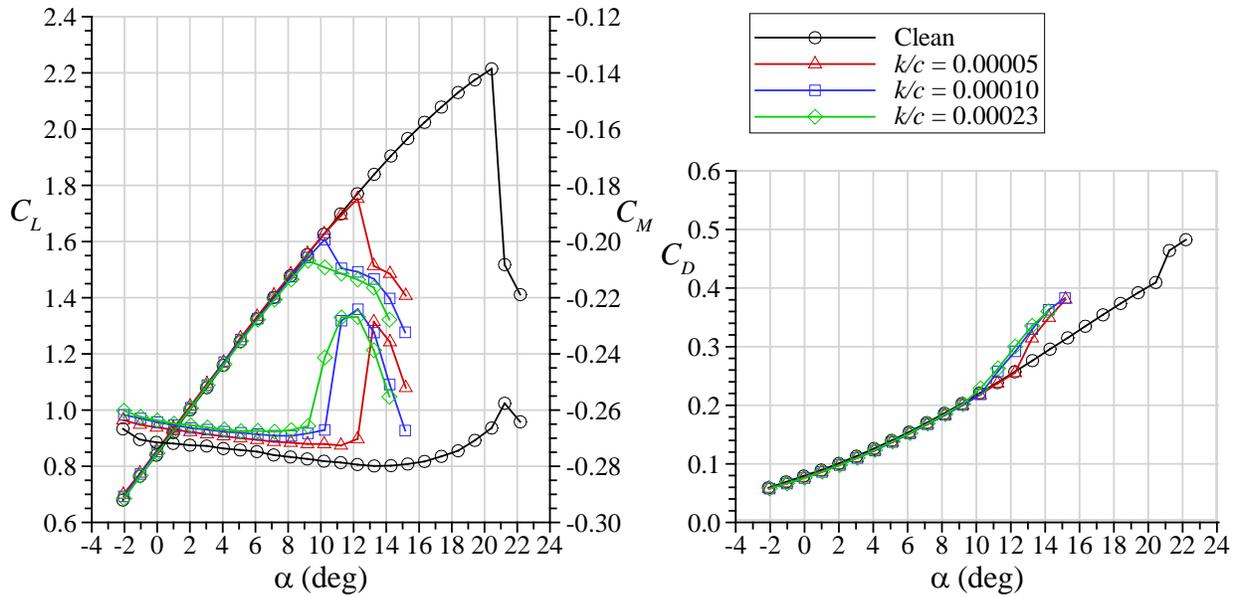
Figure 11. Effect of sandpaper roughness applied to wing leading edge from $x/c = 0.08$ on the lower surface to $x/c = 0.05$ on the upper surface.

Experiments were conducted with simulated leading-edge ice roughness and upper-surface frost in order to better understand the aerodynamic origins of the adverse performance effects due to the anti-icing fluids and ice-pellet contamination. The effect of varying roughness size on the airfoil performance is shown in Fig. 11. Bragg et al.²⁸ describe the aerodynamic effect of leading-edge ice roughness. Even though the ice roughness height tends to be many times larger than the local boundary-layer thickness the scale of separated flow tends to be limited to the immediate vicinity of the individual roughness elements. Therefore there is only a small effect on the inviscid flowfield until the airfoil stalls. These effects are illustrated in Fig. 11 where there was little change in the lift-curve slope or zero-lift angle. The chief effects of the roughness were reduced maximum lift coefficient and stalling angle. There was minimal change in the pitching moment characteristics prior to stall. There was no observed change in the drag coefficient prior to stall due to the large contribution of induced drag relative to the profile drag because of the unique model installation between small endplates. A significant increase in profile drag would be expected based upon airfoil test results.²⁸ The lift and pitching moment data seem to indicate that the leading-edge stall characteristics of the wing section were preserved even with roughness applied to the leading edge. This is evidenced by the sharp drop in lift after stall (particularly for the $k/c = 0.00005$ and 0.00010 roughness) and break in the pitching moment. Such behavior is not uncommon with other leading-edge stall airfoils such as the NACA 23012.²⁹ The magnitude of the reduction in maximum lift coefficient range from 20 to 30%, which is also lower than values reported for the NACA 23012 airfoil at similar Reynolds numbers.²⁹

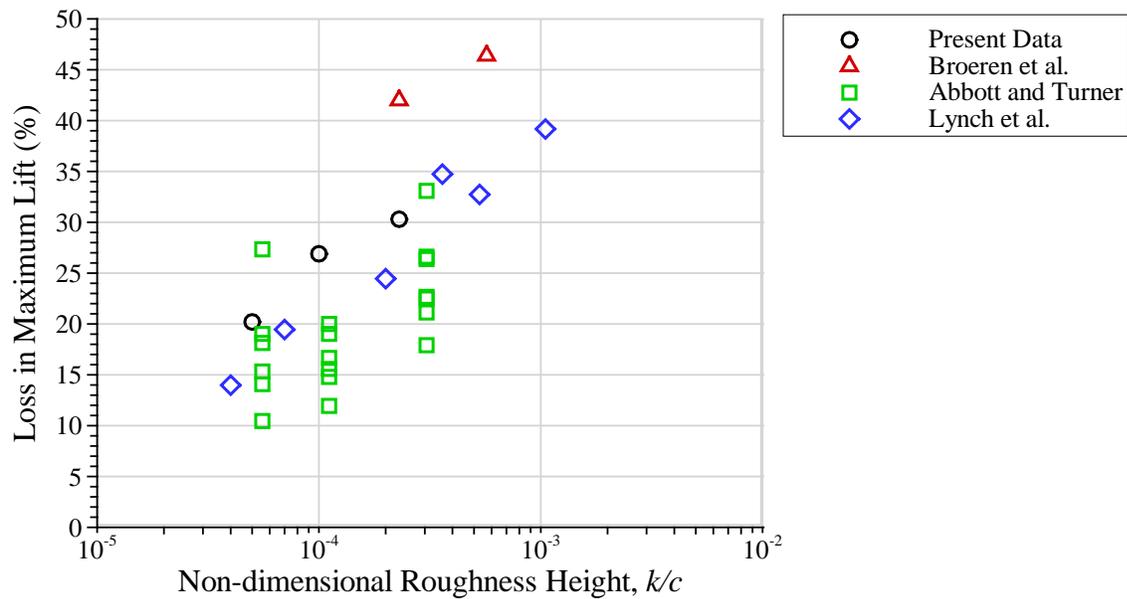
Figure 12. Effect of leading-edge roughness size on loss of maximum lift; comparison of present data to archival compilation adapted from Lynch and Khodadoust³⁰ with additional data from Broeren et al.,²⁹ Abbott and Turner³¹ and Lynch et al.^{32,33}

These results have been compiled and compared against similar tests from the icing aerodynamics literature. For example, Lynch and Khodadoust³⁰ provided an extensive review of icing aerodynamics and compiled some of the data shown in Fig. 12. Plotted is the effect of leading-edge roughness height on loss in maximum lift coefficient. Inspection of the figure shows that the maximum lift degradation measured on the thin, high-performance wing in the PIWT is within the range of many other airfoil studies.^{29,31-33} This comparison provides further evidence of suitable performance of this wing for anti-icing fluid research.

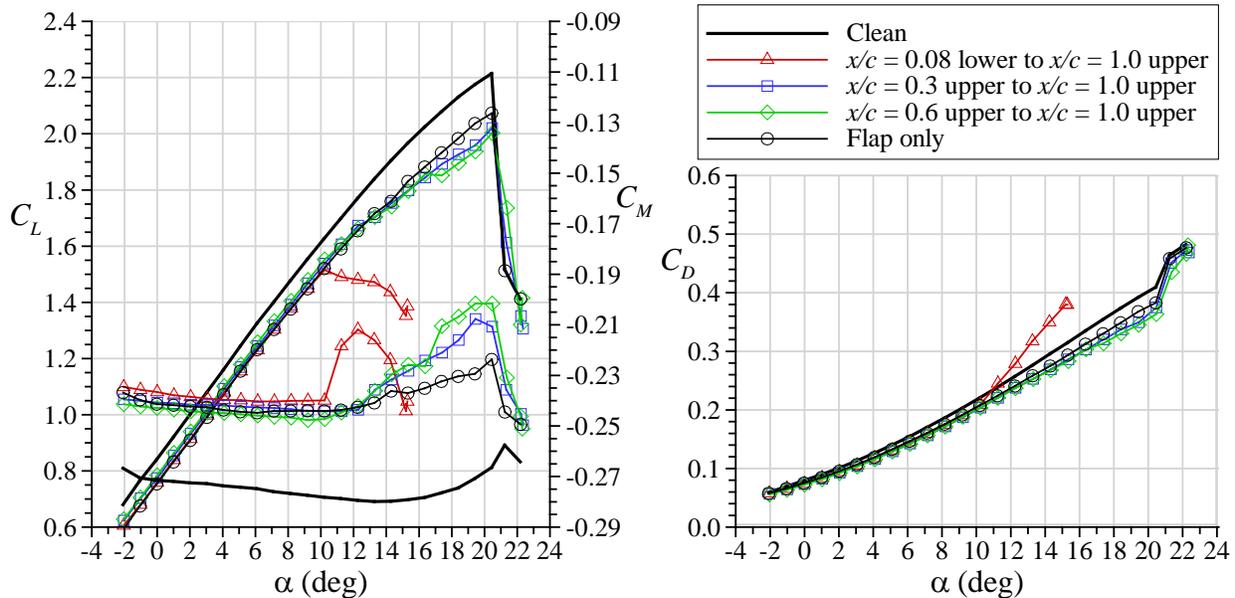
Figure 13. Effect of chordwise coverage of $k/c = 0.00010$ sandpaper roughness applied to the wing upper surface.

This result was investigated further by systematically removing the upper-surface roughness beginning from the leading edge and working downstream. As shown in Fig. 13, the aerodynamic performance tends to be similar for all of the configurations once the roughness is removed from the leading edge. There appears to be a break in the lift and pitching-moment curves at $\alpha \approx 12$ deg. for the $k/c = 0.00010$ roughness located on the aft 70% chord (i.e., $x/c = 0.3$ upper to $x/c = 1.0$ upper) and aft 40% chord (i.e., $x/c = 0.6$ upper to $x/c = 1.0$ upper). This break may indicate possible trailing-edge separation on the flap. There does not appear to be a similar break for the roughness located on the flap only. In all three of these cases (roughness located on aft 70% of chord, 40% of chord and flap only), the stalling angles are nearly identical with a small variation in maximum lift coefficient.

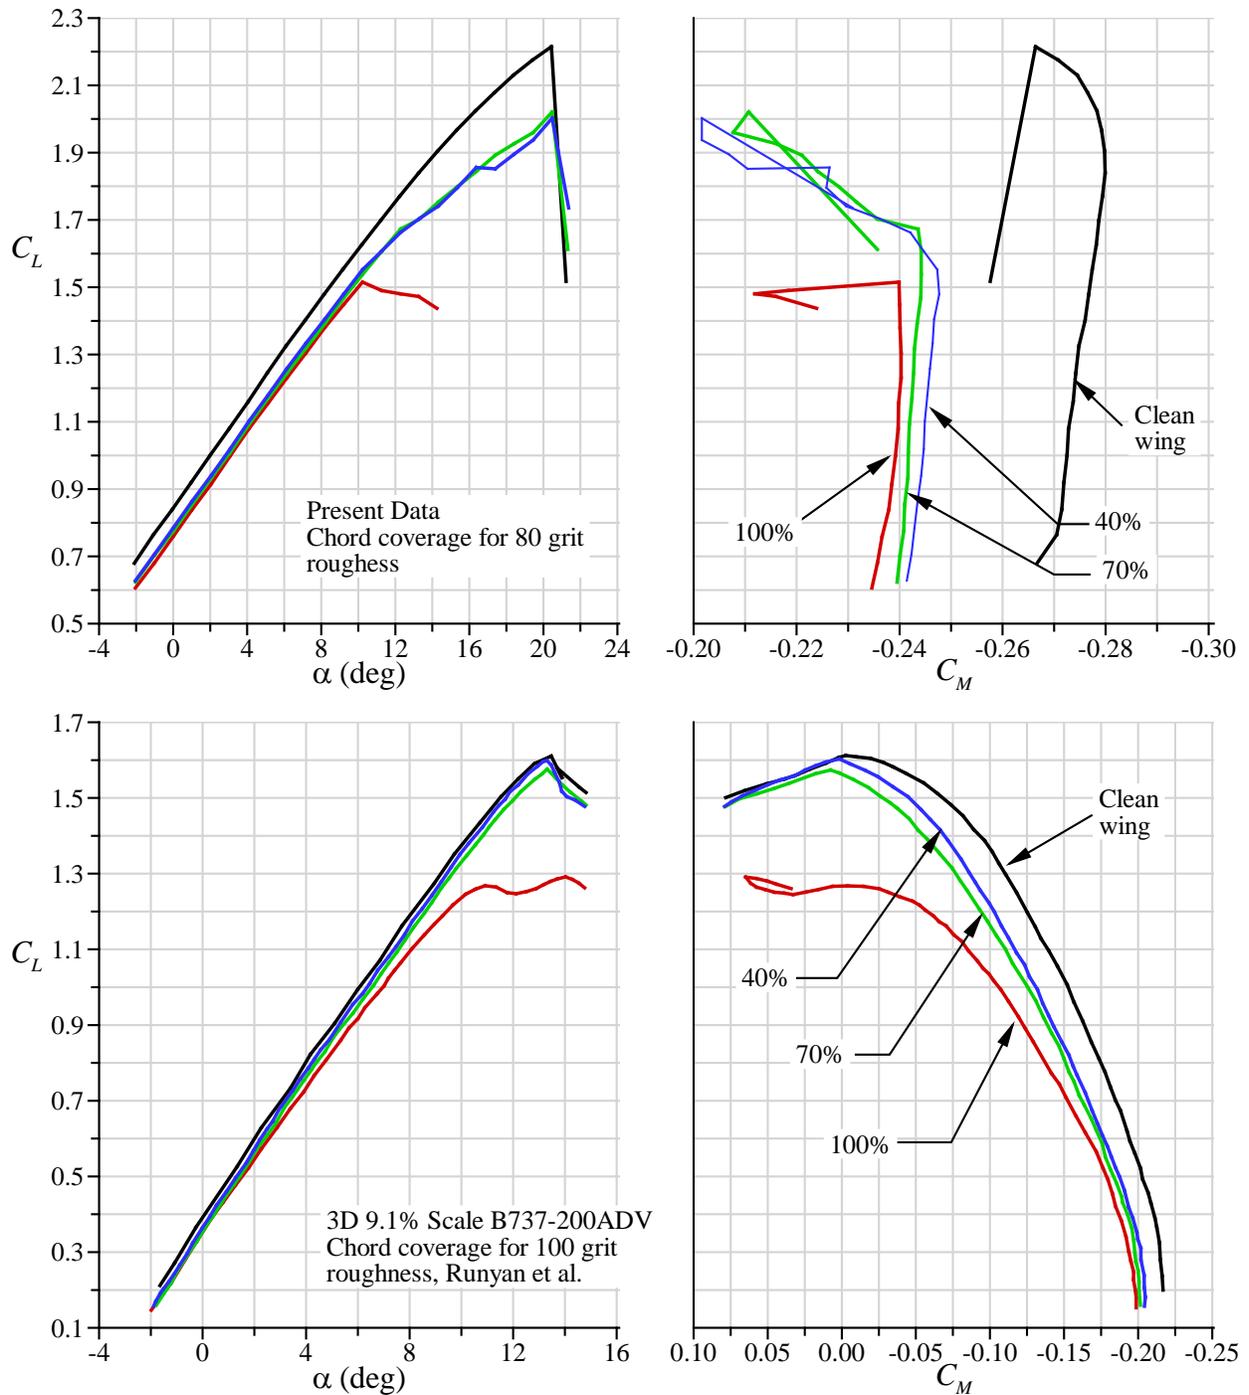
Figure 14 Comparison of aerodynamic effects of chordwise coverage of sandpaper roughness for present data and data from Runyan et al.¹⁷ on 9.1% scale 3-D B737-200ADV half-plane model.

The effect of the simulated frost coverage on aerodynamic performance was compared against results from Runyan et al.¹⁷ who performed similar experiments on an 9.1% scale, 3-D half-plane model of a Boeing 737-200ADV airplane. The experiments were conducted at near operational airspeeds, but the Reynolds number based upon average chord length was only about 1.0×10^6 due to the small model scale. Depicted in Fig. 14 are the lift and pitching-moment characteristics plotted in similar form to the original Runyan et al.¹⁷ data. The general form of the performance effects of the 40%, 70% and 100% chordwise coverage is similar between the data sets. These similarities are more readily visible in the pitching-moment coefficient variation with lift coefficient. As described earlier in this section, the large chordwise extent of the roughness has the effect of increasing the boundary-layer displacement thickness on the aft section of the wing. The aerodynamic result is a decrease in wing camber and a corresponding increase in pitching moment. There is less of an effect of the roughness on lift coefficient for the 9.1% scale B737-200ADV wing which could be due to the 3-D configuration versus the 2-D model configuration for the present tests. In addition, there could be Reynolds number effects for the 9.1% scale model data that would minimize the effect of the roughness on lift coefficient.

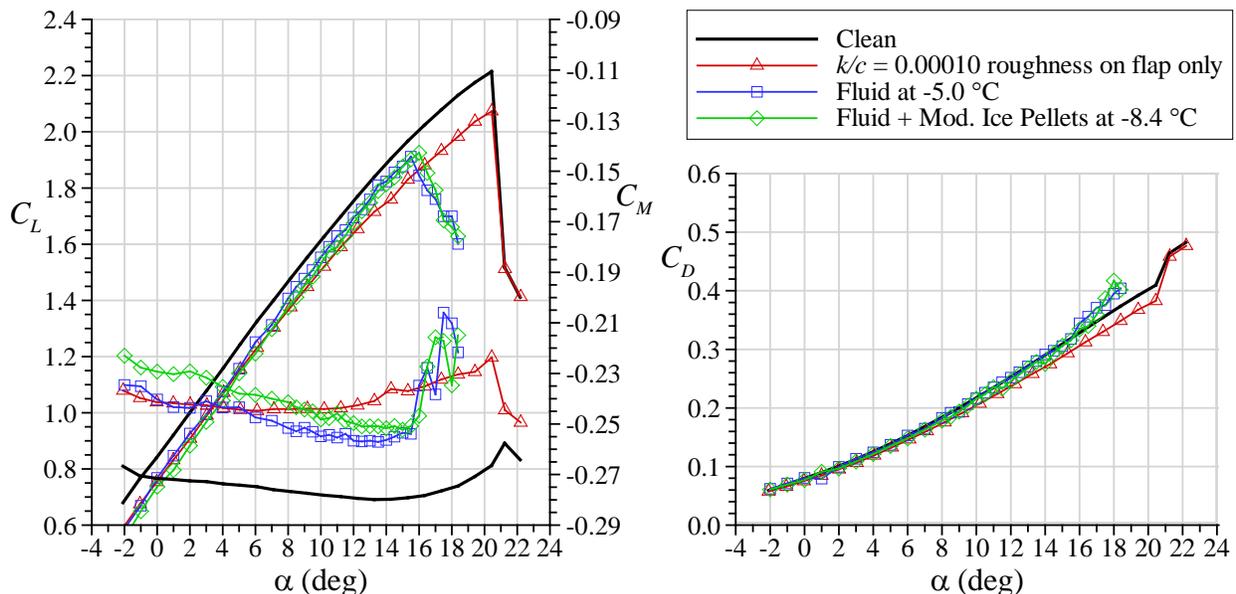
Figure 15. Comparison of aerodynamic effects of $k/c = 0.00010$ sandpaper roughness applied to the airfoil upper surface on the wing flap with fluid and fluid plus ice-pellet contamination.

The simulated frost effects were compared to the effects of anti-icing fluid and ice-pellet contamination, also following the method of Runyan et al.¹⁷ These results are shown in Fig. 15 for the $k/c = 0.00010$ roughness located on the flap compared to an anti-icing fluid tested at $-5\text{ }^\circ\text{C}$ and the same anti-icing fluid exposed to moderate ice-pellet precipitation at $-8.4\text{ }^\circ\text{C}$. Data for the latter cases (with fluid and contamination) were obtained following the procedure simulating a takeoff acceleration profile and subsequent angle of attack rotation at 2.7 deg./sec , while the roughness configuration was taken at steady-state conditions in pitch-pause mode. The obvious effect of the simulated takeoff profile is that the fluid/contamination flow off of the wing during the run. This was observed visually and recorded during the experiments. The aerodynamic effect of this is seen in both the lift and pitching-moment variation with angle of attack. The linear portion of the lift curves for the two fluid cases had slightly higher slope than for the roughness configuration. The fluid cases caused a larger aerodynamic penalty relative to the clean, dry wing at lower angle of attack. As the angle of attack was increased, more fluid/contamination flowed off the wing thus reducing the aerodynamic impact. The pitching-moment was affected in an analogous way. For the fluid/contamination cases, the pitching-moment coefficient decreased more than for the roughness configuration as the angle of attack was increased due to the dynamics of the fluid flowing off of the wing. What is perhaps more interesting is the difference in stall behavior between the roughness configuration and the fluid cases. Stall for the latter cases occurred at lower angle of attack and lift coefficient compared to the roughness configuration. Furthermore, there was no clear “break” (or slope change) in the lift curve for the fluid cases. This appears to indicate that stall may be driven by residual fluid and/or contamination located in the leading-edge region as opposed to the contamination on the aft portion of the wing and flap. This is often referred to as a “secondary wave” of fluid and is addressed in Section III.D below.

A series of experiments were conducted to investigate the aerodynamic performance effects of contamination on the wing flap. Referring back to Fig. 15, it was observed that there was a significant difference in stalling angle and maximum lift coefficient between the $k/c = 0.00010$ roughness on the flap versus the fluid/contamination configurations. One explanation for this difference is that the fluid/contamination presented a more significant flow disturbance on the flap than the $k/c = 0.00010$ roughness. This sensitivity was investigated by applying much larger

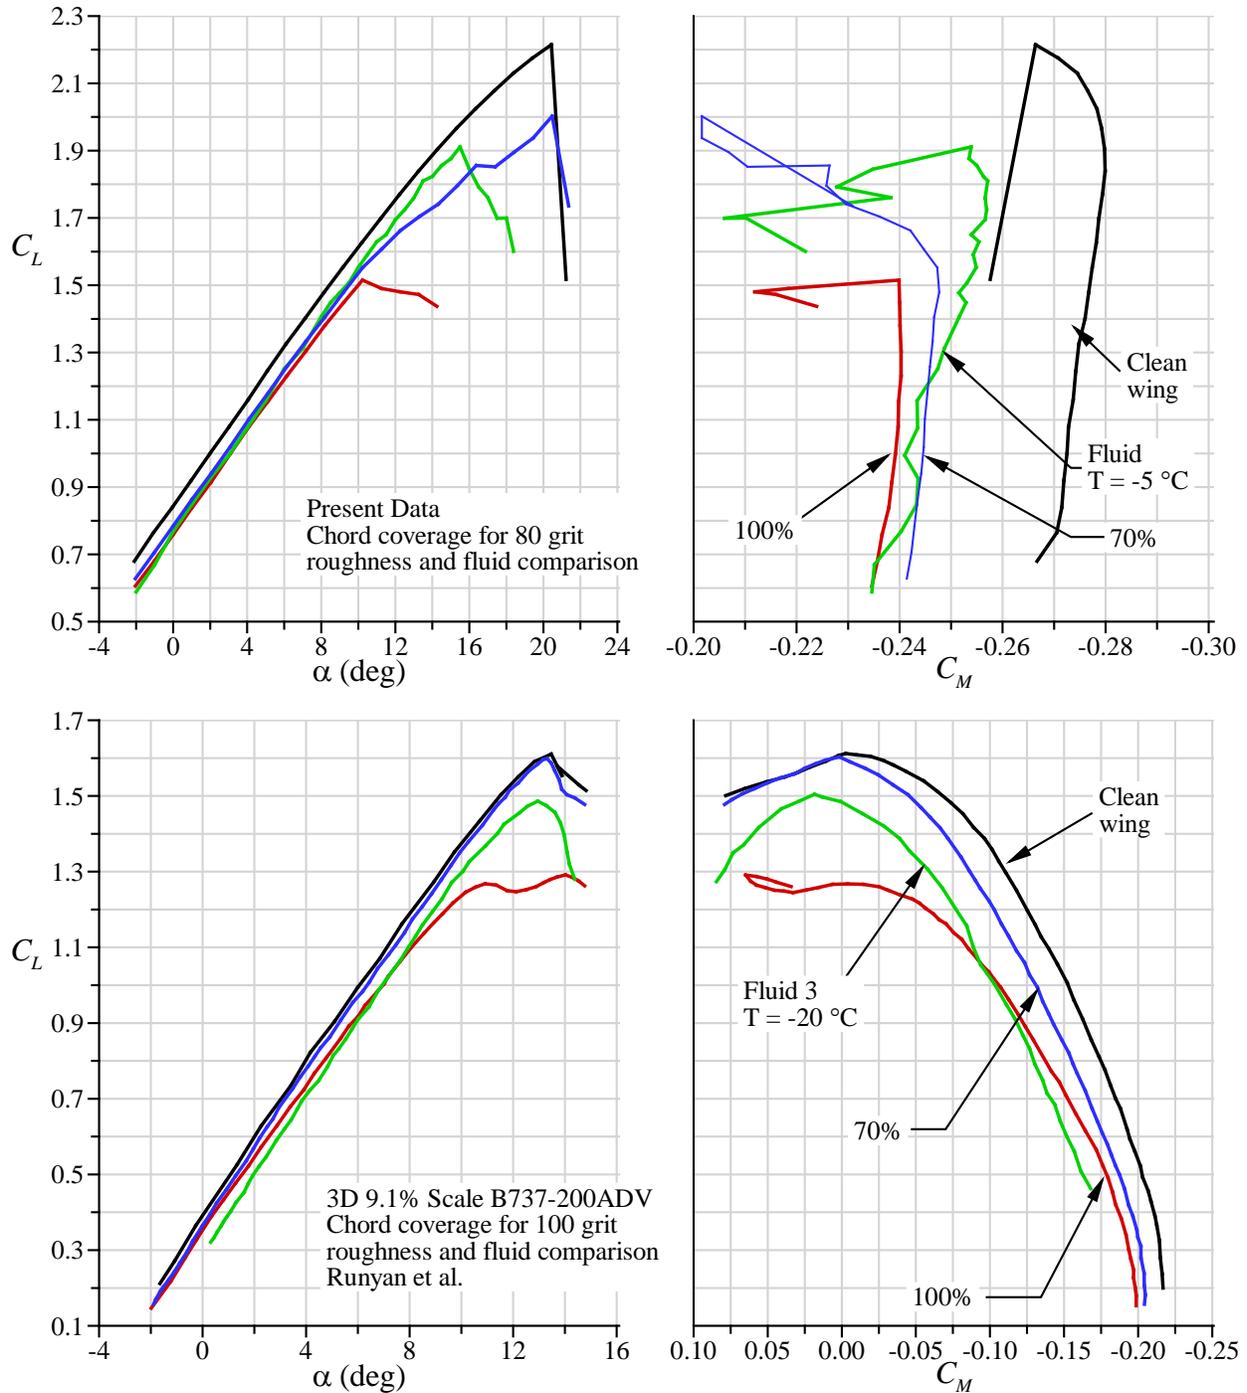
Figure 16 Comparison of aerodynamic effects of chordwise coverage of sandpaper roughness and fluid for present data and data from Runyan et al.¹⁷ on 9.1% scale 3-D B737-200ADV half-plane model.

The data in Fig. 15 were compared once again to the Runyan et al.¹⁷ results plotted in a common format in Fig. 16. The lift coefficient variation with angle of attack shows similar trends between the two data sets. In the Runyan et al. data on the 9.1% scale B737-200ADV half-plane model, the differences in lift-curve slope between the transitory fluid results and the static roughness configuration are more obvious than in the present data. However, there are very comparable effects on maximum lift coefficient and stalling angle. The trends in pitching-moment coefficient versus lift coefficient are also very comparable between the two data sets. The comparisons shown in Figs. 14 and 16 are significant because they illustrate similar trends of fluid effects on aerodynamic performance for two different wing configurations. This provides further evidence suggesting that the present PIWT wing configuration is suitable for the fluid and contamination research.

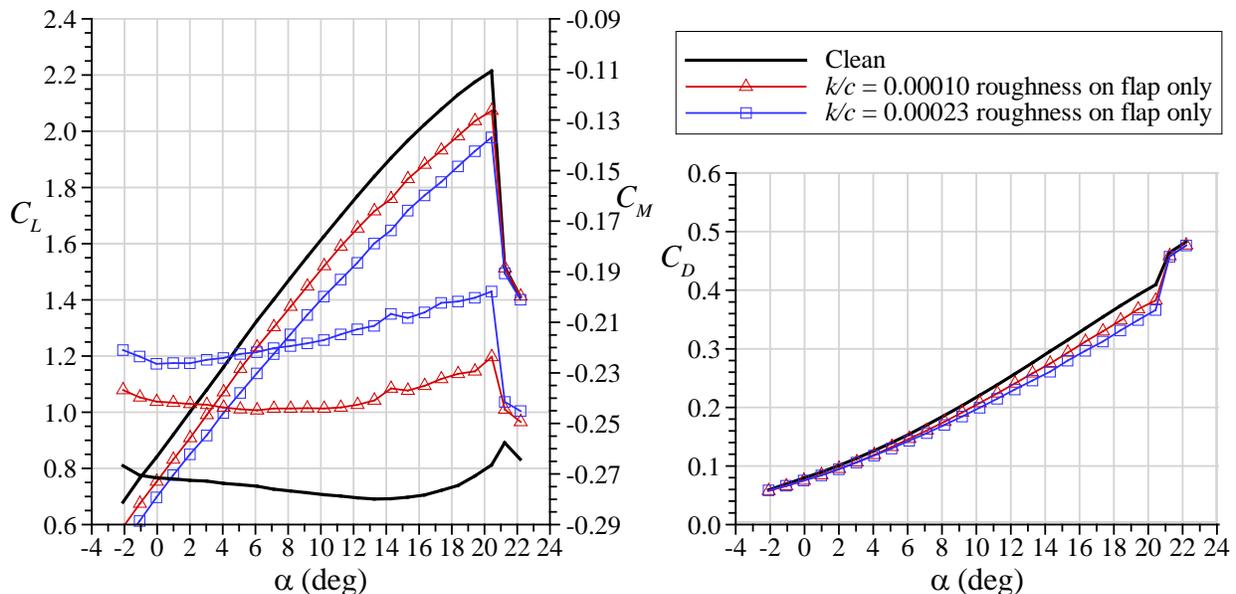
Figure 17. Aerodynamic sensitivity to roughness size on the wing flap.

$k/c = 0.00023$ roughness on the flap. The aerodynamic effect is summarized in Fig. 17. Consistent with previous results, the data show that the larger roughness caused a further thickening of the boundary layer and greater decambering of the wing.^{14,17} This could also be interpreted as decreasing effectiveness of the flap, or as an effective decrease in the flap deflection. While the larger roughness also caused a significant decrease in maximum lift coefficient relative to the smaller roughness, the stalling angles were nearly identical at 20.4 deg. This indicates that the reduced stalling angle associated with the fluid/contamination cases in Fig. 15 was likely not caused by accumulation of fluid/contamination on the wing flap.

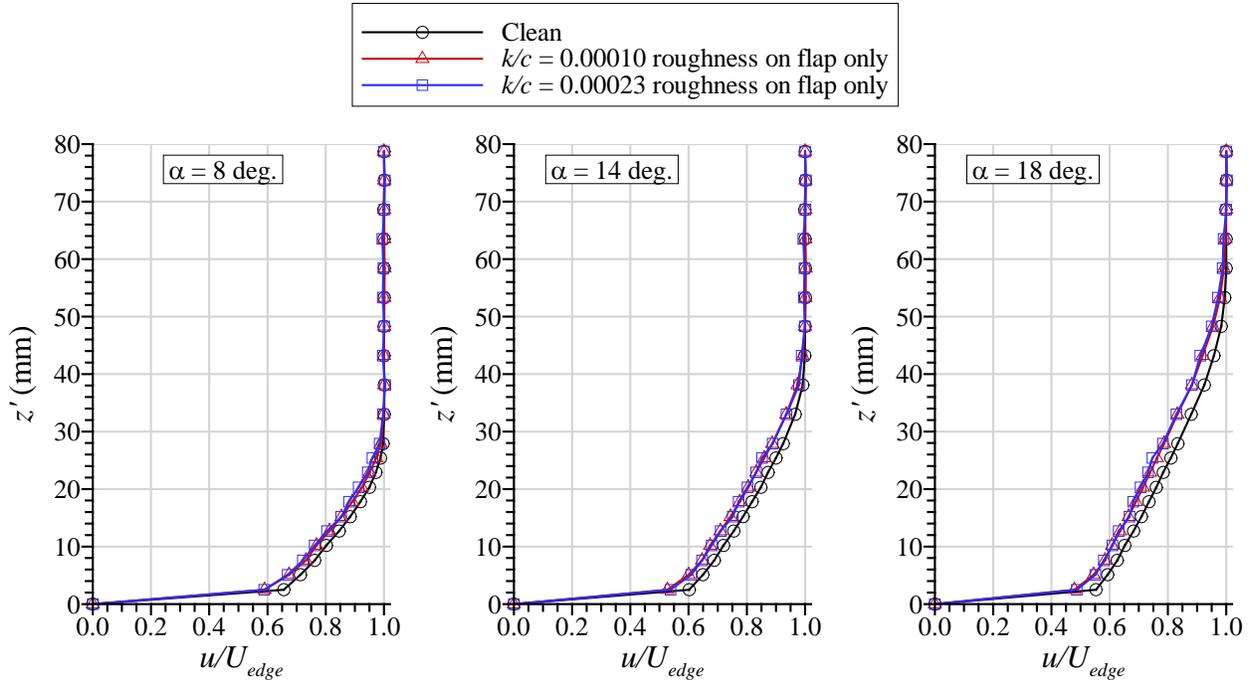
Figure 18. Effect of roughness applied to wing flap on boundary-layer velocity profiles measured near the trailing edge of the main element at the midspan station ($y/b = 0.0$).

The effect of the roughness on the wing flap on the boundary layer was investigated further. The boundary-layer pressure wake was located near the trailing edge of the main element at the midspan station ($y/b = 0.0$). The velocity profiles in Fig. 18 show that the roughness applied to the flap had a small upstream influence on the main element boundary layer. The effect increased with angle of attack as indicated in the profiles measured at $\alpha = 18$ deg., where the boundary-layers for the roughness configurations were approximately 6 to 8 mm thicker than for the clean configuration. Larger differences in the boundary-layer profiles were expected given the large differences in corresponding aerodynamic performance shown in Fig. 17.

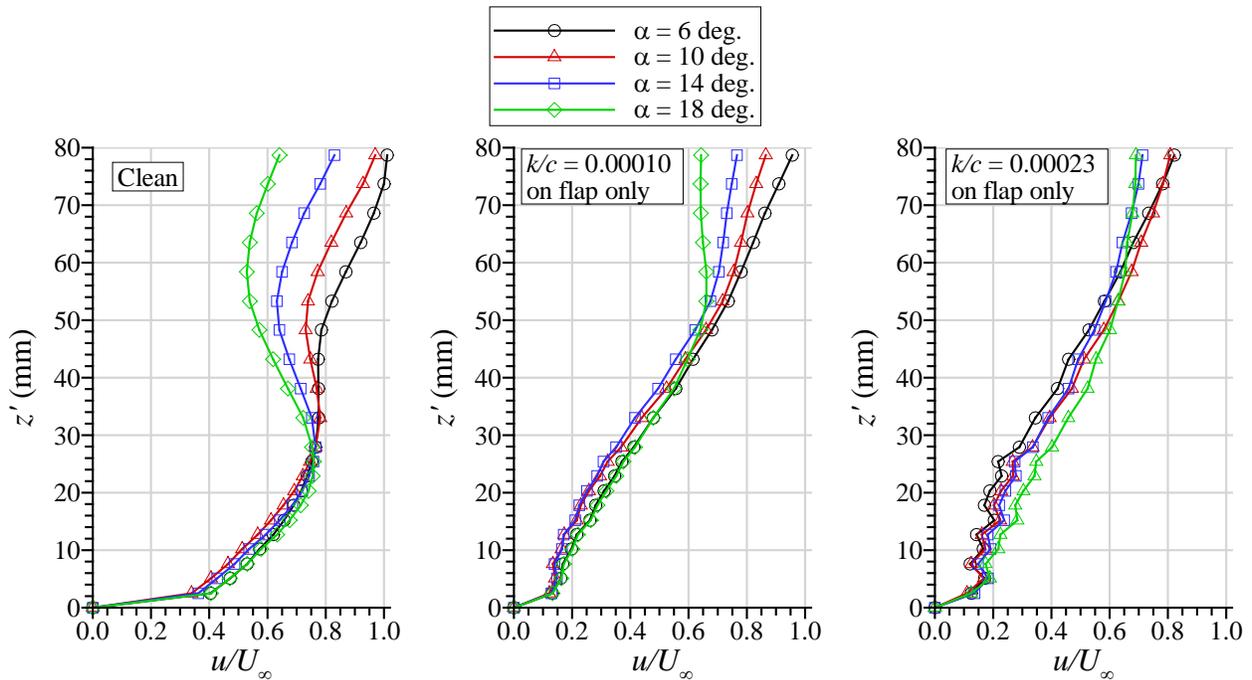
Figure 19. Effect of roughness applied to wing flap on boundary-layer velocity profiles measured near the trailing edge of the flap at the midspan station ($y/b = 0.0$).

The measurements were repeated with the pressure rake located near the trailing-edge of the flap at the midspan station ($y/b = 0.0$). These profiles, depicted in Fig. 19, illustrate the expected significant differences due to the roughness. The boundary layer on the flap was much thicker with the roughness meaning that the rake was not large enough to measure the complete velocity profile. Since the boundary-layer edge velocity was not measured, the data in Fig. 19 are normalized by the freestream velocity. The format of the plots is also changed to show the evolution of the boundary-layer profiles with angle of attack for each configuration. For the clean wing, the flap boundary-layer development was clearly seen for $z' < 30$ mm with the confluence of the main element wake for $z' > 30$ mm. It appears that the edge of the boundary layer was measured for $\alpha = 6$ deg. and that the velocity was increasing toward the edge for the other angles of attack for $z' > 80$ mm. With the $k/c = 0.00010$ roughness applied to the flap, the velocities for $z' < 30$ mm are significantly reduced from the clean configuration and the profiles appear to be on the verge of separation near the surface. Farther out in the boundary layer the velocities appear to be increasing toward the edge at $\alpha = 6$ and 10 deg. for $z' > 80$ mm. The velocity profiles for the $k/c = 0.00023$ configuration are not significantly different than the $k/c = 0.00010$ profiles over the range of z' that could be measured with the pressure rake. Based upon the performance data it was expected that $k/c = 0.00023$ profiles would show a thicker boundary-layer than the $k/c = 0.00010$ profiles. Some evidence of this is shown at $\alpha = 6$ and 10 deg. for $z' > 50$ mm. Taken together, these data indicate that effect of flow disturbances located on the flap, tend to manifest themselves primarily on the flap itself with limited upstream influence.
