Aerodynamic Characterization of a Thin, High-Performance Airfoil for Use in Ground Fluids Testing

NASA John H. Glenn Research Center, Cleveland, Ohio 44135 USA

National Research Council Canada, Ottawa, Ontario K1A 0R6 CANADA

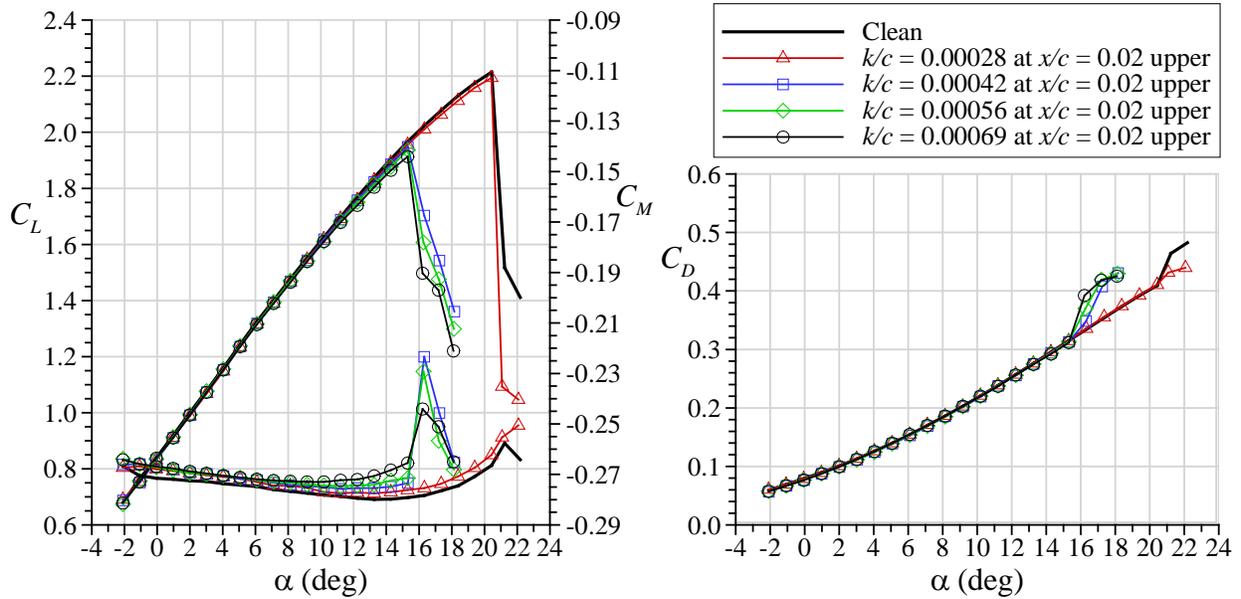
Figure 20. Effect of flow disturbances near leading edge of wing simulating fluid secondary wave.

In the present series of tests, this secondary wave was simulated with 2.0 in (50.8 mm) wide layers of aluminum speed tape with the forward edge placed at $x/c = 0.02$ on the upper surface. This location was selected to be upstream of the laminar boundary-layer separation location that was documented with the surface oil flow visualization described in Section III.A. The effect of increasing tape thickness is illustrated in Fig. 20 (cf. Table 4 for dimensional thickness range). Little or no effect on maximum lift and stall angle was observed until the height of the flow disturbance reached $k/c = 0.00042$, where there was a significant decrease in stalling angle and maximum lift coefficient. Incrementally increasing the disturbance height had no further adverse effect on the stalling characteristics up to $k/c = 0.00069$. The range of maximum lift coefficient was 1.91 to 1.95 at $\alpha_{stall} = 15.3$ deg. for the $k/c = 0.00042$ to 0.00069 cases. This compares to a range of $C_{L,max} = 1.91$ to 1.93 and $\alpha_{stall} = 15.5$ to 16.0 deg. for the fluid and fluid with moderate ice pellets cases in Fig. 15. The fact that these values are nearly identical strongly suggests that the reductions in maximum lift coefficient and stalling angle for the fluid/contamination cases were at least partially due to secondary wave effects.

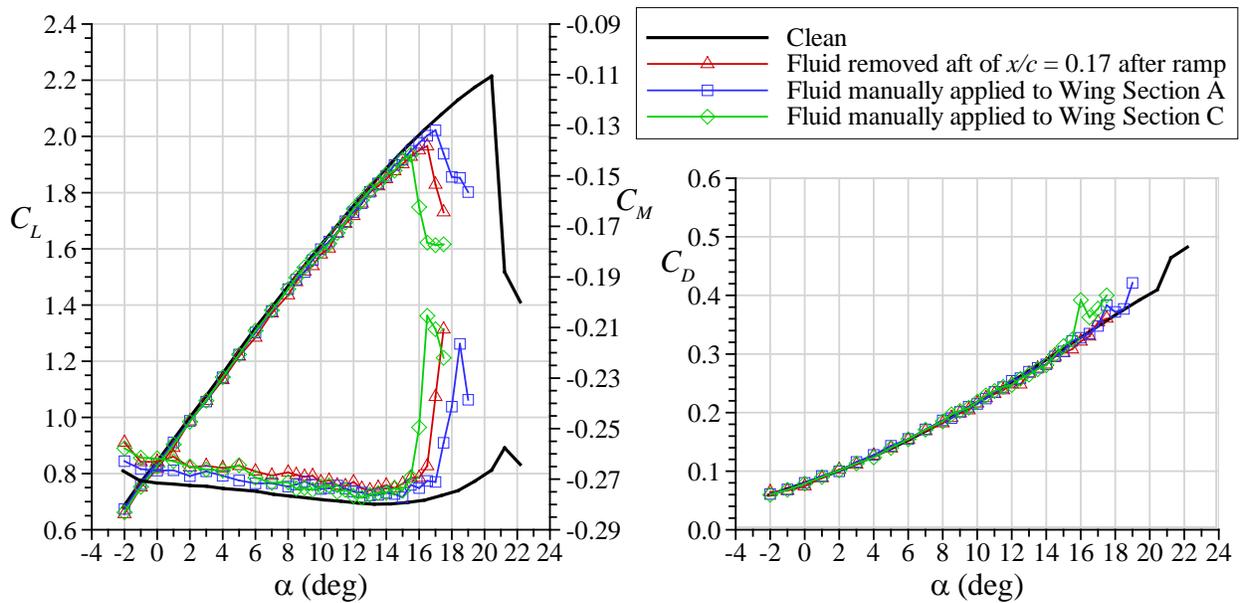
Figure 21. Comparison of secondary wave effects from fluid tests.

Additional fluid tests were performed using a modified ramp and rotation procedure to isolate secondary wave effects from the overall fluid effects. Anti-icing fluid was applied to the wing using the standard procedures. The airspeed was accelerated to 80 knots with the wing at $\alpha = -2$ deg. and then stopped to achieve fluid distribution on the wing that typically occurs prior to rotation. Fluid was then removed from the upper and lower surface of the wing aft of $x/c = 0.17$. In other tests, fluid was removed from the upper and lower surface separately. The airspeed was then accelerated to 80 knots followed by the wing rotation from $\alpha = -2$ to 22 deg. Additional tests were performed where fluid was manually applied to the wing upper surface upstream of $x/c = 0.17$ (identified as “Wing Section A”) and to the wing lower surface upstream of $x/c = 0.17$ (identified as “Wing Section C”). The resulting aerodynamic effects are summarized in Fig. 21. The lift and pitching-moment data show only minor deviation from the clean wing values for angles of attack less than 12 deg. This result is expected since in all cases there was no fluid on the wing aft of $x/c = 0.17$ and therefore minimal effect on the downstream boundary layer. This result is similar to the static simulation tests with leading-edge roughness (Fig. 11) and aluminum speed tape layers (Fig. 20). Also similar is the effect on the stall angle and maximum lift coefficient that were both significantly reduced from the clean wing values. The lowest values of α_{stall} and $C_{L,max}$ in Fig. 21 occurred when the fluid was manually applied to the wing leading edge on the lower surface (“Wing Section C). Fluid located in this region was likely directed toward the upper surface by the stagnation point moving downstream as the wing was pitched from $\alpha = -2$ to 22 deg. This is exactly the scenario described by Hill and Zierten¹⁴ as a secondary wave. The values of α_{stall} and $C_{L,max}$ for the fluid manually applied to Wing Section C configuration agree very well with the simulated secondary wave results presented in Fig. 20 for $k/c \geq 0.00042$. Returning to Fig. 21, the next highest values of α_{stall} and $C_{L,max}$ are for the fluid removed aft of $x/c = 0.17$ after ramp. This configuration likely had less total fluid in the leading edge region, but fluid still remained on the lower surface after the ramp. When fluid was manually applied only to the upper-surface, leading-edge area (Wing Section A), the values of α_{stall} and $C_{L,max}$ were the highest. There was still a significant performance penalty due to fluid in this location. These fluid test results were consistent with the results
