NASA/CR-2016-219005

Flight Services and Aircraft Access: Active Flow Control Vertical Tail and Insect Accretion and Mitigation Flight Test

*Edward A. Whalen
The Boeing Company, Hazelwood, Missouri*

January 2016

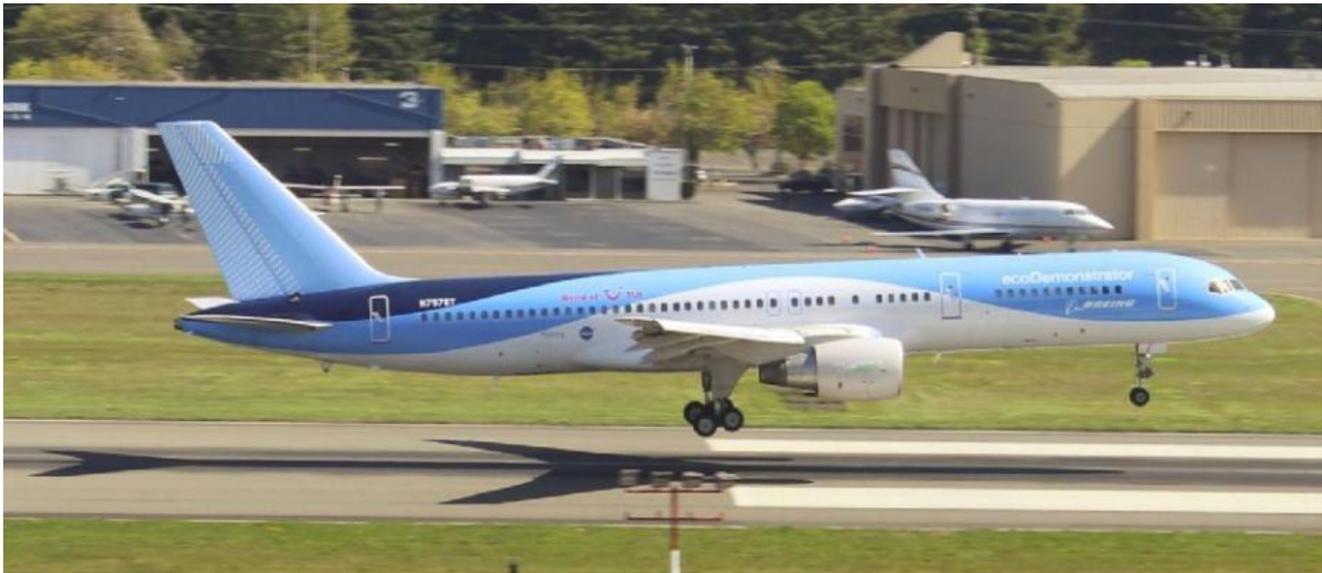
Figure 2: 757 ecoDemonstrator as configured for AFC Testing

The airplane was also modified both internally and externally to incorporate other technologies being tested by Boeing independent of this contract and to install flight test instrumentation. The airplane entered layup for installation of hardware and instrumentation on 1 Sept 2014. First Flight was on 17 Mar 2015. The airplane as configured for AFC testing is shown in Figure 2.

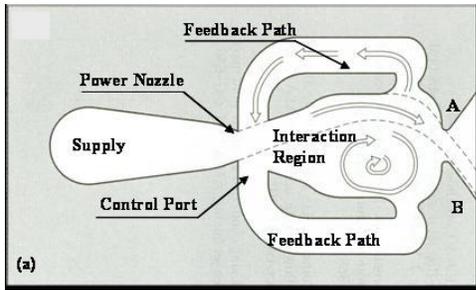
Figure 3 shows the features of a sweeping jet actuator that is representative of the type used for these demonstrations. The device achieves a sweeping motion due to a dynamic instability inherent in the design of the interaction region of the device. The instability is excited via feedback paths resulting in the cyclic attachment of the jet to either wall of the interaction region, which causes the exiting jet to sweep across the nozzle between exit walls "A" and "B".

Figure 3: Drawing of the components of a sweeping jet actuator

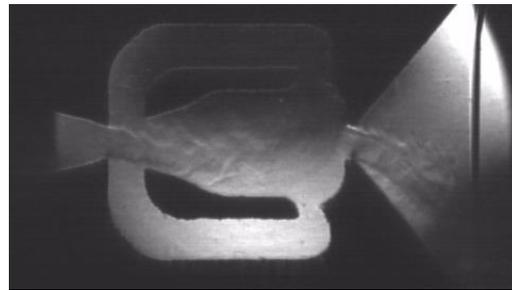
Figure 4 presents a Schlieren visualization of the flow field generated by a sweeping jet actuator. In the vertical tail application, the actuators were installed with the long axis perpendicular to the trailing edge of the fixed portion of the tail. This resulted in a spanwise (vertical direction) sweeping motion of the jet.

Figure 4: Schlieren image of a sweeping jet actuator flowfield. Note the jet that is toward the bottom of the nozzle at the right side of the image. (Photo credit: Caltech)

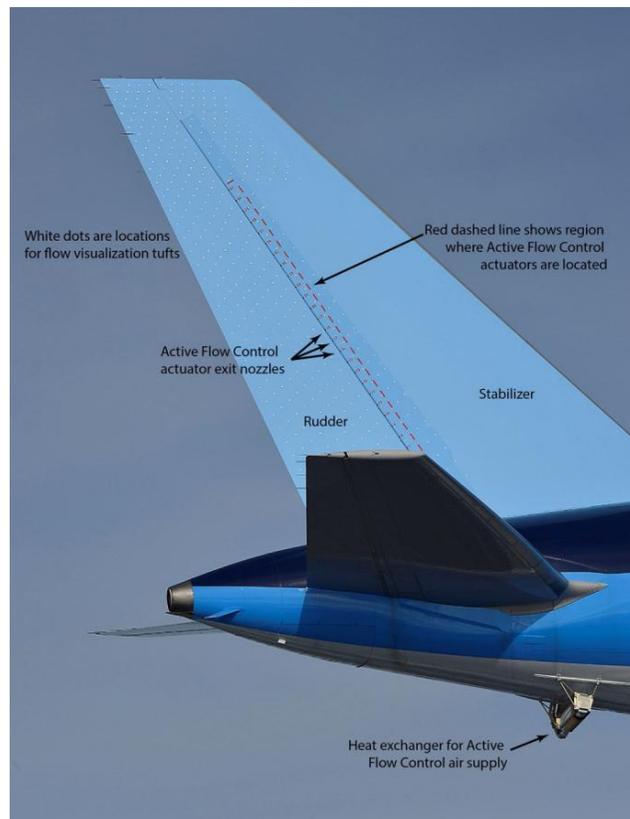
Figure 5 is an annotated photograph depicting the external arrangement of the AFC system on the 757 ecoDemonstrator.

Figure 5: External AFC system arrangement

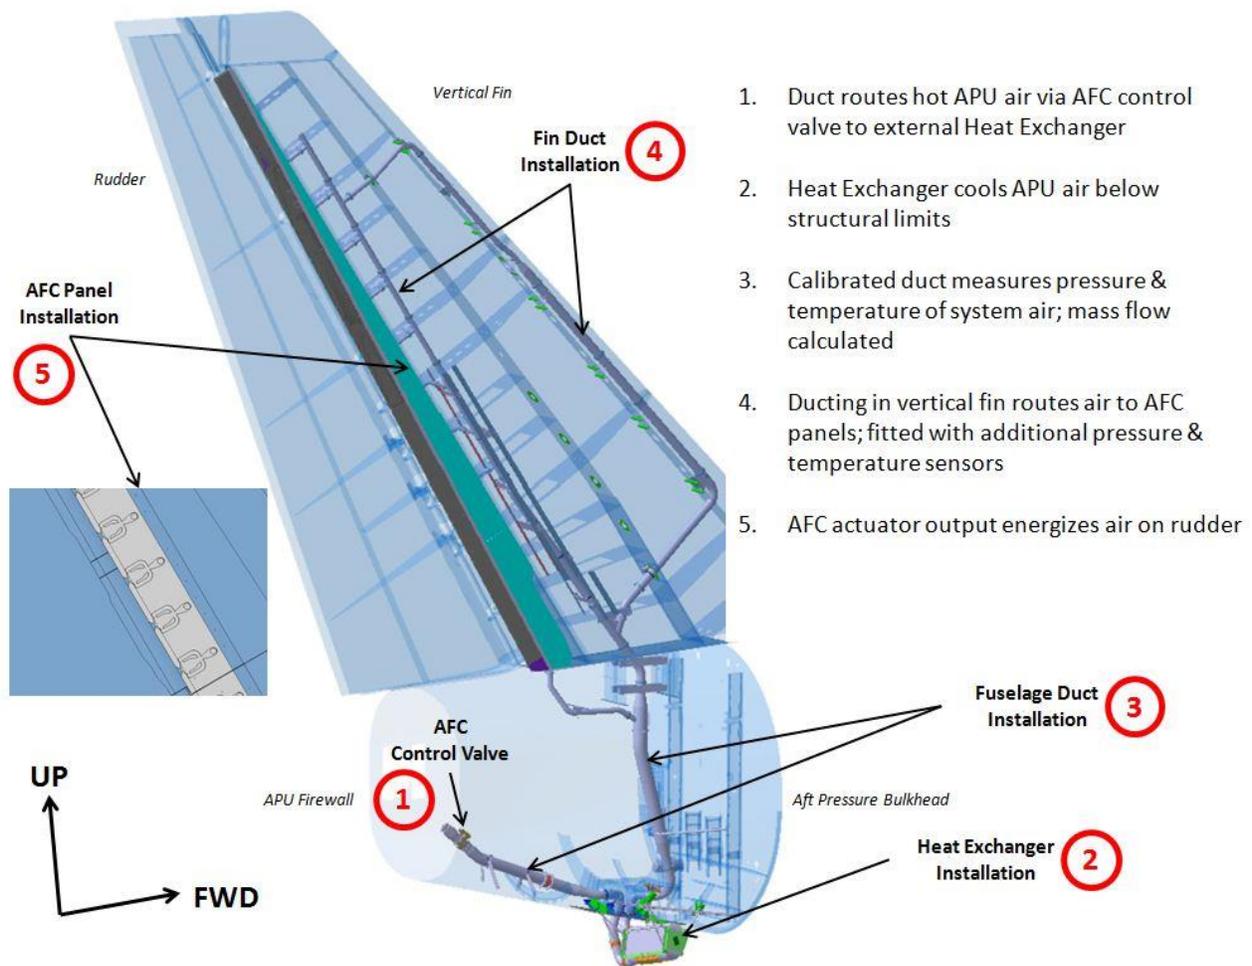
The sweeping jets added momentum to the mixing of near-wall flow over the rudder. This helps to keep the flow attached over the rudder and can increase rudder effectiveness at higher rudder deflections.

Figure 6: AFC Modifications to 757 EcoDemonstrator Aft Fuselage and Vertical Fin

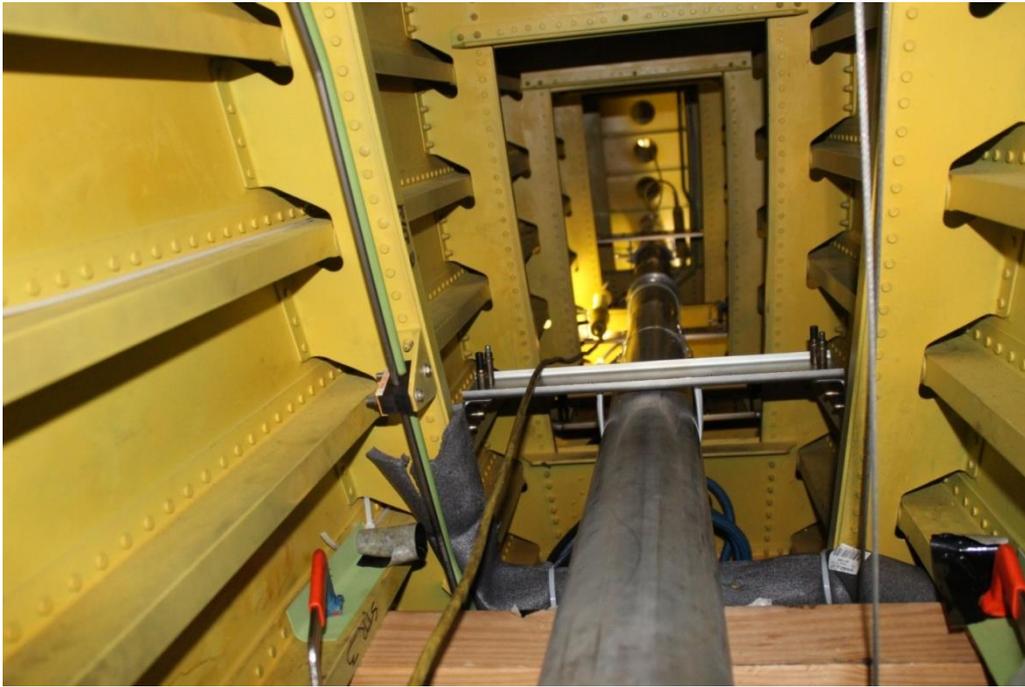
Figure 8 shows some of the ducting installed inside the vertical fin and the access challenges. Since many tubing joints were required, periodic leak checks were performed during installation to ensure proper sealing. This disciplined approach saved time overall by not having to “chase leaks” at the end when access to repairs would have been much more difficult.

Figure 8: Duct installation inside the vertical fin

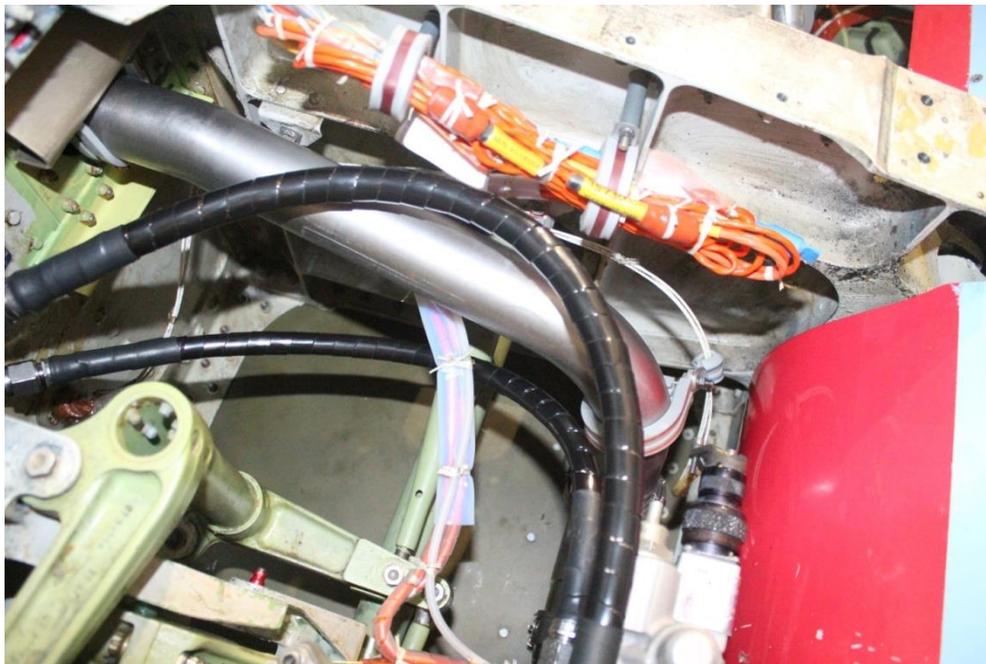
In addition to routing tubing around structure, it was also necessary to mitigate interference with systems. As shown in Figure 9, ducting ran through equipment bays containing rudder control actuators. A slight interference with hydraulic hoses was remedied by installing 45 degree angle fittings at the hose ends and “clocking” the hoses away from the duct. As an additional precaution, the hoses were wrapped with a protective coating to prevent abrasion in case of incidental contact under load. An inspection plan was put in place to look for damage during flight. None was found.

Figure 9: Hydraulic lines and AFC ducting

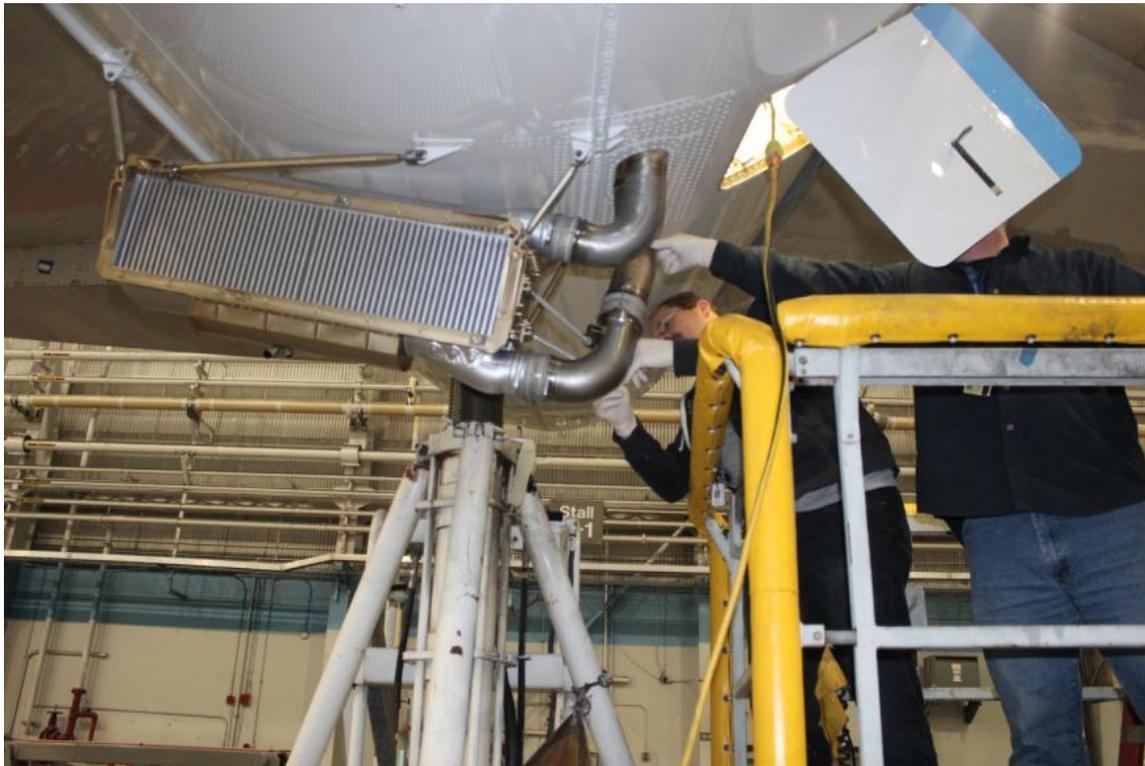
exchanger provided the most cost effective solution. An existing qualified unit was used that provided both acceptable back pressure and the necessary thermal performance. Figure 10 shows the heat exchanger mounted underneath the aft fuselage and some of the structural reinforcements at the tubing penetrations and heat exchanger attachment points. This type of installation would obviously not be appropriate for a production design.

Figure 10: Installation of the heat exchanger below the aft fuselage

Structural stiffeners shown in Figure 15 were installed underneath the maintenance platform in the aft fuselage to ensure that if the heat exchanger suffered a bird strike, the damage would not propagate into the fuselage.

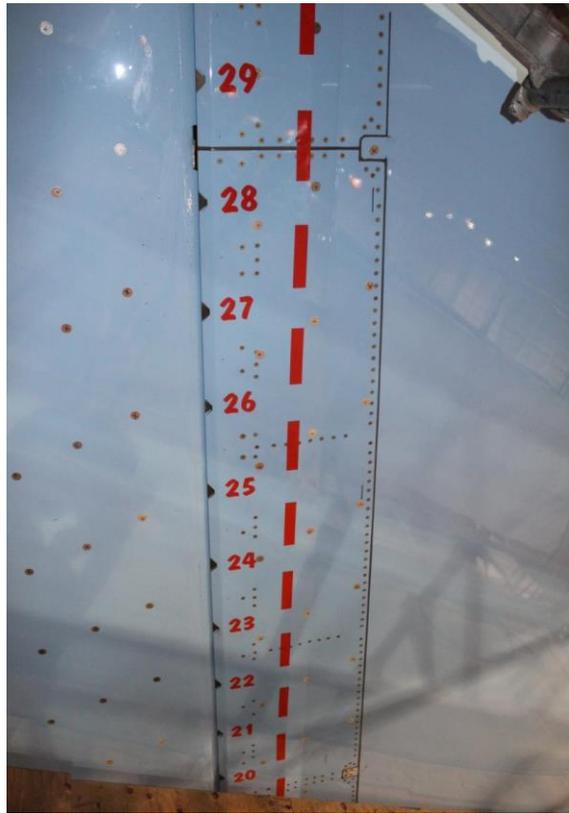
The AFC panels were installed on the fixed portion of the vertical stabilizer. The actuator nozzle outlets were located immediately upstream of the rudder bullnose and each actuator was numbered to aid in data analysis. Figure 11 shows the installation during the build process. The actuator outlets appear as black triangular shapes between the actuator number and the rudder. The circles on the rudder mark locations for future installation of flow cones. The final configuration is shown in Figure 12 with the flow cones installed. These were used to provide flow visualization during the flight test program.

Figure 11: Close-up external view of typical AFC panel installation

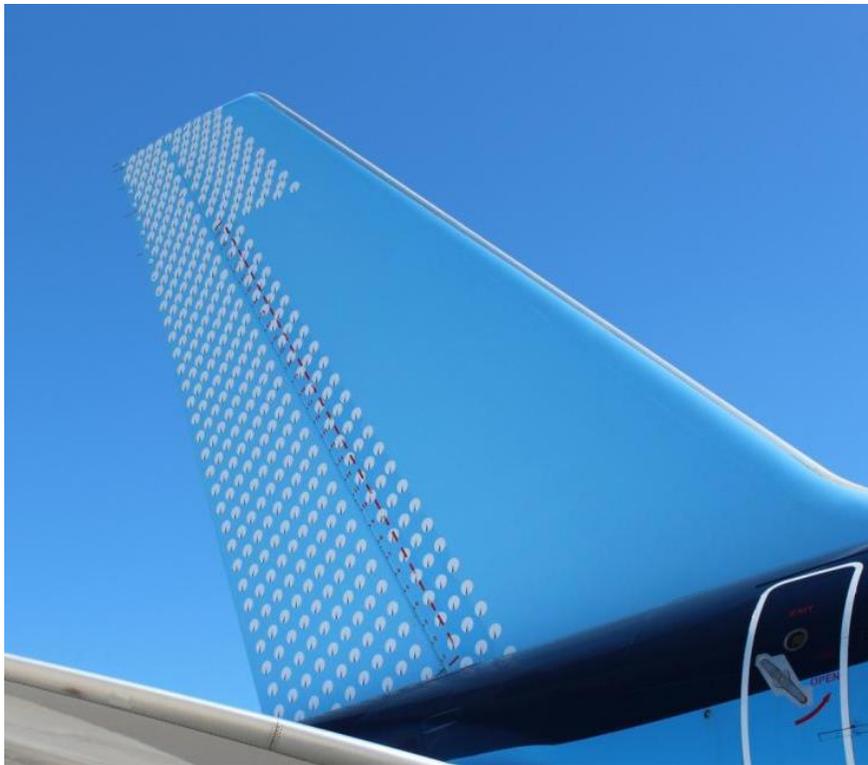
Figure 12: Flow cone installation on the vertical fin and rudder

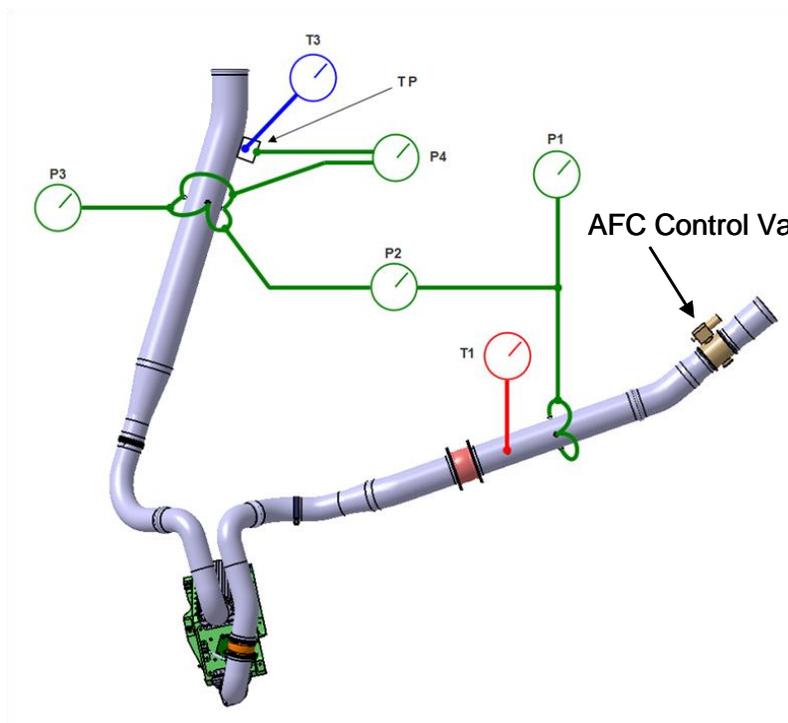
Only category 2 instrumentation to monitor and record AFC system performance was installed under the NASA task order. Figure 13 and Figure 14 illustrate details of the AFC system instrumentation used in the aft fuselage and the vertical fin, respectively.

Figure 13: AFC Fuselage Instrumentation

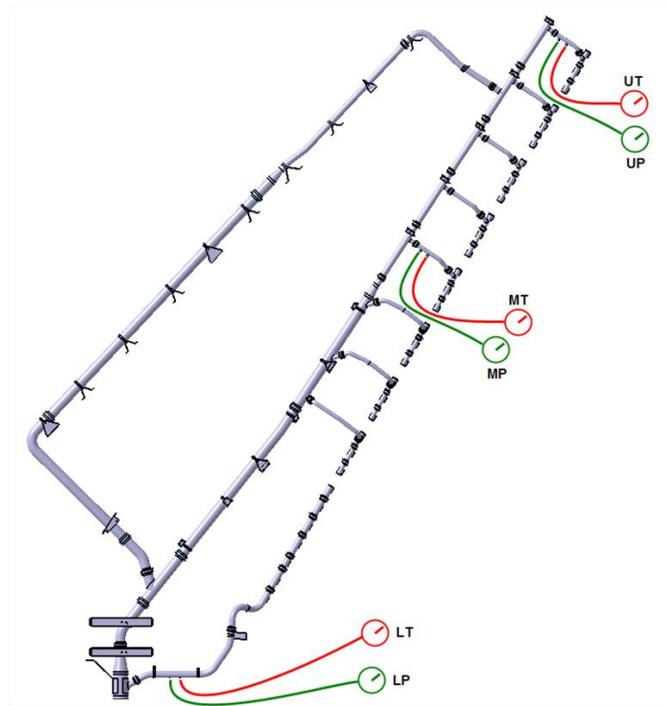
Figure 14: AFC Vertical Fin Instrumentation

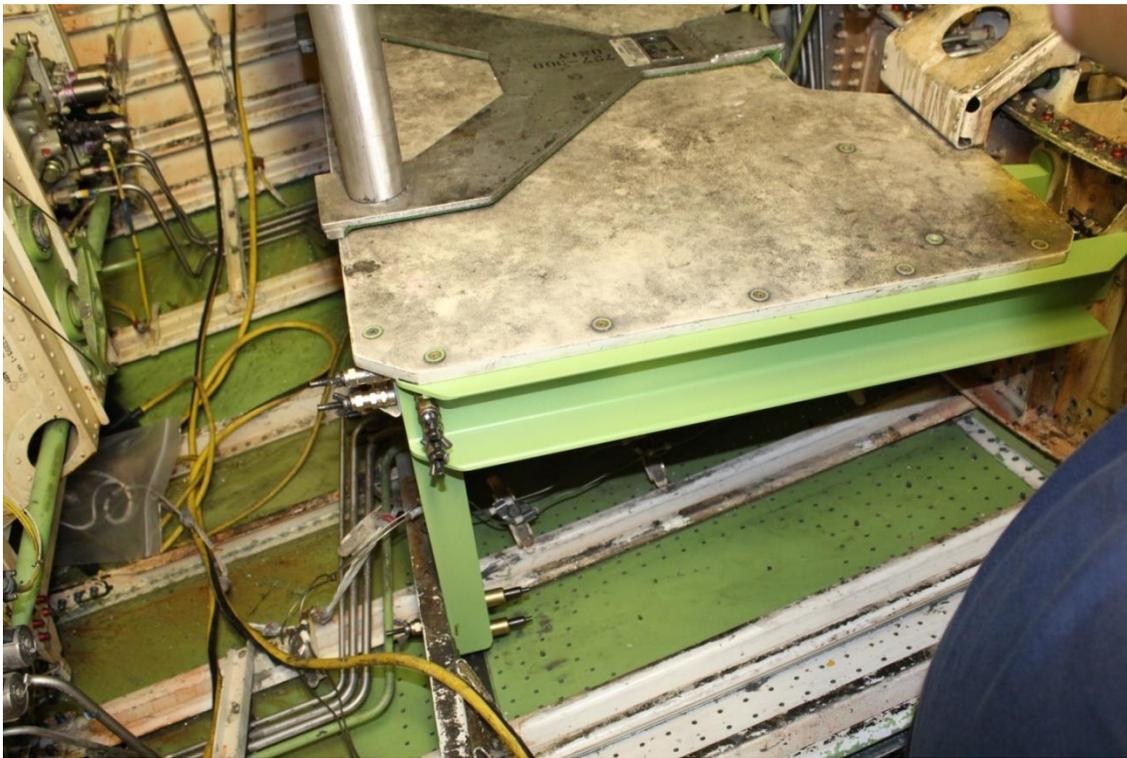
Figure 15: Structural stiffeners under the maintenance platform

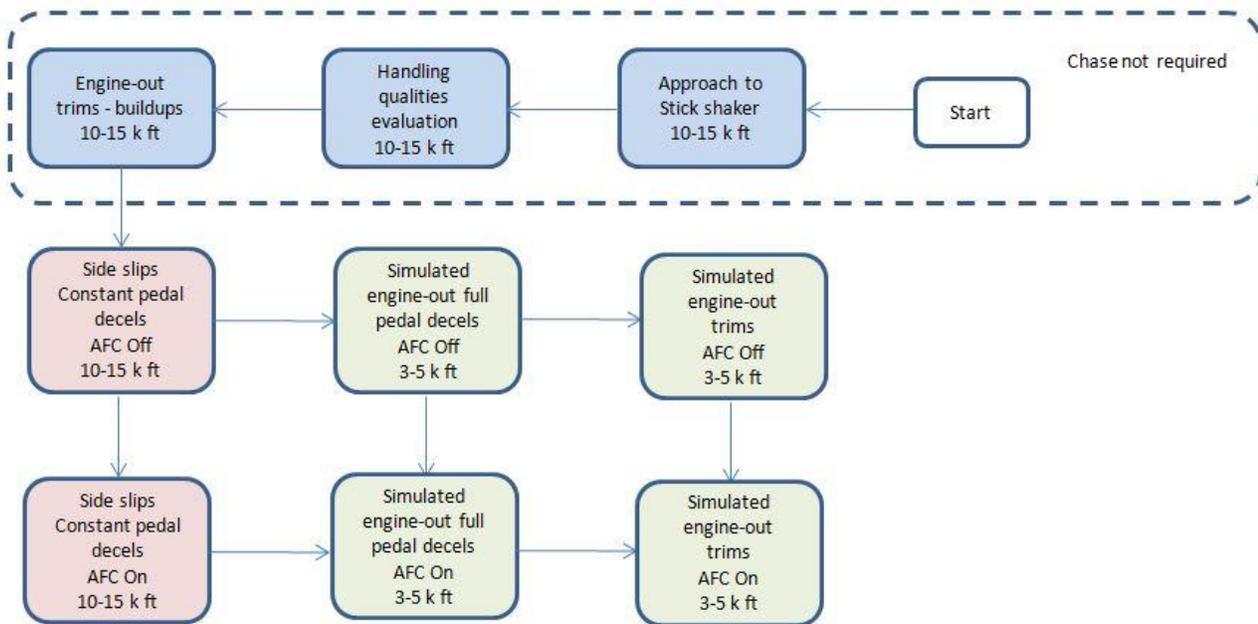
Figure 17 shows the AFC flight test sequence. Initial testing included all 31 AFC actuators. After this was completed, the system was modified to disable 15 actuators and test the remaining 16 AFC actuators (every other actuator operational).

Figure 17: AFC Flight-Test Sequence

The AFC system was modified after the third day to disable airflow to every other actuator, leaving 16 of the original 31 operational. This was done to simulate a partially-failed system.

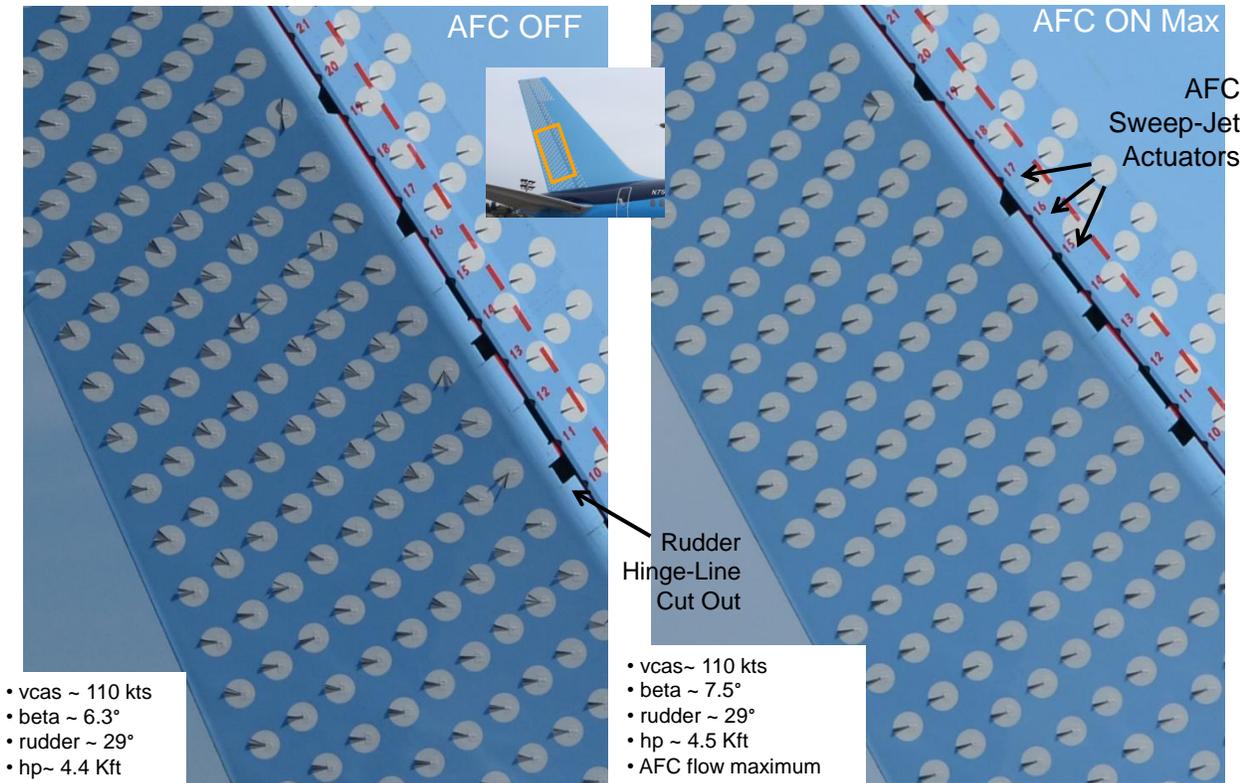
The photos from the chase plane of the vertical fin flow cones were digitally overlaid to provide an enhanced composite snapshot of the air flow during a given test condition. Each composite image represents one second of time during a condition and combines approximately five separate sequential images taken from the chase plane. The attachment points of each cone were aligned in each photo to construct the composite images. Figure 18 illustrates the difference in flow field with AFC off and on. When AFC is off, the tuft orientation at many locations on the vertical fin does not coincide with the cone orientation in previous or subsequent photos taken within a fraction of a second of each other. This spreading or scattering of the cones in the composite photo indicates unsteady separated flow. When the flow is attached and smooth, the cone from one picture to the next nearly coincides. The Figure below shows much less variation in cone orientation when AFC is on, indicating that AFC is positively affecting the air flow over the rudder.

Figure 18: Composite images of vertical fin flow cones with AFC off (left) and AFC on (right)

Preliminary analysis of aircraft parameters indicates that AFC increases rudder effectiveness at the flight conditions tested. These results are consistent with the flow-visualization results obtained from cone images.

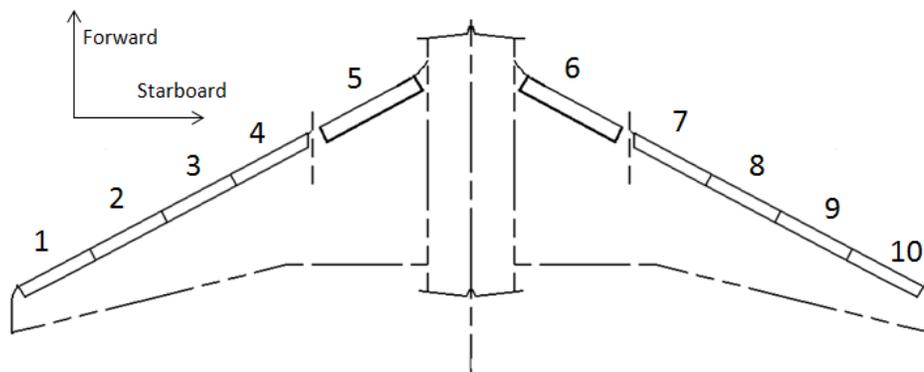
Figure 19: 757 Slat Numbering Nomenclature

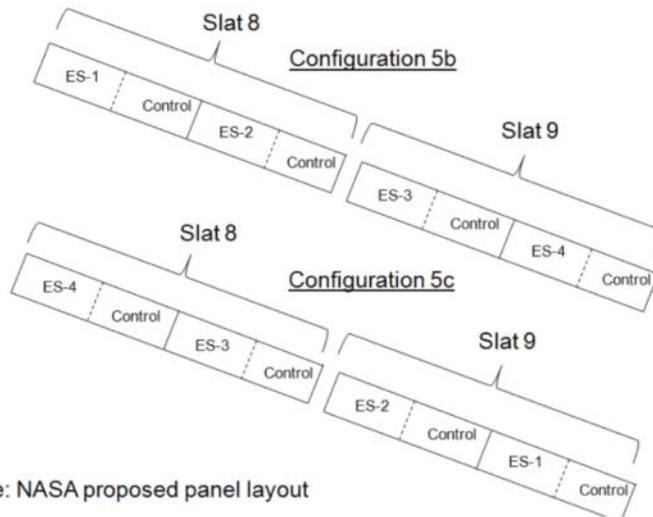
Figure 20: Substrate Installation Locations on Slats 8 and 9 (Top View).

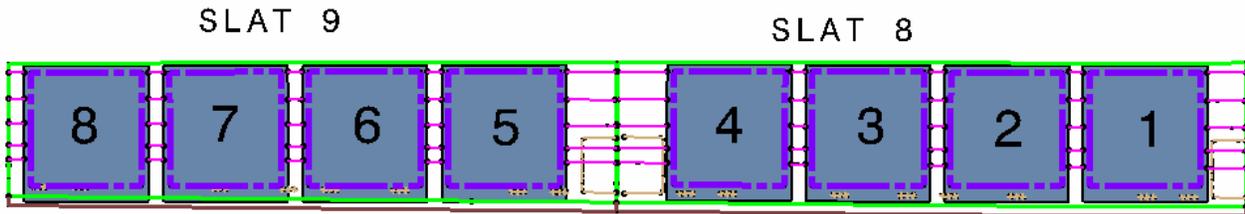
Figure 21: Substrate numbering locations on slats (Front View)

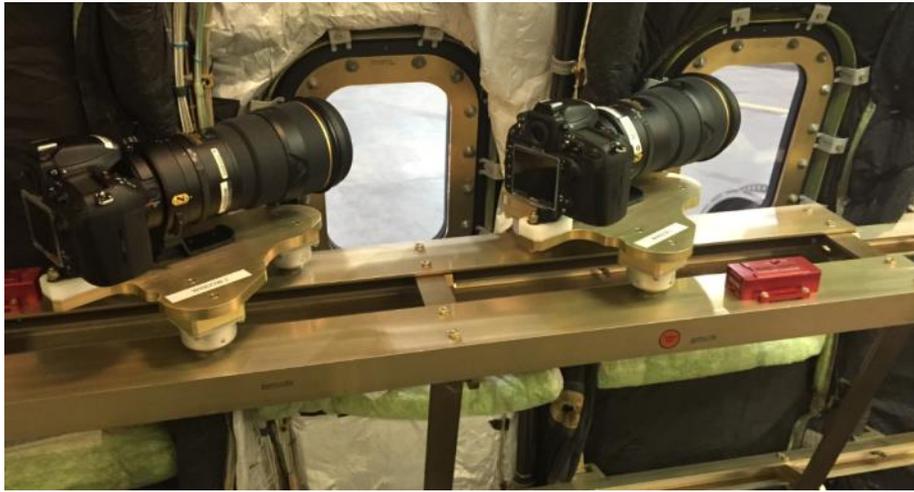
The IAM cameras were positioned in the passenger cabin of the aircraft at windows 2 and 3 on the starboard side as shown in Figure 22. This was done to provide an adequate field of view to capture the test panel locations as shown in Figure 23. The camera at window 2 was focused on Slat 9, and the camera at window 3 was focused on Slat 8. The camera, lens and mounting assemblies (GFP 6.2-6.4) were installed on a camera mount assembly that was attached to the aircraft. Further details of the camera mount design can be found in the Camera Mount Design section below.

Figure 22: IAM Cameras Mounted in Windows 2 and 3

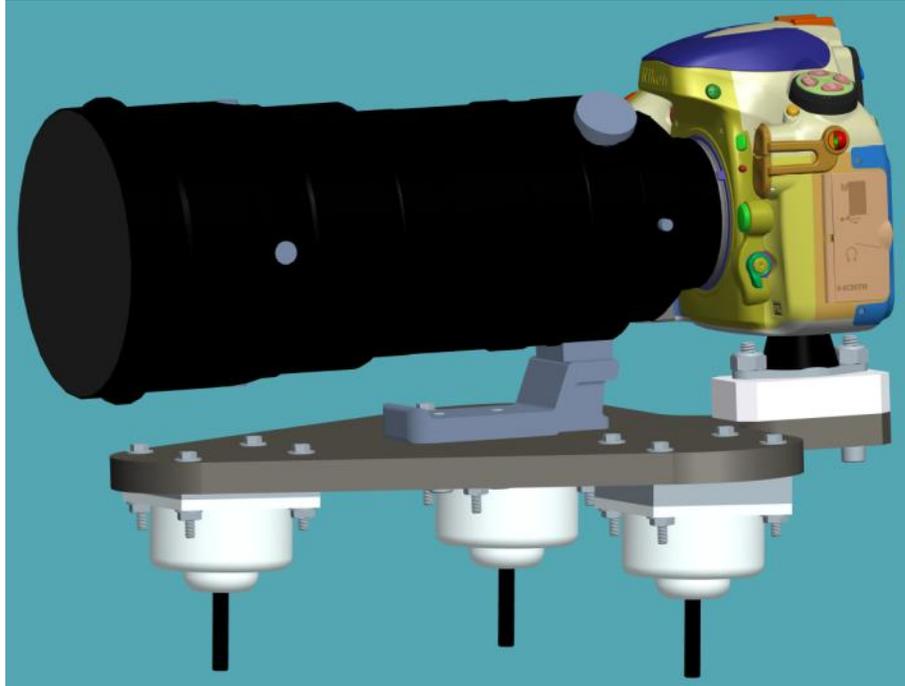
NASA designed the mounting hardware connected to the camera that would interface with the mount connected to the aircraft structure. Boeing provided a general vibration environment (Reference (23)) so dampeners could be incorporated to reduce the risk of image blur due to high-frequency vibrations. A tripod base mount was developed for each camera that would connect to the lens and incorporate the dampeners in the feet of the mount. Figure 24 shows the camera mount design model with the camera included.

Figure 24: NASA Mount Design with Camera Attached

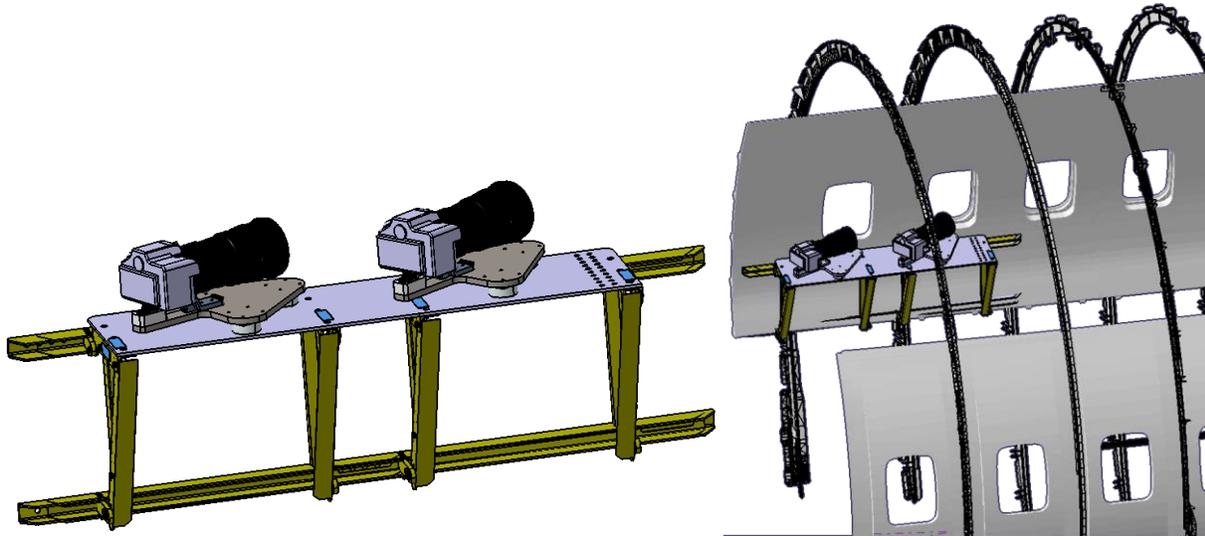
Boeing designed a “table-top” rack that would attach to the internal fuselage frame. The table top design allowed both cameras to be attached to the same mount while positioned to view out windows 2 and 3, as shown in Figure 25.

Figure 25: Boeing "Table-Top" Camera Mount Design

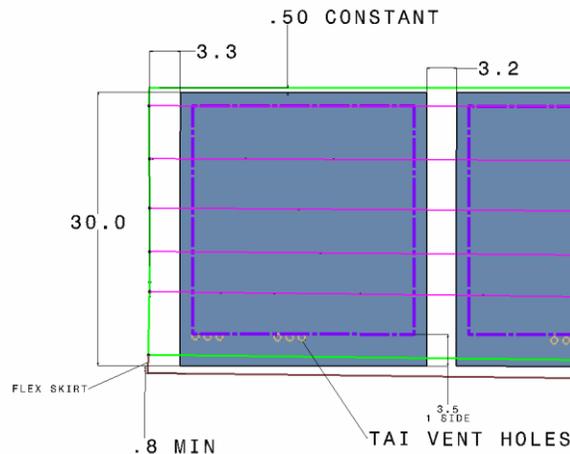
An objective of the design was to have all panels the same size and rectangular. This would allow any panel to be located in any position and minimize the cost of substrate manufacturing, installation, tracking, and shipping. The final panel size recommendation (Deliverable 4.19) was 27 inches in width (measured in spanwise direction) by 30 inches in length (measured in chordwise direction). The chord length was determined by the maximum chord length at the outboard end of slat 9. The substrate was installed with a 0.5 inch offset from the slat upper surface trailing edge to provide for surface area to bond speed tape during installation. Similarly, the panel was 0.9 inches away from the seal skirt trailing edge. See Figure 26 for the dimensions along the outboard edge of slat 9 and Figure 27 for the inboard end of slat 8.

Figure 26: Selected Panel size fitted at the outboard end of slat 9 (Front View)

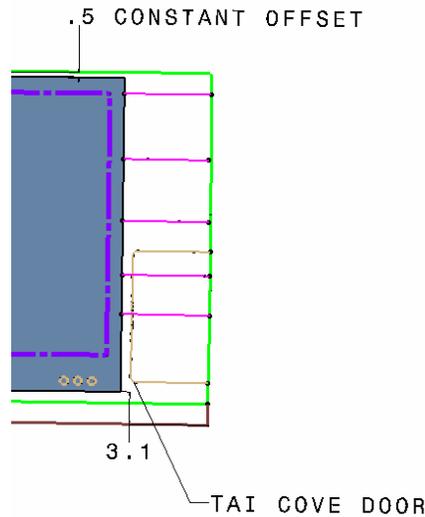
Figure 27: Substrate installation on the inboard end of slat 8 (Front View)

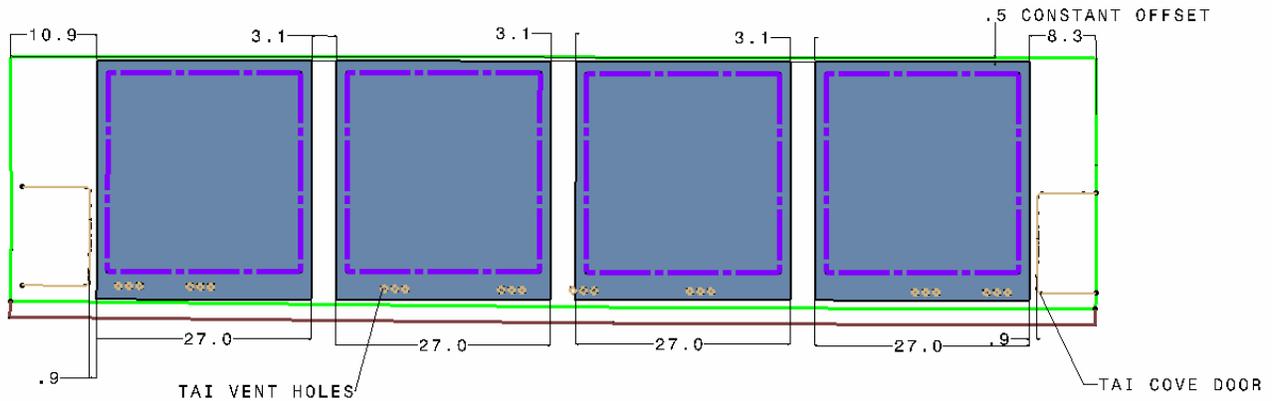
Figure 28: Panel spacing on slat 8 (Front View)

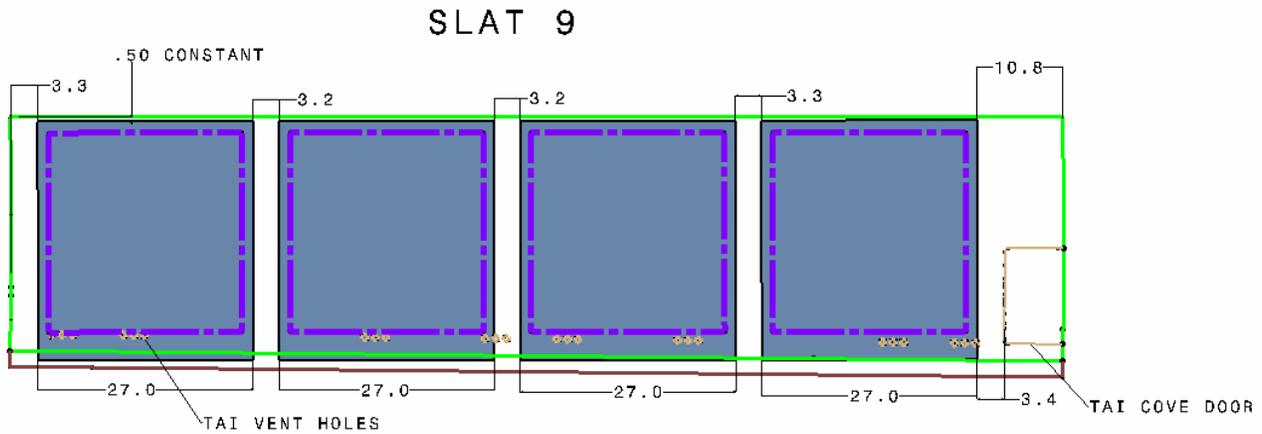
Figure 29: Panel Spacing on Slat 9 (Front View)

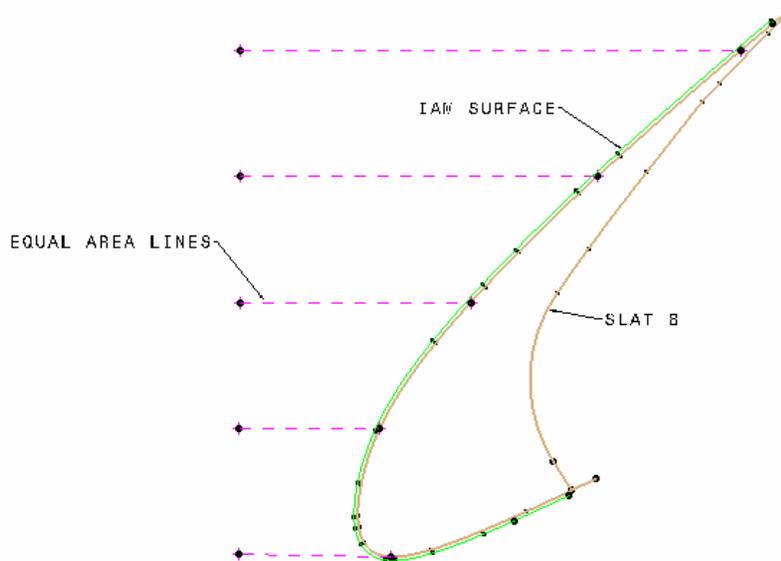
To assist in determining insect accretion along zones of the slat, equal frontal area markings were placed on the slats. The frontal area was split into 4 zones starting at the upper engineering surface starting point and at the lowest highlight on the slat. See Figure 30 for a side view of the area line markings. The lines were projected normal to the frontal plane onto the slat surfaces. An additional line was added at the lower visible location from the camera mounted in the fuselage window since the underside of the slat was not viewable. Due to the varying size profile of the slat chord across the span, the area line markings spacing varied spanwise. See Figure 31 for an isometric view of the slat with area line markings and spacing. Outboard marking of vertical separation is 3.64 inches and inboard is 4.20 inches. The lines were not marked on the Engineered Surface so as to not interfere with the insect accretion. Additional lines were added following the same process on slats 7 and 10 to aid in bug counting on additional slats. One-quarter inch thick lines were painted on the slats with primer. Photo targets were added along the area lines to split between the IAM panels and split the other slats into 4 similar sections. These were added for computer photo processing capability. See Figure 32 for a view of outboard slat 7 and slat 8 with photo targets and painted lines.

Figure 30: Side view of equal area line markings

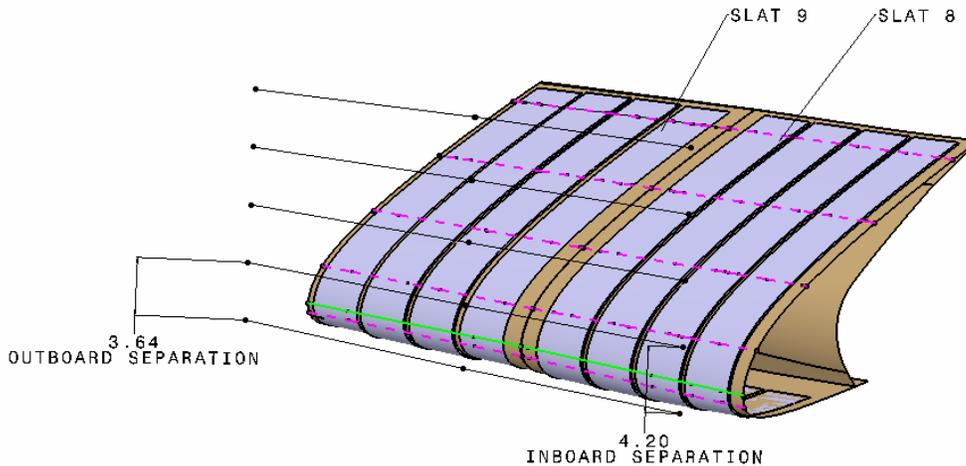
Figure 31: Side View of Equal-Area Line Markings

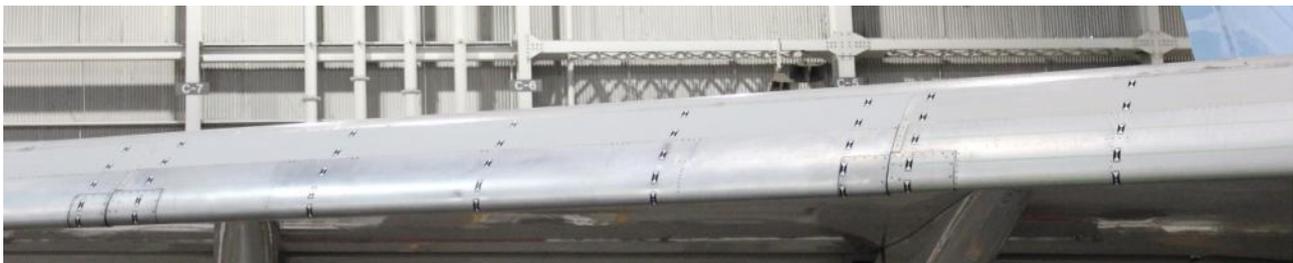
Figure 32: Painted Lines and Photo Targets on Slats (no IAM panels installed)

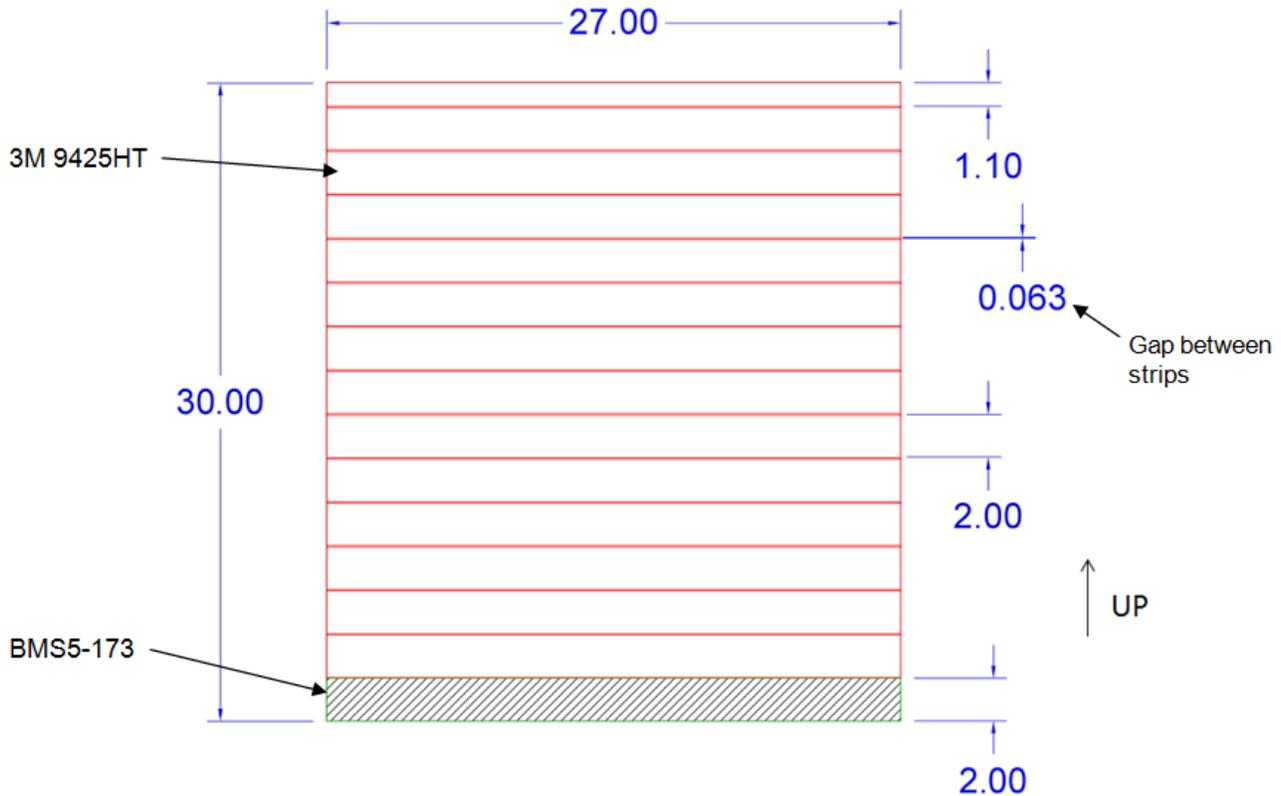
The tape was laid along the whole inner surface of the substrate in an effort to eliminate air bubbles that may lead to disbonding under aerodynamic load. Due to the stiffness of the aluminum sheet, 2-inch strips of tape with 0.063-inch gaps were laid spanwise along the back surface of the substrate. See Figure 33 for tape configuration on the inner surface of the substrate.

Figure 33: Double-Sided Tape Configuration

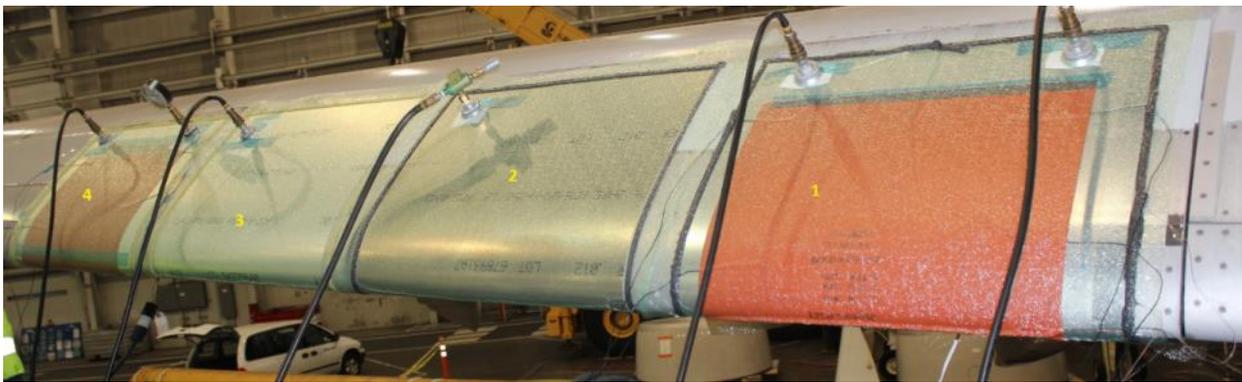
To ensure full bonding adhesion from the pressure sensitive tapes and to reduce voids, vacuum pressure was used for the panel installation. First, the substrate panels were bonded on using the double-sided tape. The panels were then vacuum bagged for a minimum 1 hour at a minimum of 22 inches Hg to ensure full strength. See Figure 34 for view of vacuum bagged substrates. An NDI was performed after bagging to check maximum air void sizes. Prior to installation, Kraft paper was placed over the engineered surface to protect the coating. A tap test was performed on the panel and the voids were drawn on the Kraft paper. The void sizes were checked against the allowable void sizes per the stress analysis prior to removal.

Figure 34: Vacuum Bagging of Substrate on Slats

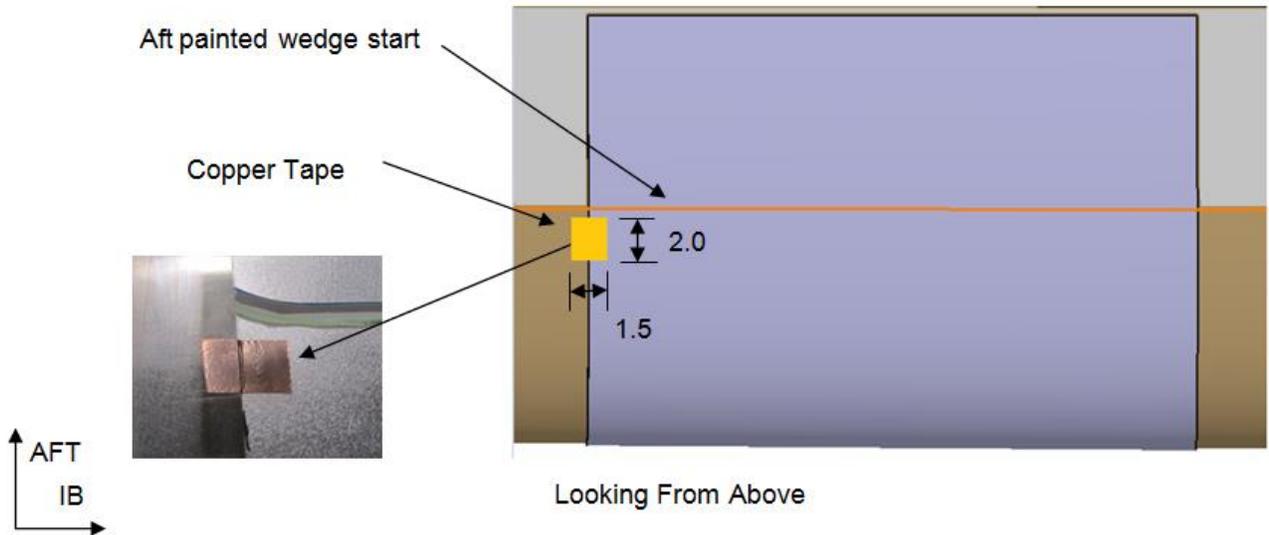
The substrates are exposed to air flow and are required to be grounded for EME/EMI. A 2.0-inch wide x 1.5-inch long 3M 1181 copper tape is used for grounding from the substrate outer surface to the slat outer surface. See Figure 35 for substrate ground path installation.

Figure 35: Copper Tape Ground Path Installation (Substrate)

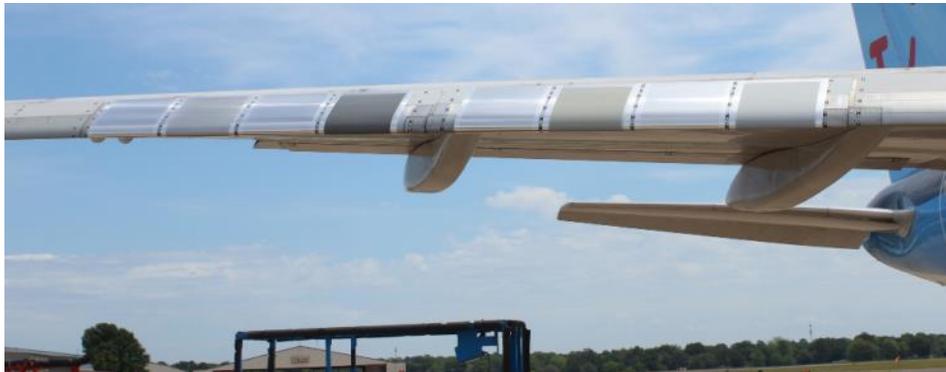
To install the panels, the leading edge was first extended to the landing position. The substrates are temporarily located to the locating features without removing the backing tape. The tape at the nose is first removed and bonded. The tape backing strips are then removed one at a time as the panel is rolled/pressed onto the surface working forward to aft to avoid voids. To develop the tape bond strength, a vacuum is then applied. After vacuum bagging, a tap test was performed to confirm acceptable void sizes. The voids are drawn on the Kraft paper protecting the engineer surface as shown in Figure 37. After the voids are deemed acceptable, the Kraft paper is removed and the bonding copper tape is applied and resistance checked. The periphery is wrapped in speed tape and the outboard edge holes are installed. See Figure 38 for a view of the completed installation.

Figure 38: Complete IAM Panel Installation

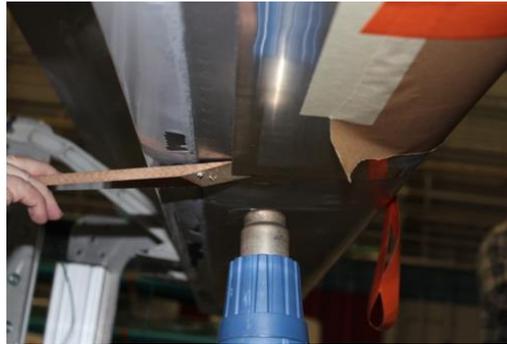
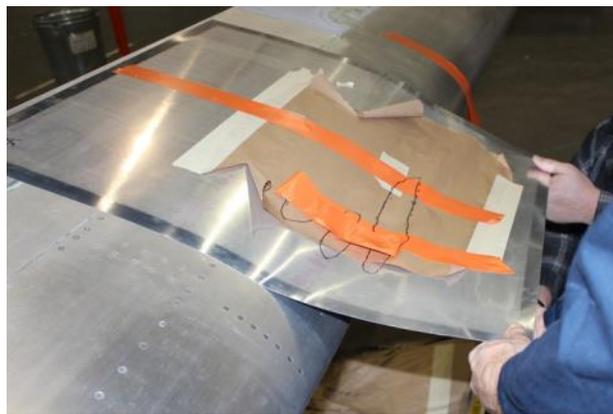
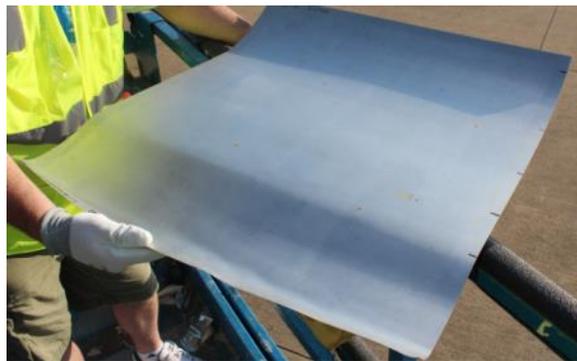
scraper to separate the high tack tape from the slat surface. See *Figure 39*, *Figure 40*, and *Figure 41* for removal details. After removal, the substrates were placed in shipping boxes as shown in *Figure 42*.

Figure 39: Peel substrate away from slat surface (Lower Surface View)

Figure 40: Peel IAM Panel Away From Slat (Upper Surface View)

Figure 41: Flat Removed IAM Panel with Edge Marked for Area Lines
