NASA/CR-2016-219005

Flight Services and Aircraft Access: Active Flow Control Vertical Tail and Insect Accretion and Mitigation Flight Test

*Edward A. Whalen
The Boeing Company, Hazelwood, Missouri*

January 2016

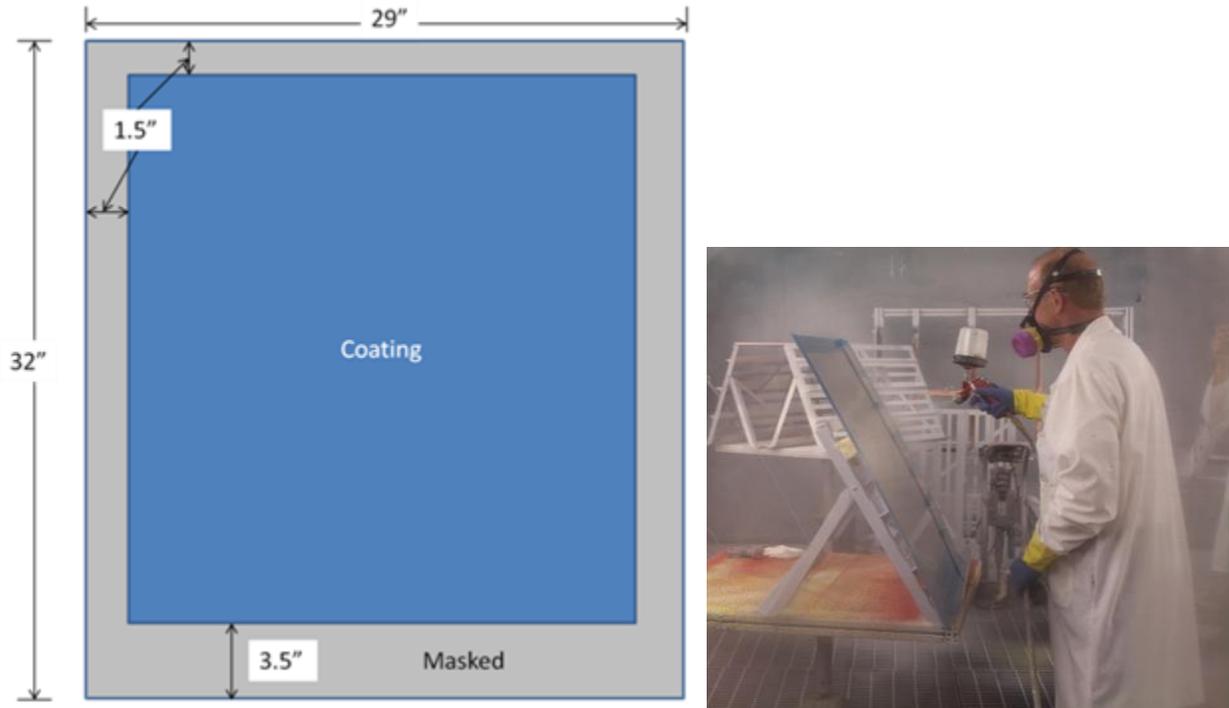
during the cure, and that up to 8 panels of a formulation will need to be cured at one time. Using a commercially available, high temperature cure, polyurethane aerospace coating as the test bed formulation, it was found that the 7075-T6 substrate panels could be sprayed nearly vertically (70 degrees from horizontal) when taped onto a 0.040" 2024-T3 backing panel using Shercon PC-90 tape. The panels could then be cured at 170 °C for up to 6 hours when laid flat in the cure oven without warping or having silicone contamination from the tape, and that the tape could be used to picture-frame the coating so that there would then be areas for adhering the test panels onto the slat without applying the Flight Test tape to the coating and potentially causing tape adhesion issues (Figure 44).

Figure 44: Example of IAM Coated Substrate Appearance

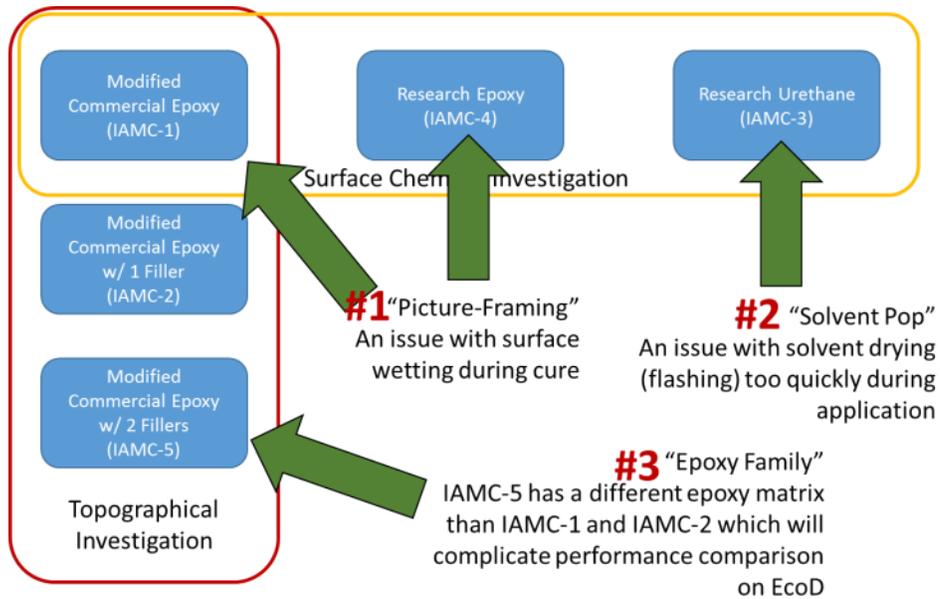
. Figure 45: Areas for Improvement Needed Based on Sprayout 2 (From NASA LaRC)

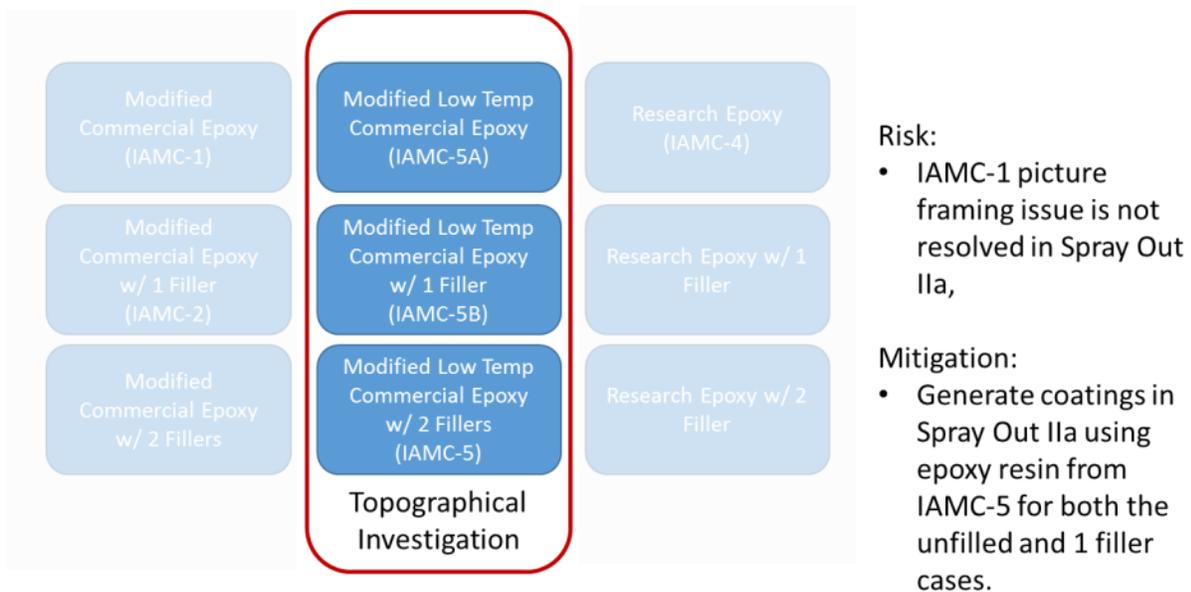
Figure 46: Areas for Improvement Needed –Topographical Investigation Alternative (From NASA LaRC)

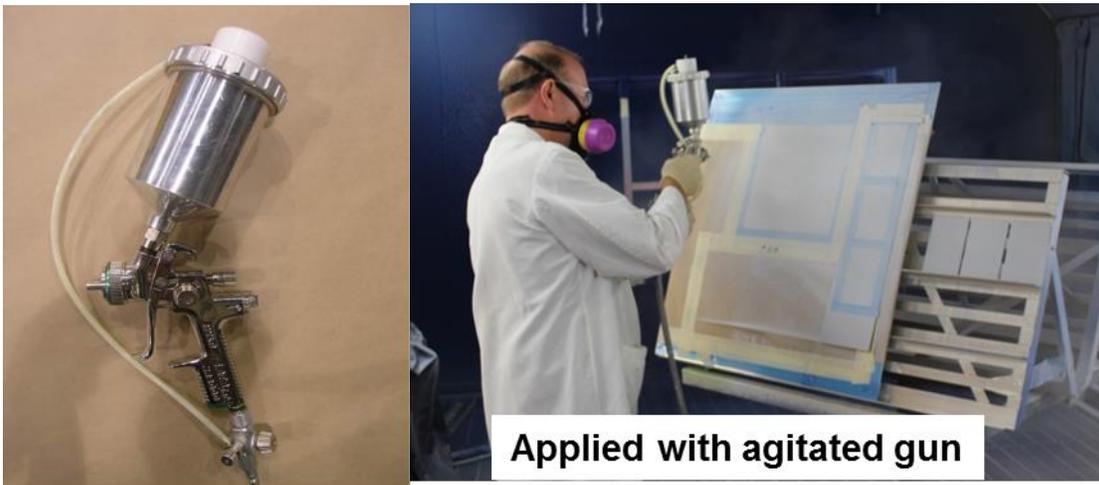
Figure 47). In order to minimize the “picture framing” issue identified in the previous sprayouts, an elevated temperature flashoff at 30 °C and a multiple temperature step cure up to 170 °C was specified for IAMC-1 and -4 by LaRC. Based in part on the solvent packages in commercial high temperature cured urethanes, such as that used in the pre-trial of Sprayout 2, the IAMC-3 solvent package was modified to be a mixture of MAK and cyclohexanone, which are less volatile solvents than the MEK used in Sprayout 2, and the temperature was slowly ramped up to the specified cure temperature of 120 °C.

Figure 47: Sata NR2000 D=Gravity Fed Paint Gun with Agitator

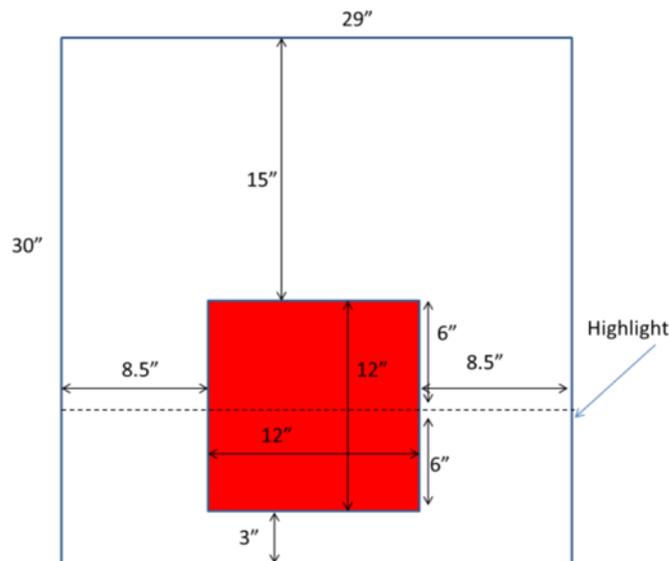
Figure 48. These panels were also given to the Structures group for testing on the ecoDemonstrator slat. All substrates were sprayed with an adhesion promoter conversion coat, AC-131. In this sprayout, only formulations -3 (urethane base), -and 5B (filled epoxy) were followed by an aerospace, non-chrome containing corrosion inhibiting primer. The other formulations were unfilled epoxies.

Figure 48: Large Panel Pattern for Sprayout 2A.

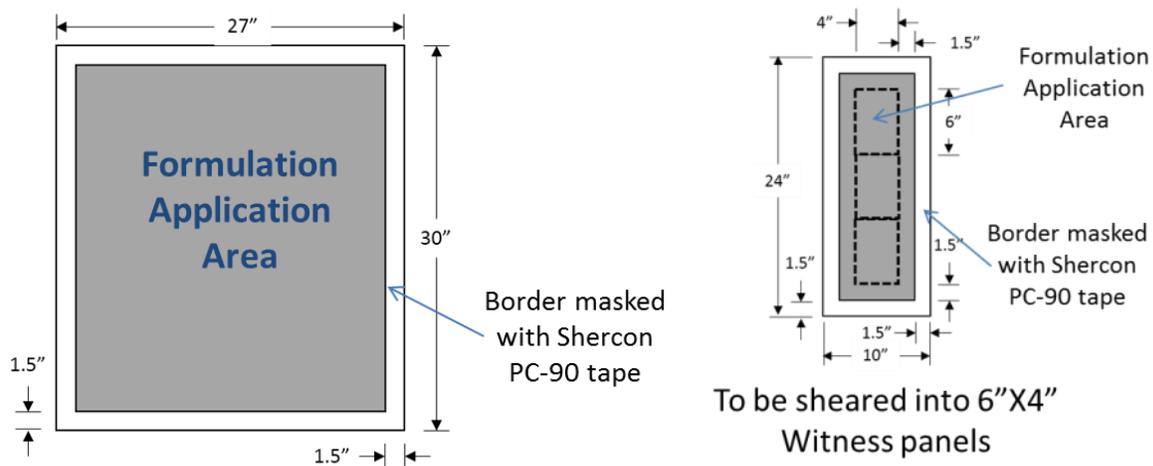
Layout for coating application used on the Flight Test Panels and the witness panels that were sent to LaRC are shown in Figure 49. After the sprayouts, a judging board consisting of Boeing and NASA personnel ranked the large 0.012" X 27" X 30" 7075-T6 Al clad panels from 1 to 8 within each formulation for uniformity and consistency. The higher ranked panels from each coating formulation were then to be used in the Test Flights in Shreveport.

Figure 49: Layout of Large Flight Test and Witness Coated Panels

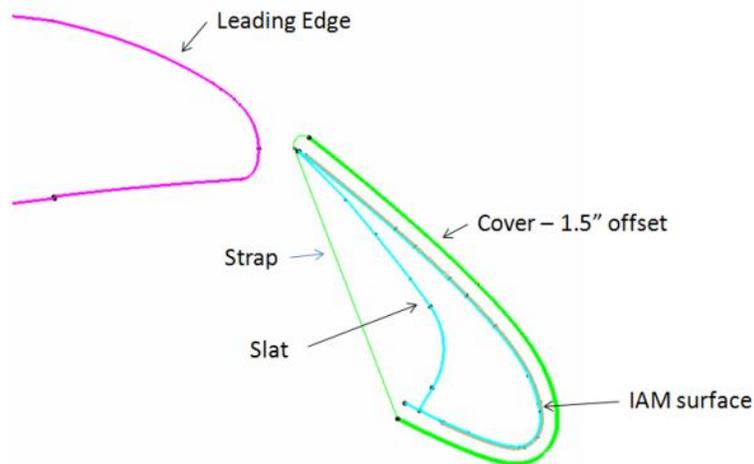
Figure 51: Slat Cover Installation Cross-Section

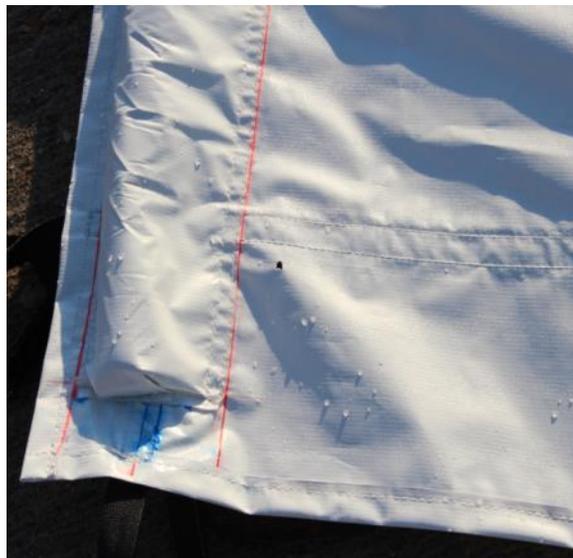
It was determined a cover for each slat was preferable over one large cover. This would make the cover more manageable to prevent contact of the IAM surface during installation. The covers were successfully tested with a watering can. 0.25 inch diameter holes were punctured at the lowest inboard points adjacent to offsets to provide a water drain path. See Figure 55.

Figure 55: Drain Path for Water Pooling at Covers Lowest Point

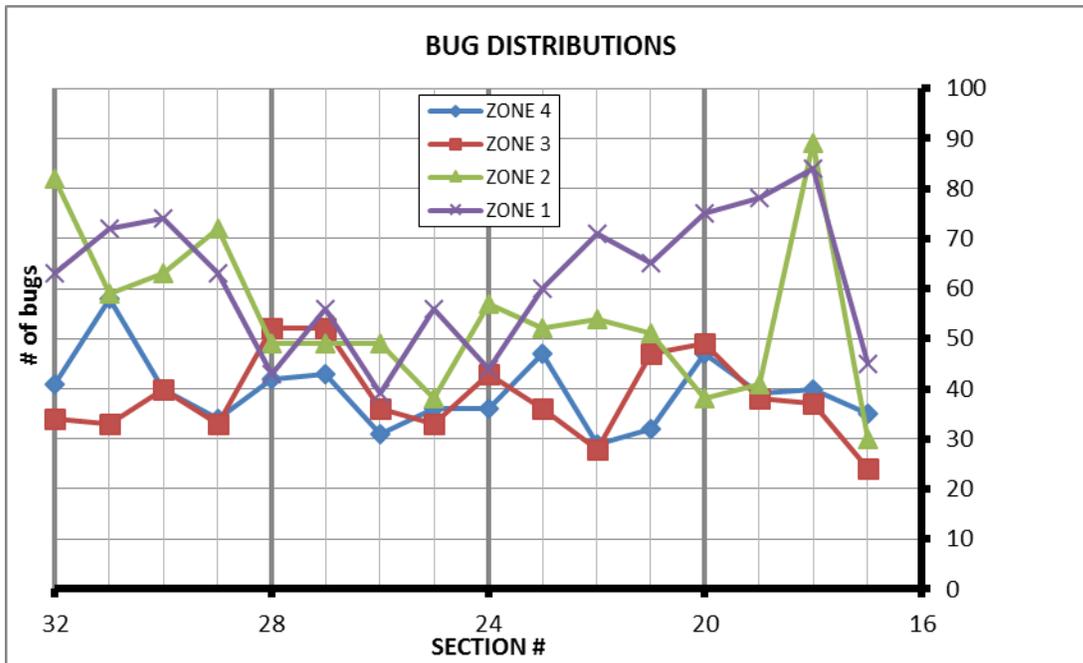
Figure 61: Flight 4 Accretion Distributions

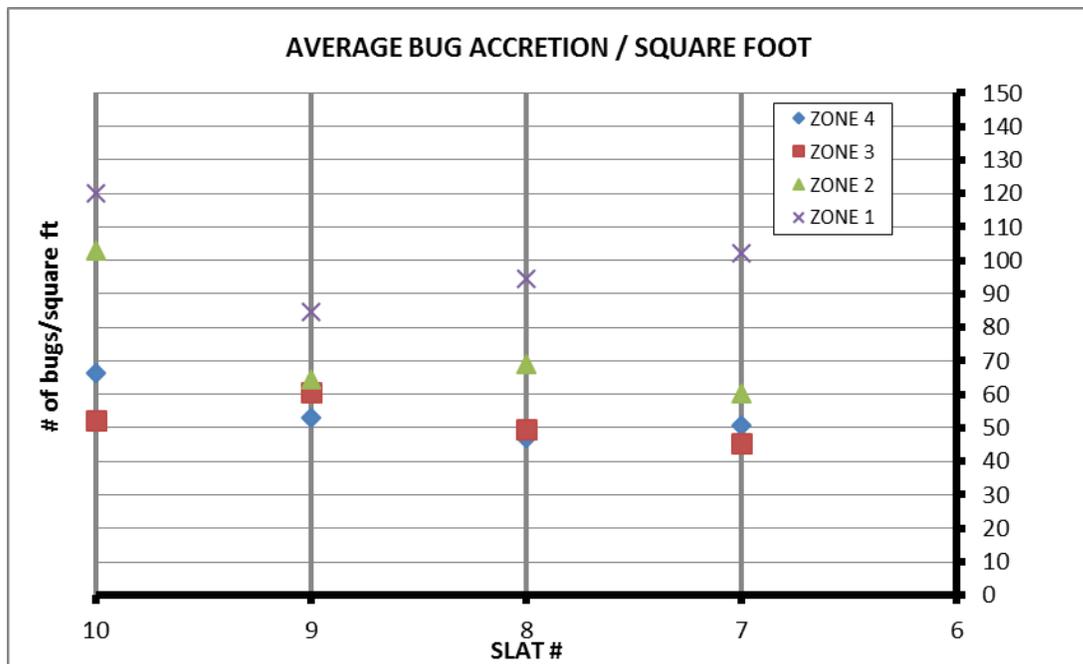
Figure 62: Flight 4 Accretion Per Square Foot
