# The Human Factors of an Early Space Accident: Flight 3-65 of the X-15

Presented to  
the Technical University of Munich  
October 25th, 2016

Immanuel Barshi, NASA Ames Research Center  
Irving C. Statler, NASA, Ames Associate (retired)  
Jeb S. Orr, The Charles Stark Draper Laboratory, Inc.

## INVESTIGATION OF THE CRASH OF THE X-15-3 AIRCRAFT ON NOVEMBER 15, 1967

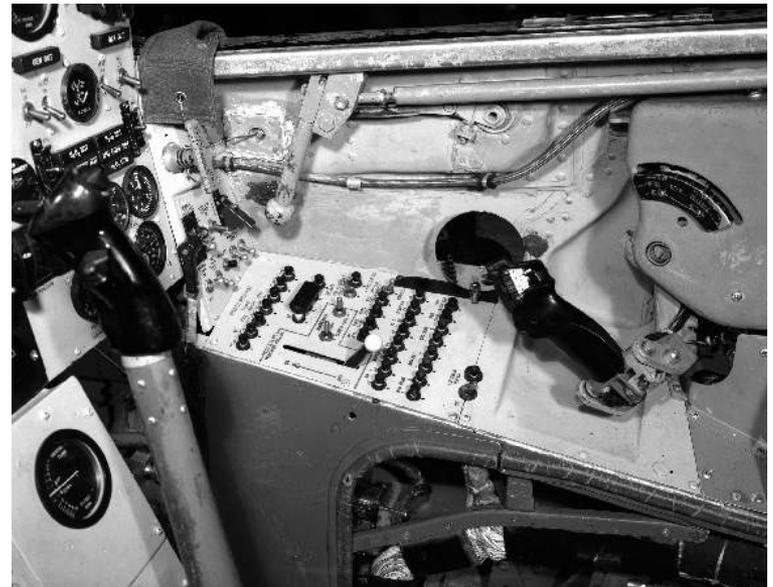
Right side stick

- ❖ Automatic control of the gain of inputs to the aerodynamic control surfaces in all three axes as a function of dynamic pressure
- ❖ Automatic engage/disengage of the reaction controls
- ❖ Ability to use the right side stick for both aerodynamic and reaction controls

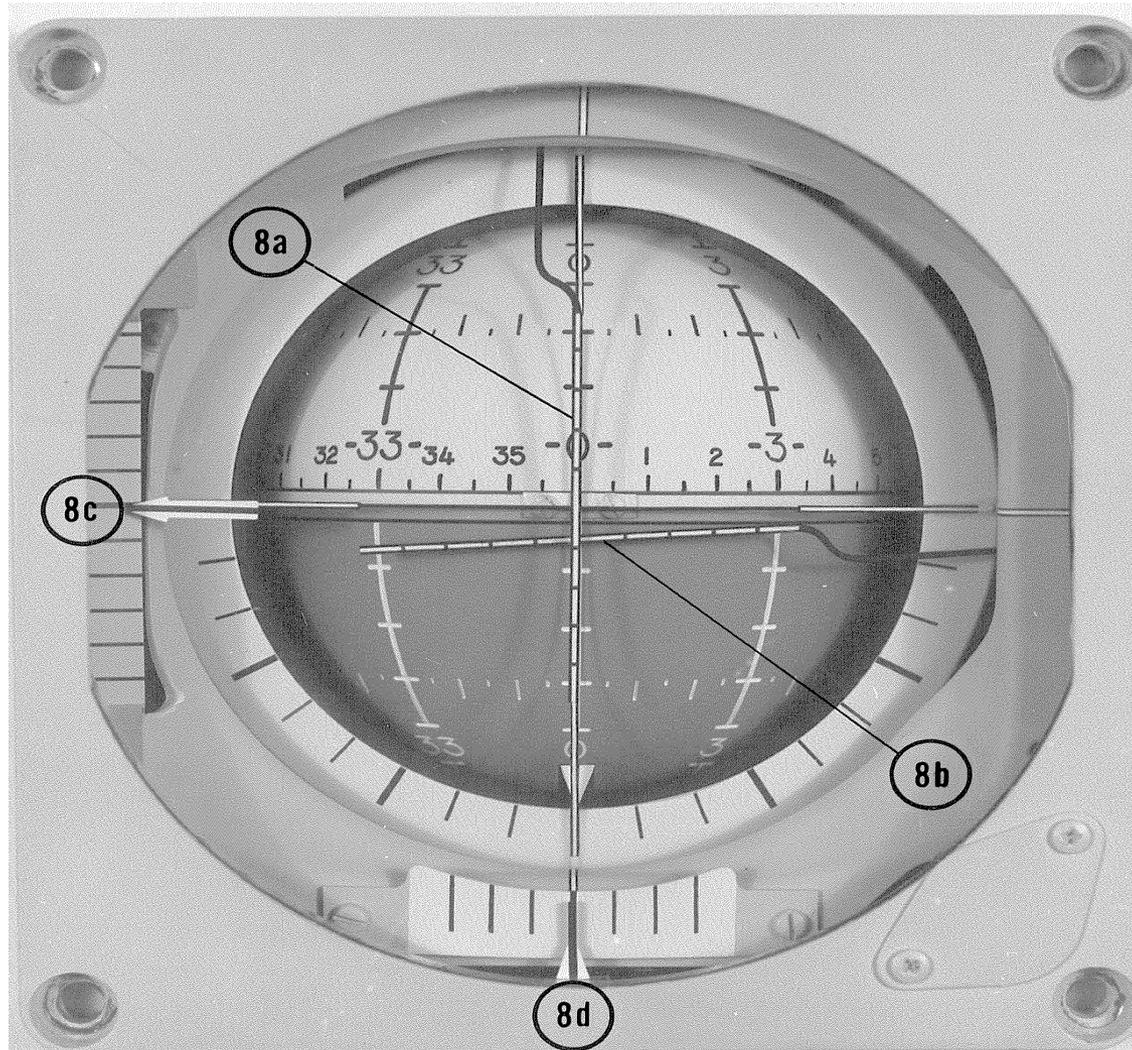
# The Attitude Director Indicator in the X-15-3

**10:31:34** – Pilot switched ADI to PAI mode and switched source of data for  $\alpha$  and  $\beta$  as well as for altitude and velocity from the nose ball to IFDS and IMU (while the malfunction lights were still on).

7. Evidence suggests that Major Adams' responses to the PAI were consistent with an ADI mode when he switched to the left-hand stick control of the RCS.

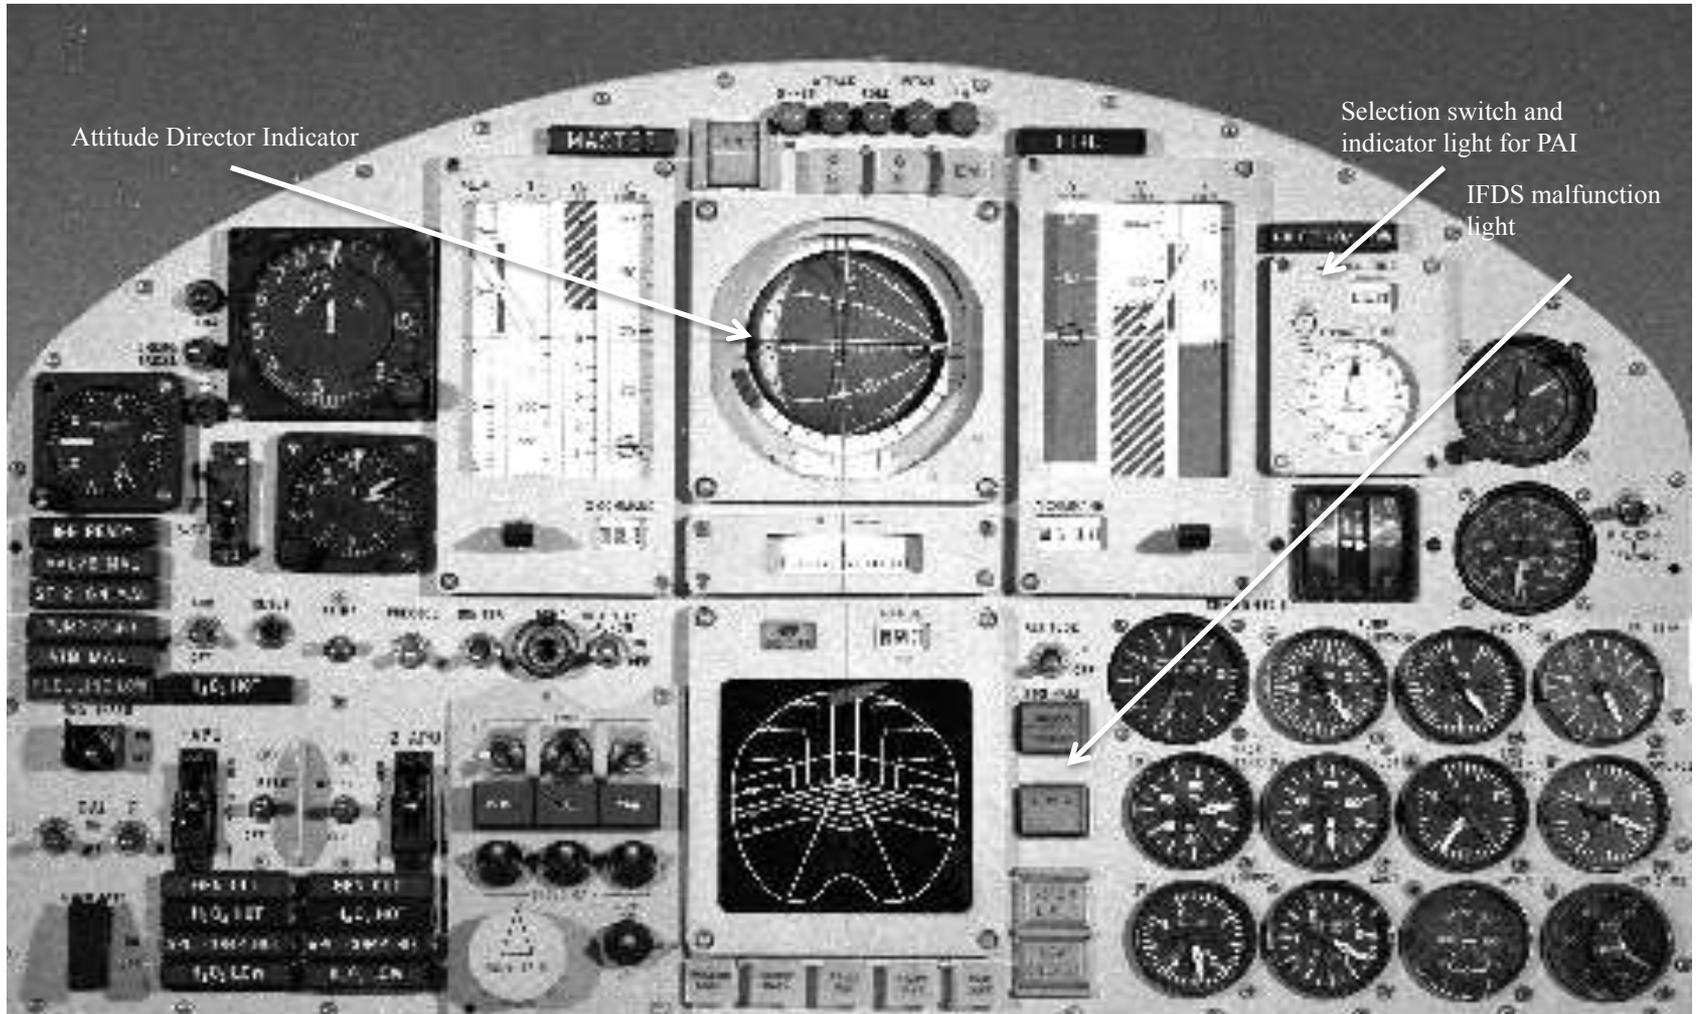
# Pilot's Display Panel in the X-15-3

- Three different X-15 models were produced.
- All three relied on a Stability Augmentation System – the first 2 models had pilot-selectable control gains.
- The MH-96 Adaptive Flight Control System was unique to the X-15-3 – provided automated gain control and automated engagement of reaction controls.
- Pilot's display in X-15-3 was importantly different from first 2 models.

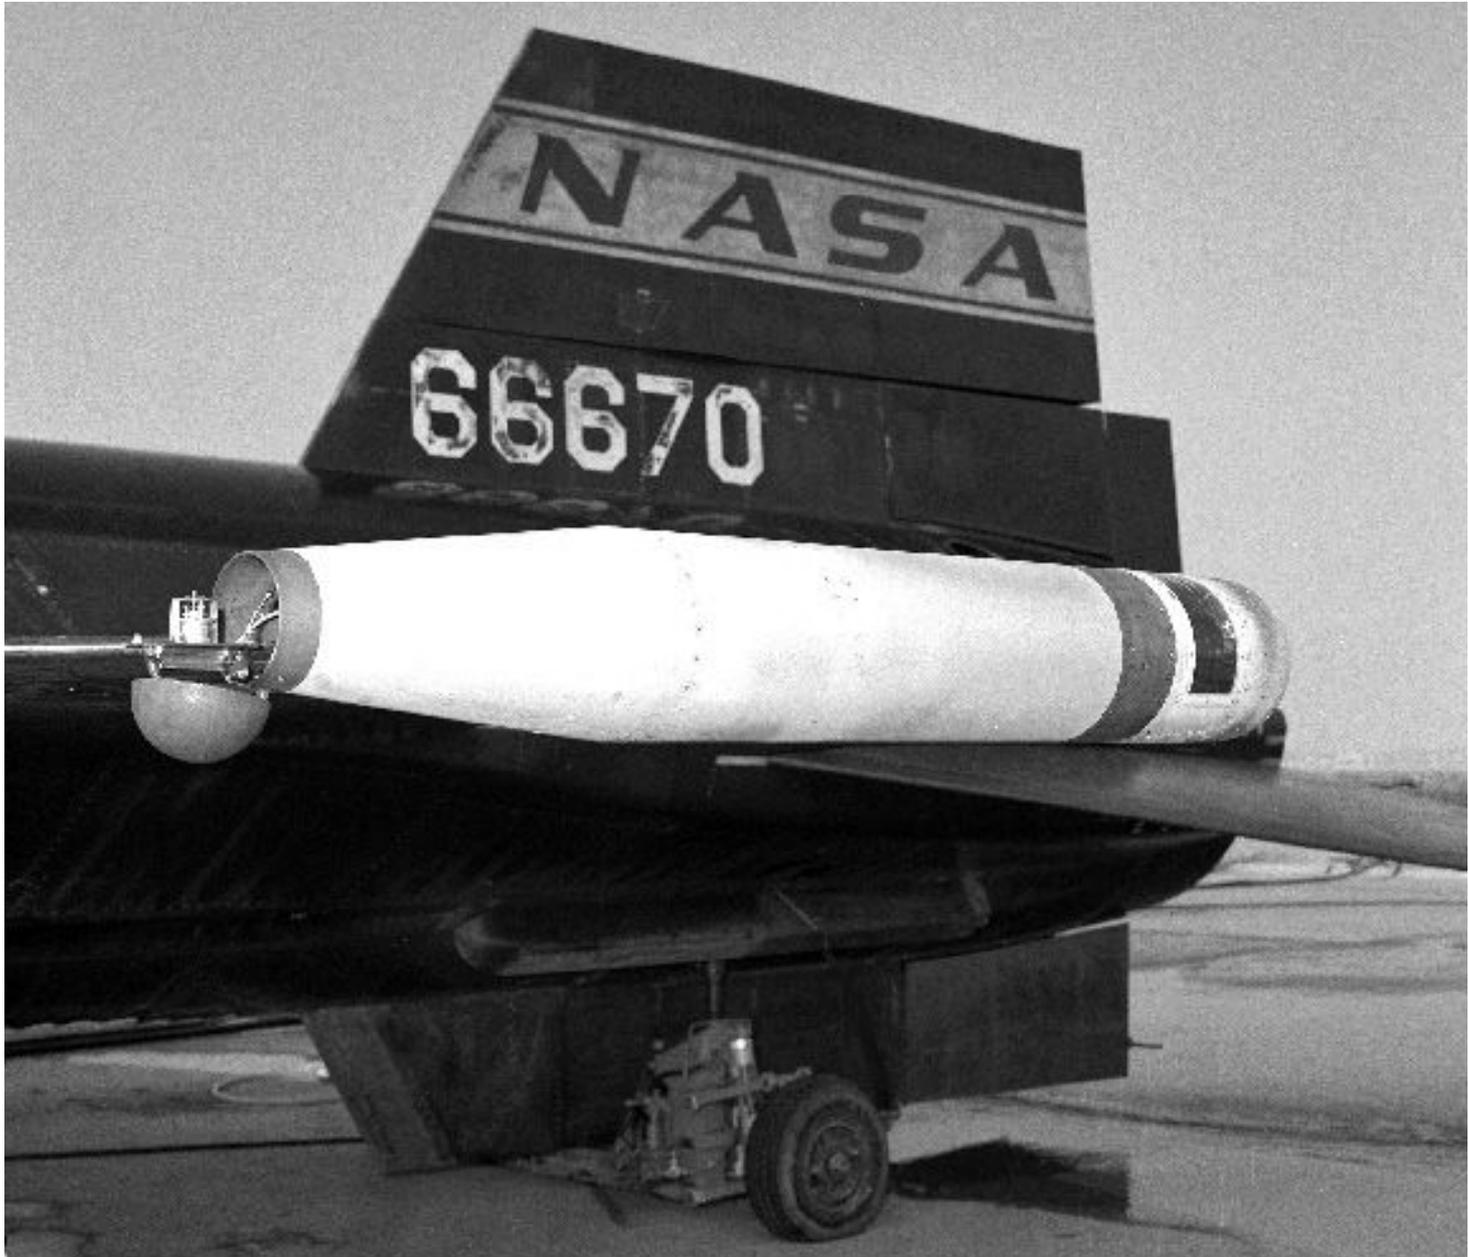
# The Wing-tip Pod for Experiment Installation

- 65<sup>th</sup> flight of the X-15-3.
- A high altitude flight –max altitude ~ 250,000 feet.
- Flight plan and configuration similar to previous two X-15-3 flights.
- Flight 3-65 had a full schedule of maneuvers and experiments including:
  - bow-shock standoff measurement,
  - solar-spectrum measurements,
  - ultraviolet exhaust-plume measurements, and
  - micrometeorite collection.
- Differences in configuration of the X-15-3 for Flight 3-65 included a traversing probe installed in the pod of its right wingtip that was operated for the first time in a high-altitude flight.

**10:31:07** – at about 90,000', arcing from the motor drive of the traversing probe caused an electrical disturbance to the aircraft's electrical system that continued until 10:33:53. Noise begins in all telemetered data channels.

*A Latent Causal Factor* of the Flight 3-65 accident was management's failure to require environmental testing of experimental equipment before it was installed on the aircraft.

1. The electrical disturbance due to arcing of unqualified experimental equipment precipitated the accident.
2. The pilot had no reliable control during the electrical disturbance.
3. The pilot was, very likely, unable to recognize the control problems.
4. Flight 3-65 would have very likely been recoverable, if ground control had aborted the mission when they had clear indications of malfunctions.
5. The focus of Major Adam's attention on performing the precise wing-rock maneuver using an intermittent RCS may have distracted him from noticing the yaw angle acquired during the boost phase.

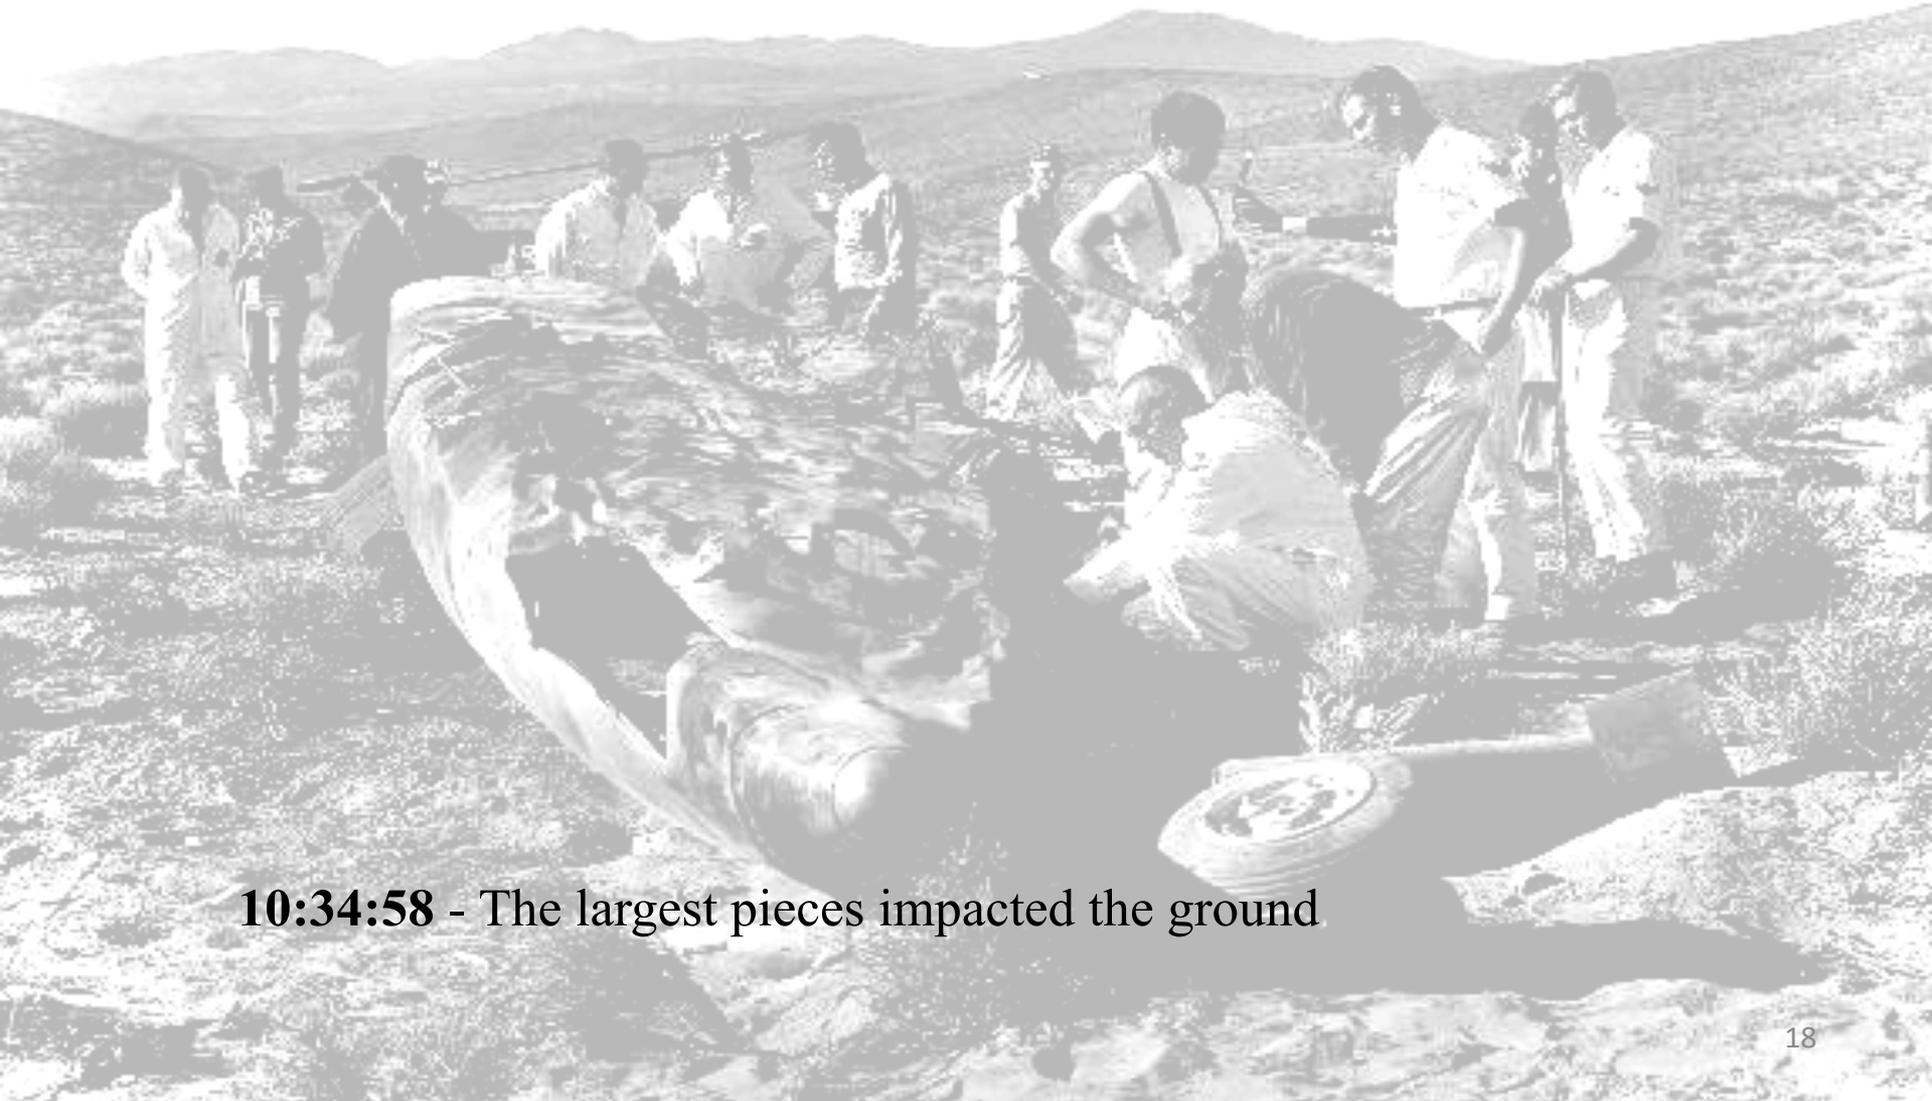
**10:34:54** - The aircraft began to break up.

**10:34:58** - The largest pieces impacted the ground

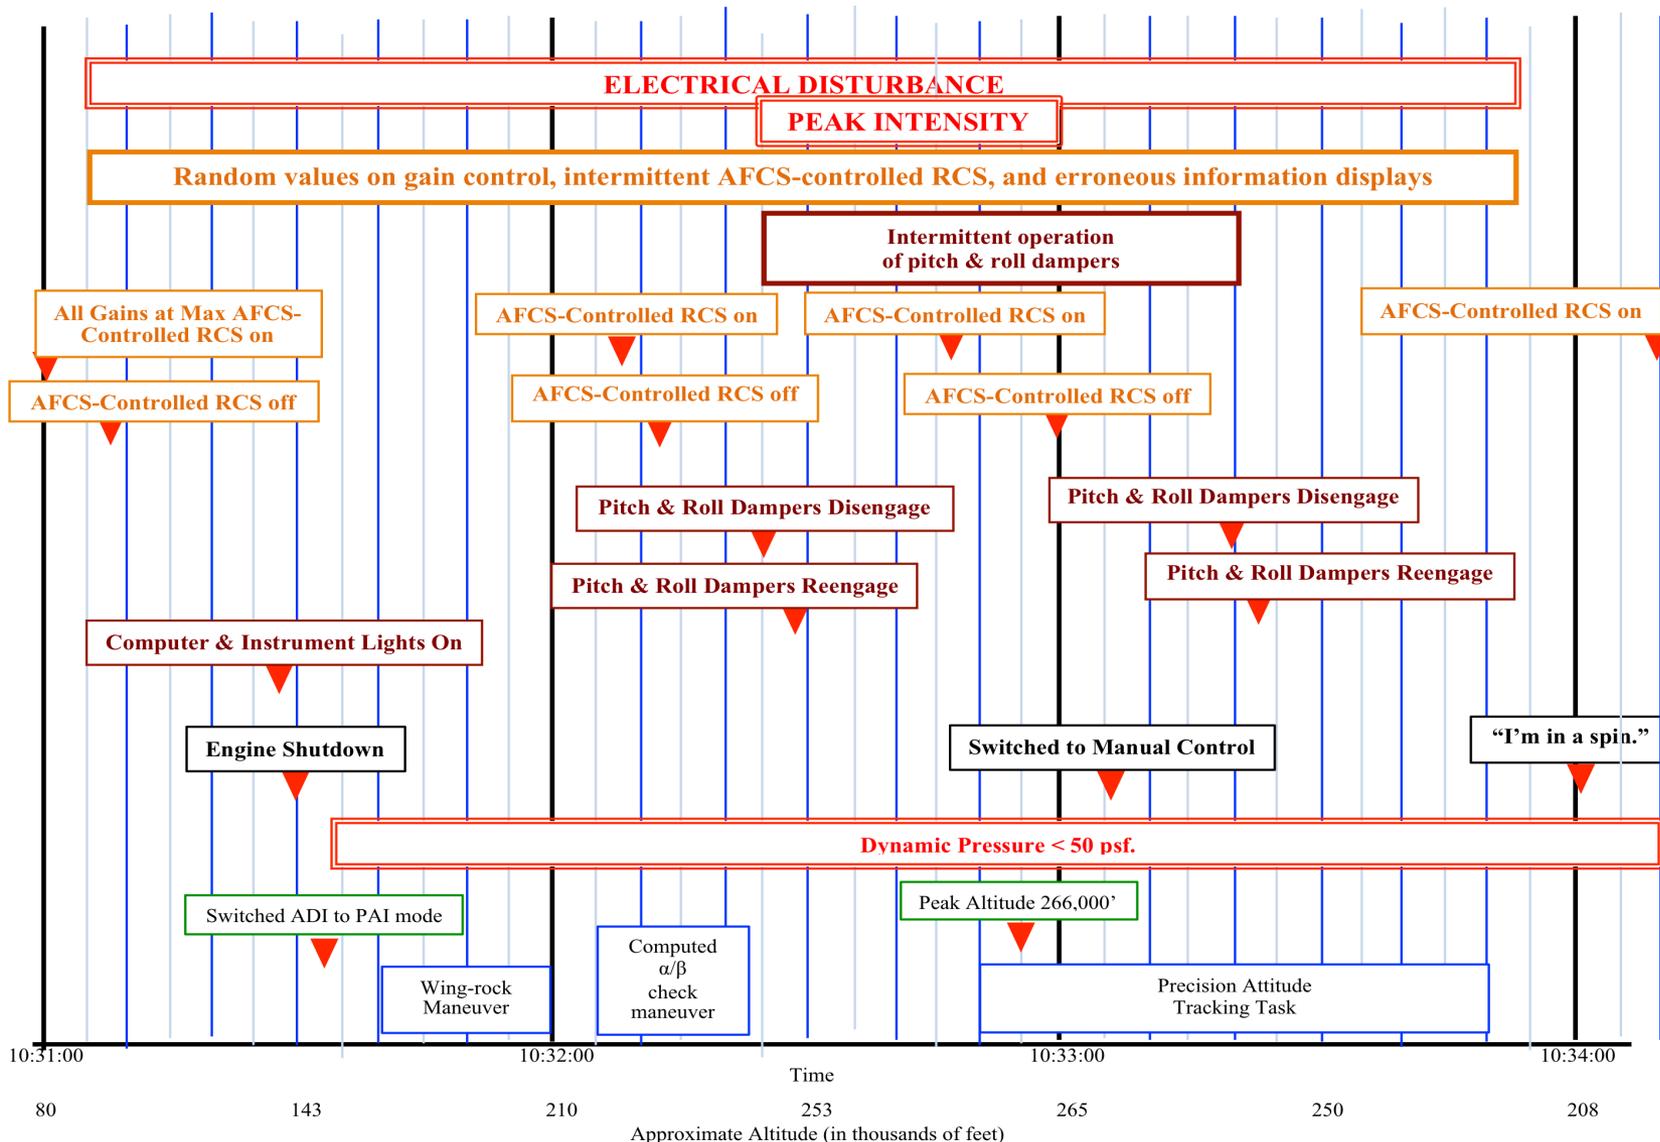
# Time Line of Critical Events Prior to Spin

← **Approximately 3 Minutes** →

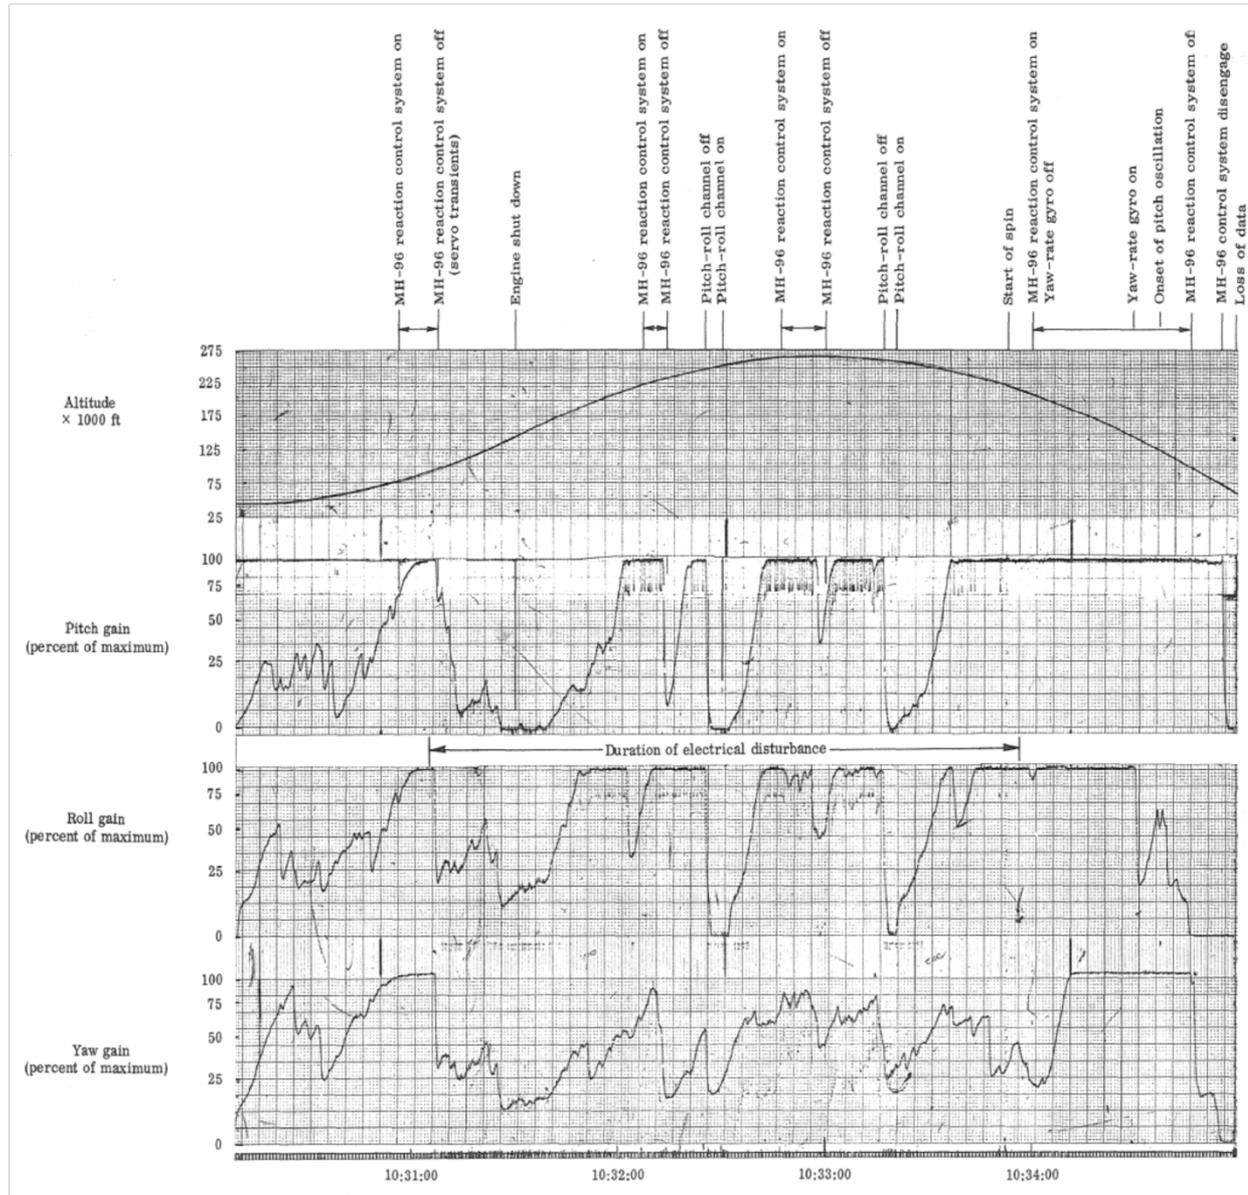
# Time History of MH-96 Gains During Flight 3-65

**10:34:37** - the MH-96 AFCS entered into a limit-cycle instability forcing control surfaces into rapid, cyclic oscillation to their limit of travel at their maximum rate of 26° per second.

1. The design of the adaptive gain control in the MH-96 allowed a failure in the AFCS to interfere with the pilot's ability to control the aircraft.
2. The design of the pilot's interface with the MH-96 AFCS was very complex and difficult to understand.
3. The MH-96 AFCS had a known tendency to go into limit-cycle oscillations when the system was operating at or close to maximum gain.
4. The pilot's display used a single critical instrument, the Attitude Director Indicator, in two different modes; one a normal mode used most of the time, the other a mode (Precision Attitude Indicator) that was used only occasionally.
5. There was no provision for backup source of reliable information for the pilot at high altitude when the IFDS computer malfunctioned.

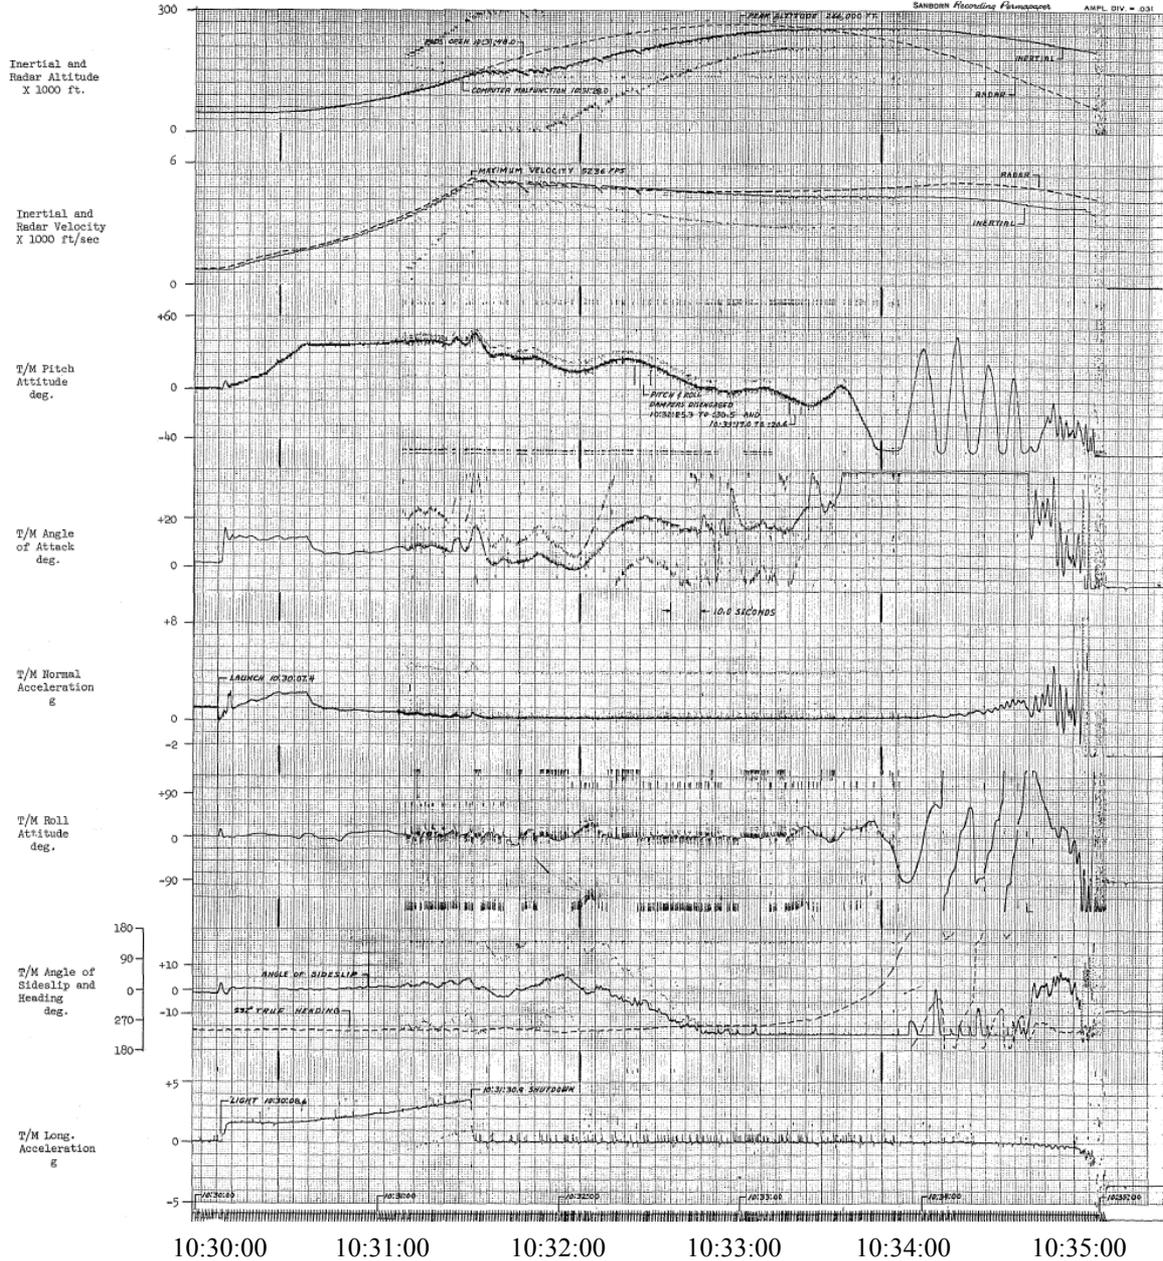
# Time history Telemetered Parameters of Flight 3-65

- At 10:31:07 (just 1 minute after launch), all of the telemetered data suddenly became erratic and remained so for several minutes.
- Starting at 10:31:07, the telemetered data on altitude and velocity differed from the radar data and was noted by a ground controller.
- At 10:31:58, the Flight Controller acknowledged the pilot's report that the IFDS computer and instrument malfunction lights were on.
- Between 10:31:40 and 10:32:00, during the wing-rock maneuver, a member of ground control reported to the Flight Controller that the pilot was having a control problem based on his observations of larger than normal pitch-roll servo excursions.
- At 10:32:26, disengagement of the pitch and roll dampers was reported by the pilot and acknowledged by the Flight Controller.
