NASA Technical Memorandum TM 103814

Debris/Ice/TPS Assessment And Photographic Analysis For Shuttle Mission STS-41

DEBRIS/ICE/TPS ASSESSMENT
AND
PHOTOGRAPHIC ANALYSIS
OF
SHUTTLE MISSION STS-41

October 6, 1990

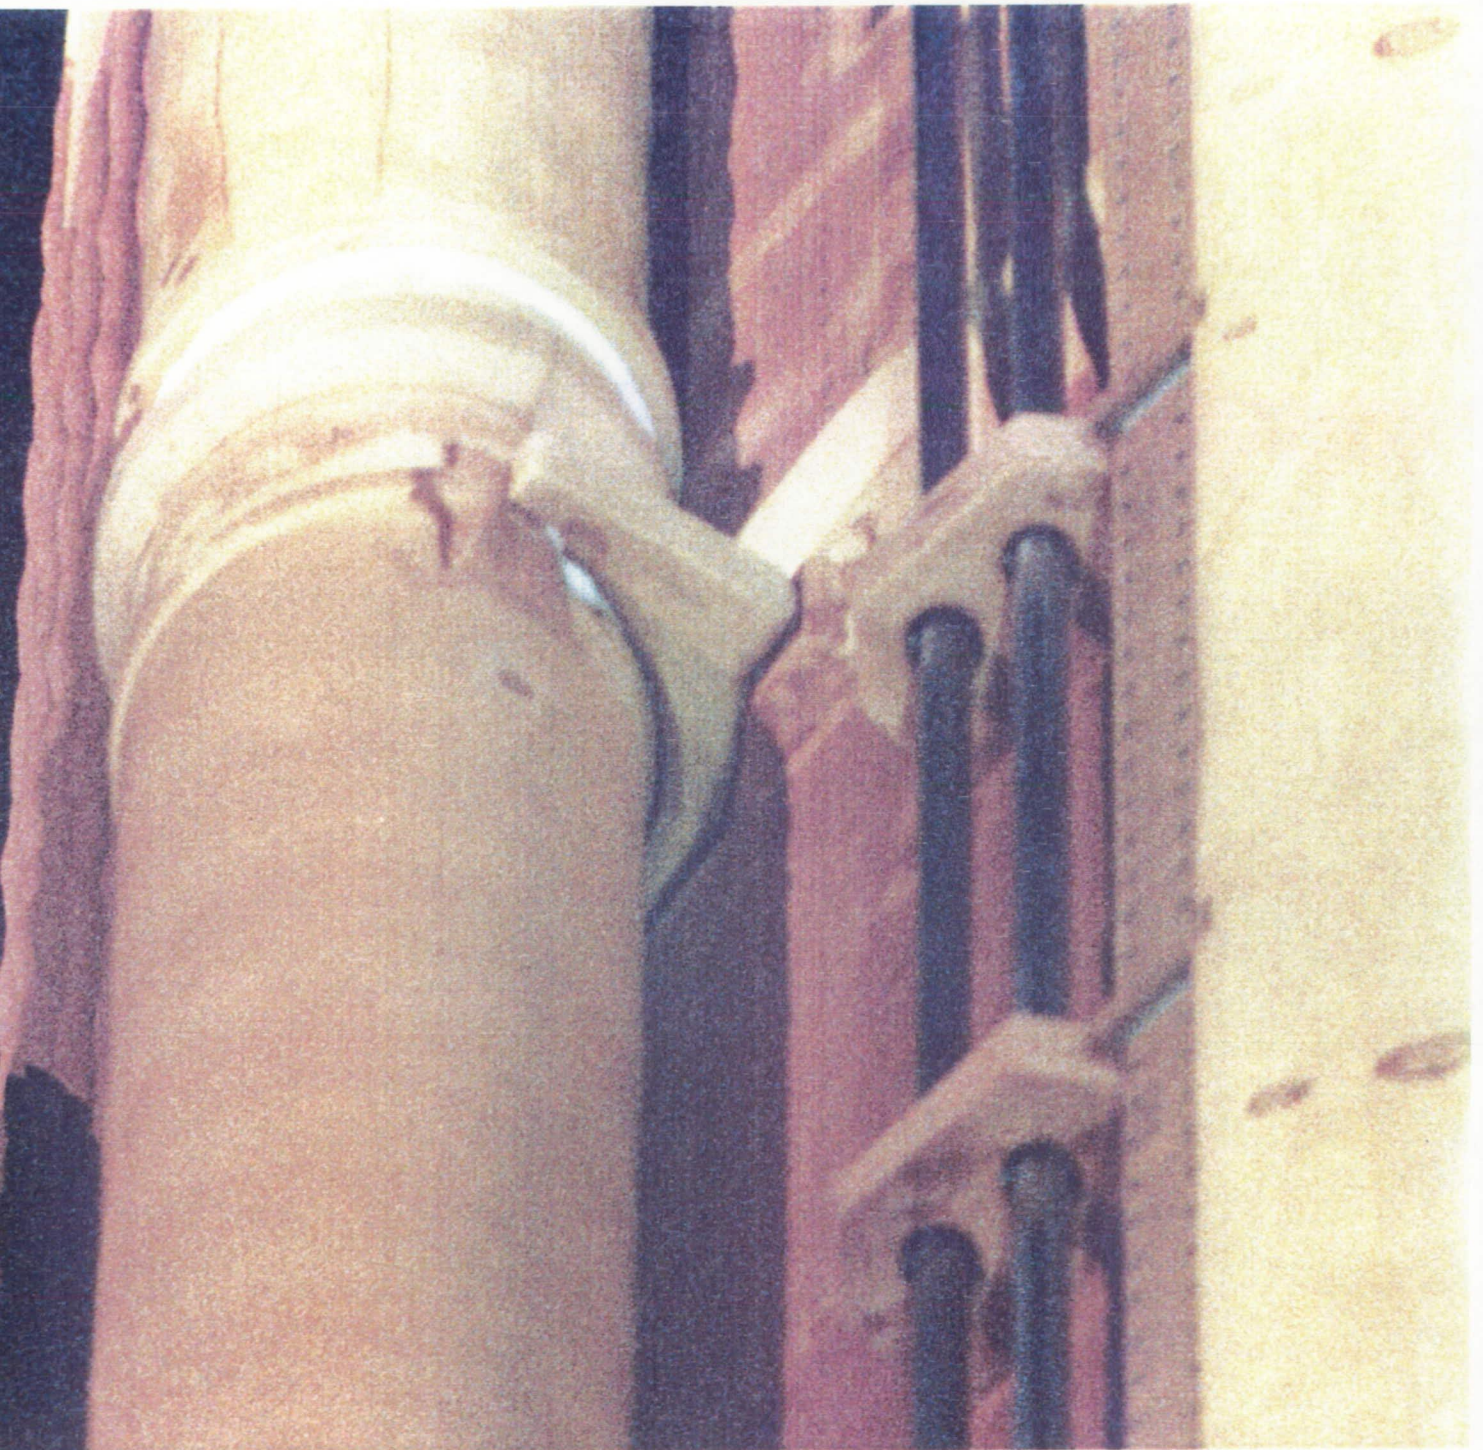
Typical ice/frost accumulation in the LO2 feedline upper
bellows and support brackets

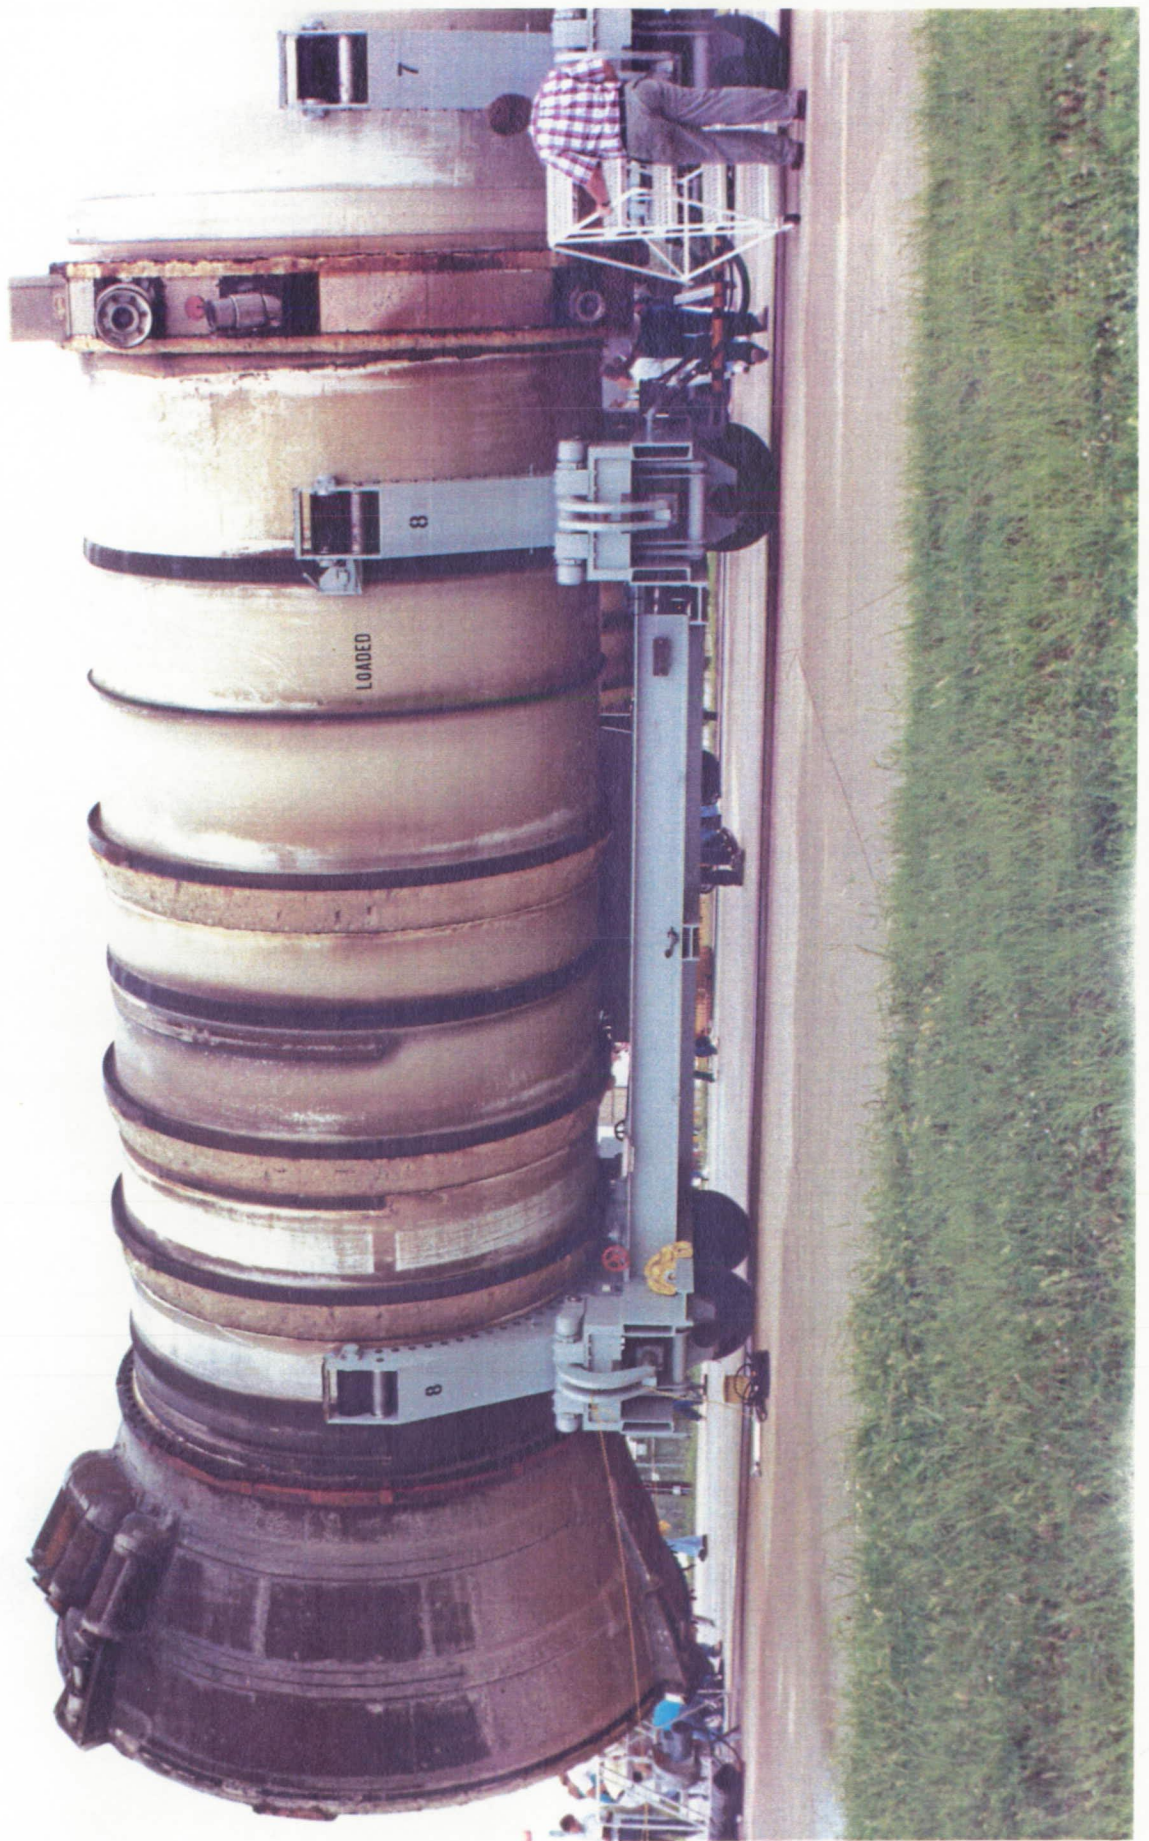
Post flight condition of LH aft booster

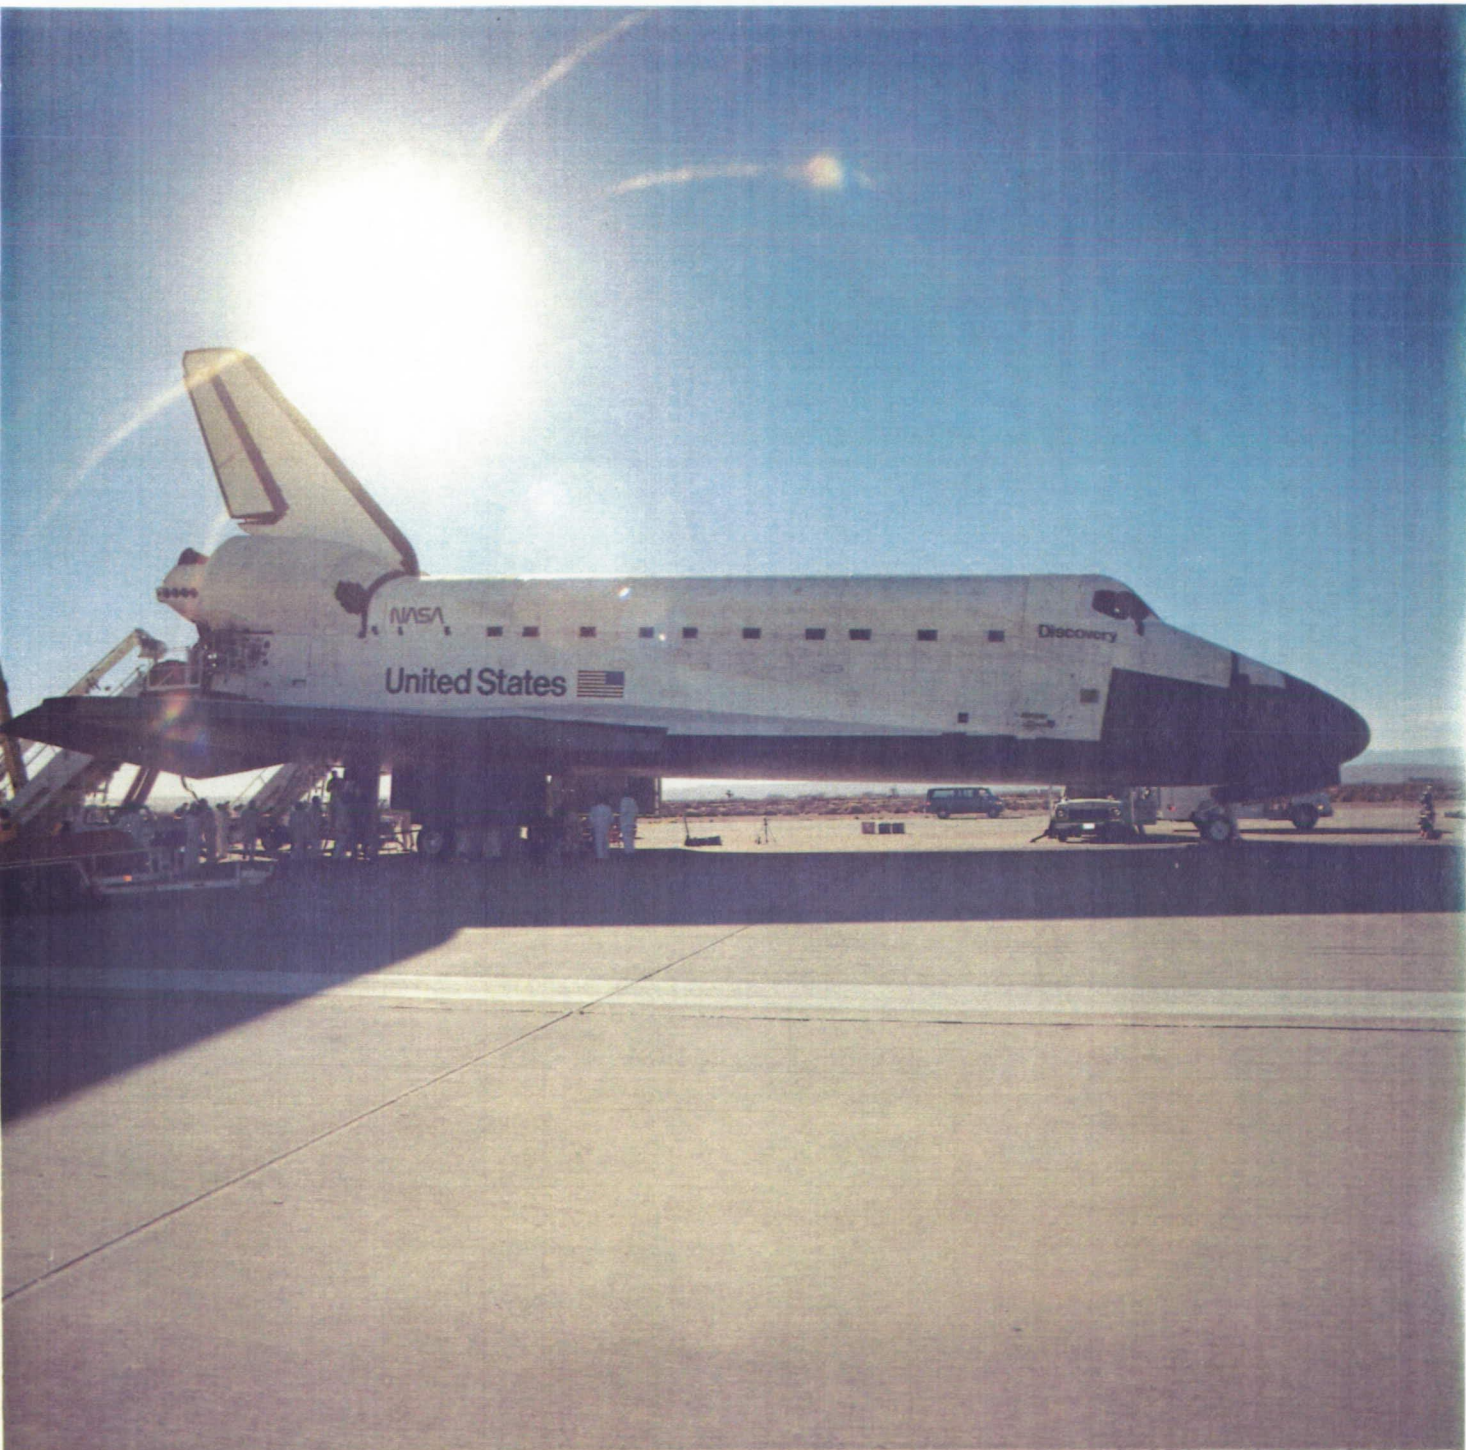
Overall view of OV-103 RH side after landing

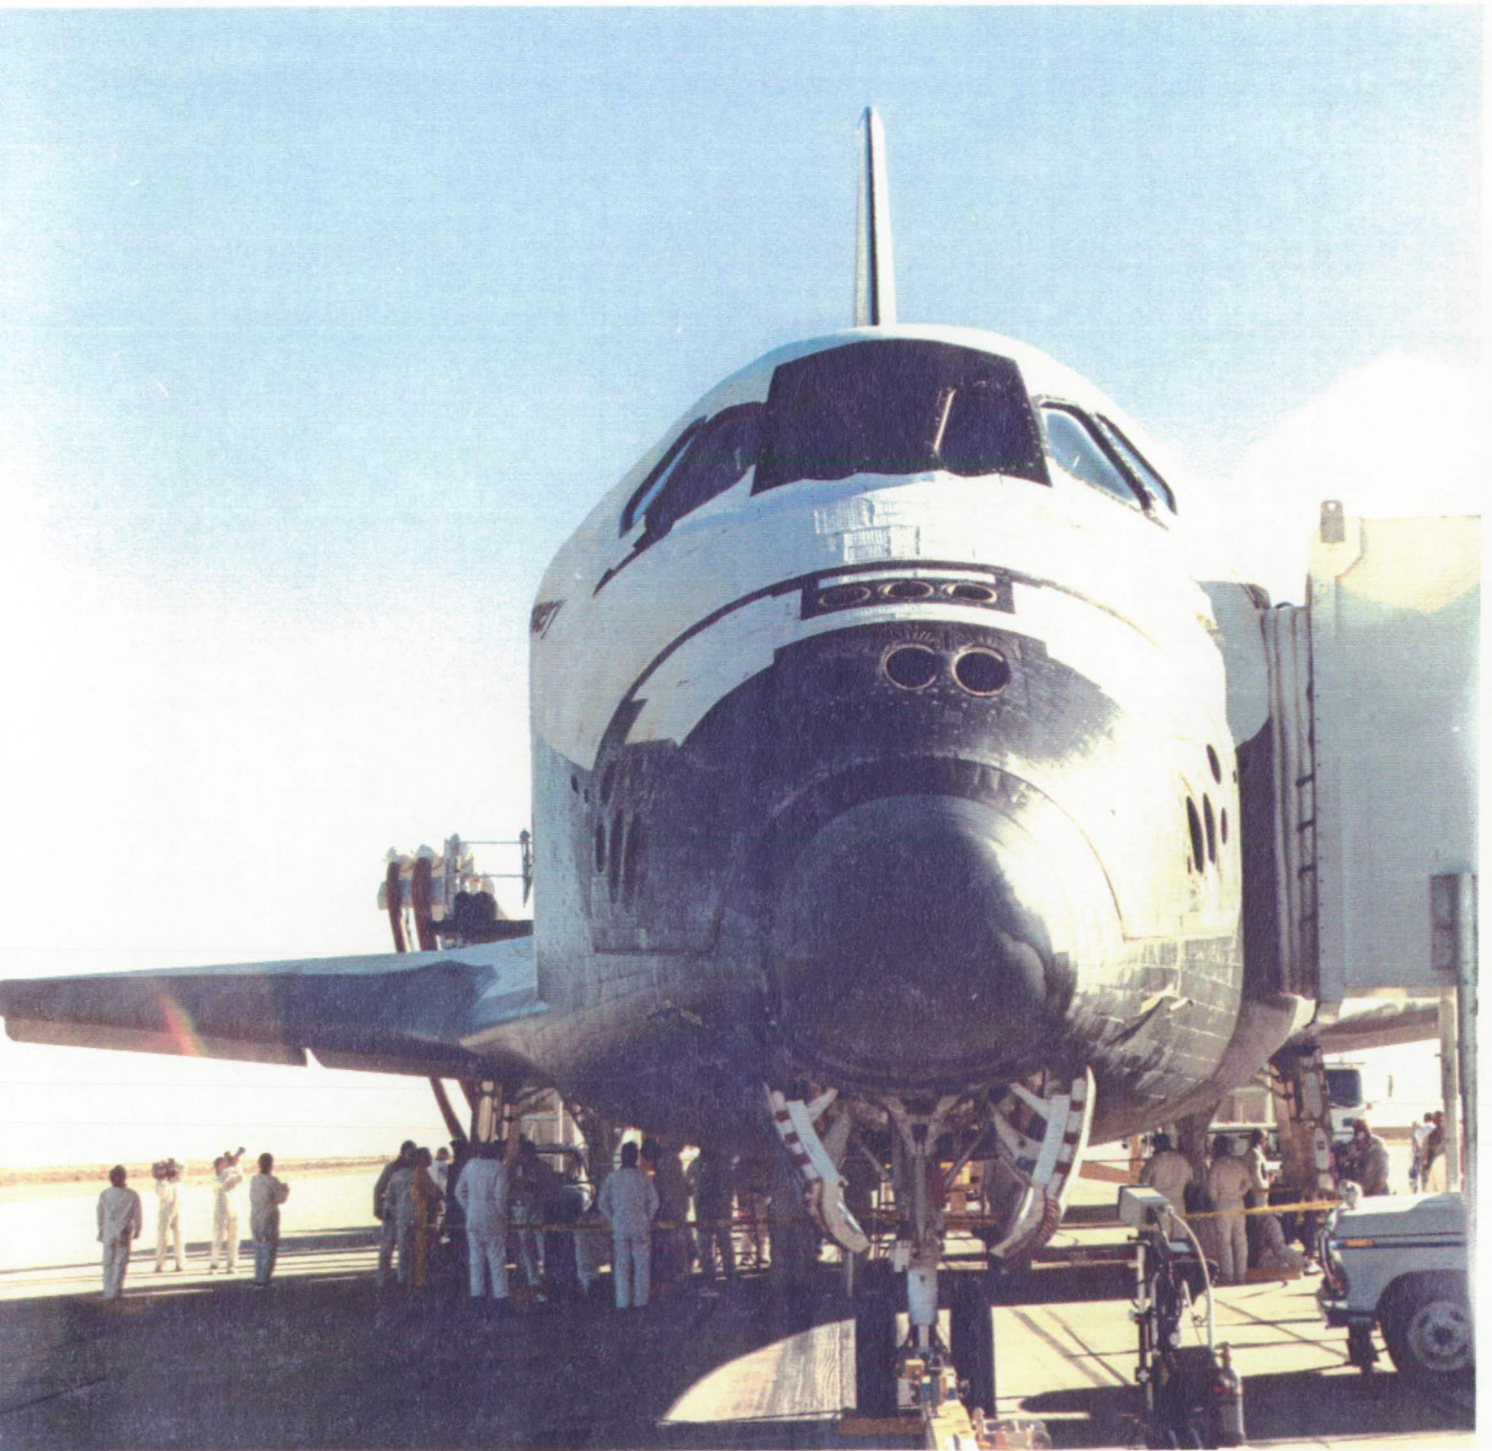
Post landing condition of OV-103 nose tiles and windows

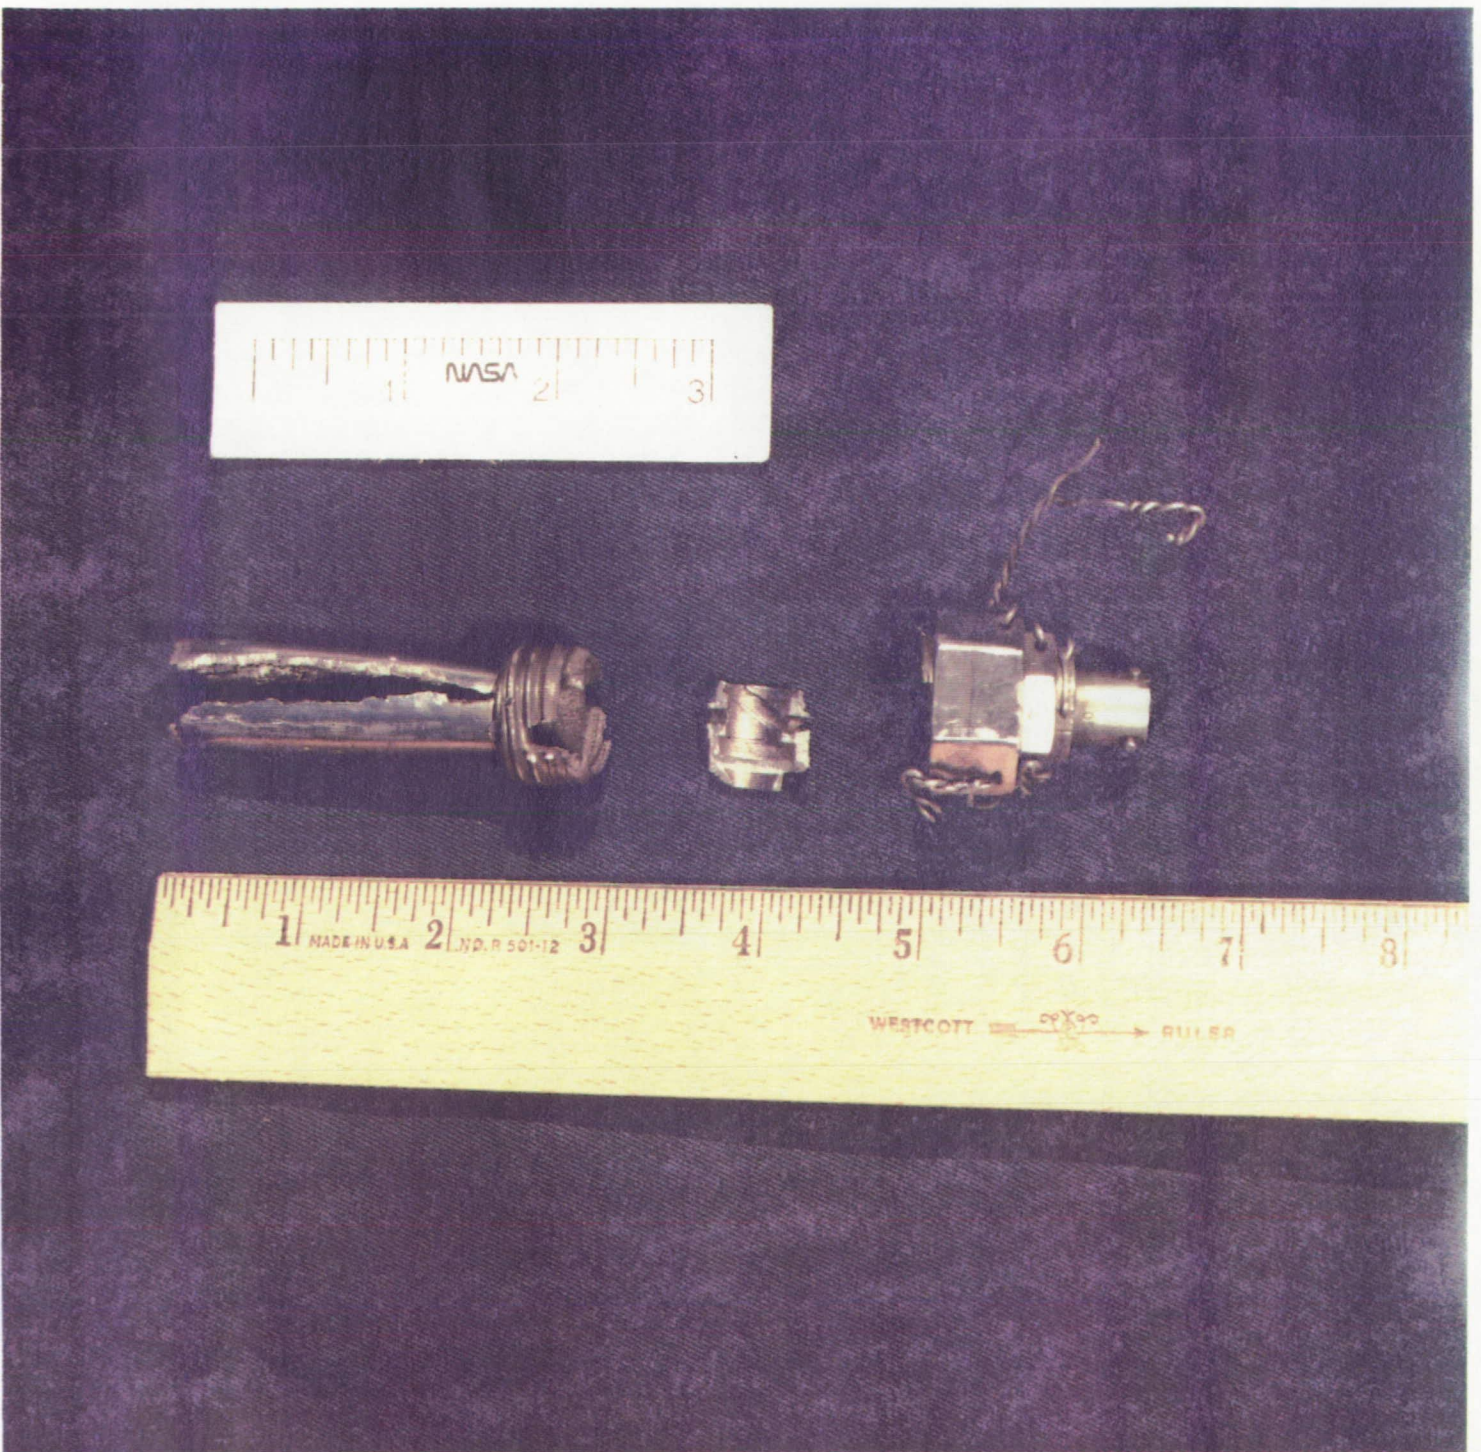
Three pieces of spent ordnance (detonator, booster fragment, connector piece) lay on the runway below the EO-2 attach point
126
