Boiling Experiment Facility (BXF): Post Flight Assessment Anomaly Investigation Report

*Wendell H. Booth
ZIN Technologies, Incorporated, Middleburg Heights, Ohio*

This document serves as the report for presenting the results and conclusions of investigation activities that were performed to determine the root causes of the anomaly, camera misalignment, and dissolved gas concentration issues and to verify the calibration and accuracy of the pressure and temperature measurements.

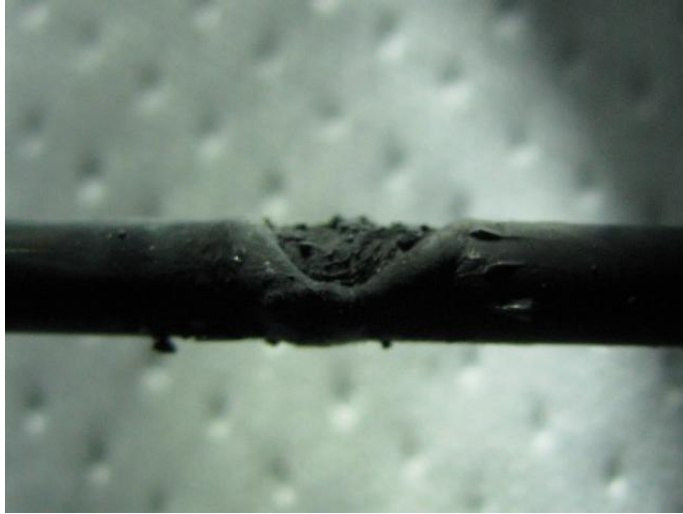
Figure D.27.—Close-up of melted surface near Heater 1 tip.

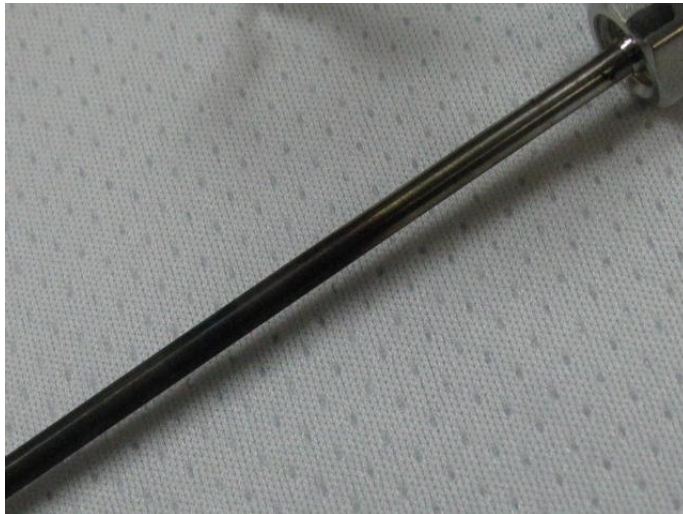
Figure D.66.—Heater 2 fluid immersed portion: Note bluing and blackening.
