Final Report
STUDY THERMOGRAPHIC FLAW DETECTION

Contract Number: NAS8-38609

Samuel Russell
EH13
National Aeronautics and Space Administration
Marshall Space Flight Center, AL 35812
(205)-544-4411

July, 1996

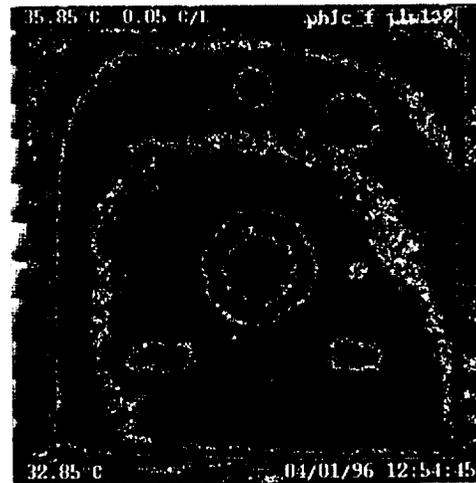
Figure 9. Image before and after digital filter.

Using digital filtering techniques an attempt to enhance the back surface heated image was made by applying the Winfree (Laplacian) filter and several self developed filters. The Laplacian filter was unable to resolve the thermal profile of the part. On the other hand a simple “edge enhancement” filter proved to be very useful by defining the shapes of each planned defect (Figure 9). The filter consisted of a 7 x 7 array in the form shown in Table 2.

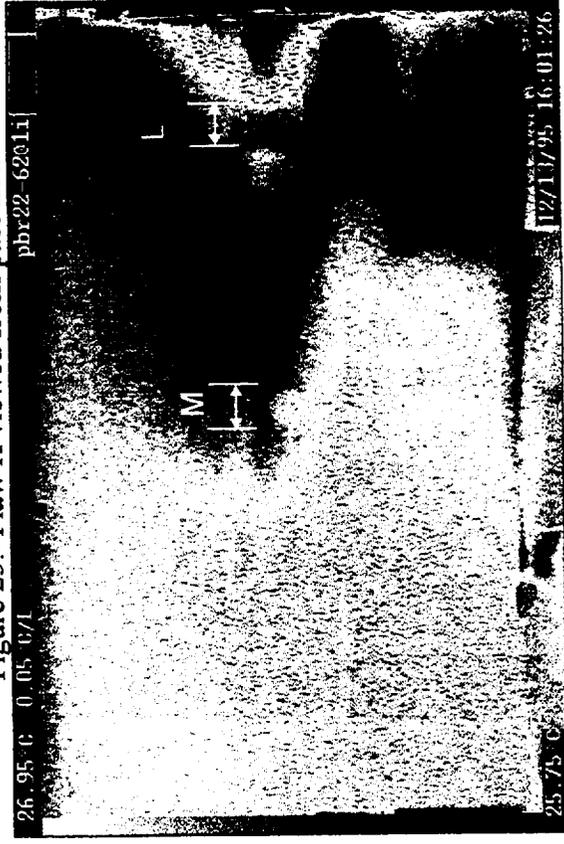
Figure 27. Flaws M and L viewed from pass BR.

During pass “BR” flaws A, B and C were again apparent, Figure 28, but this time flaws L, M, N and O were also visible (Figures 27 and 28). Figures 29 and 30 show that during pass “DR”, flaws L, M and N were again visible.

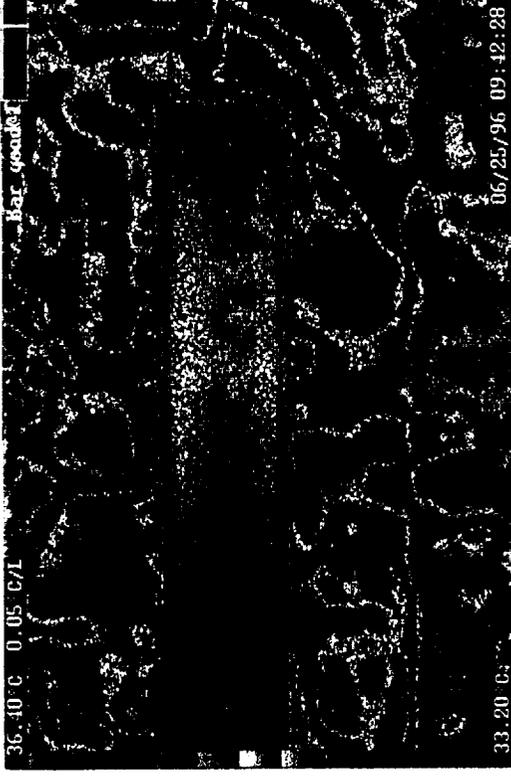
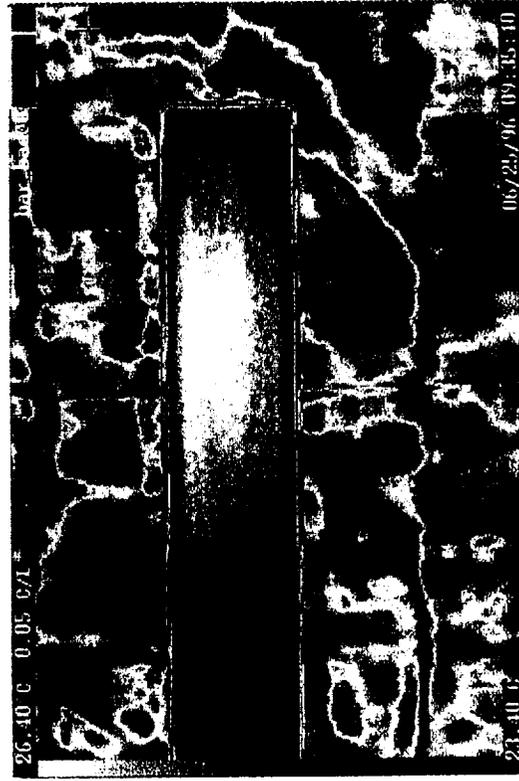
A graphite/epoxy channel was inspected using pulse heating with the Bales Scientific TIP. One end of the channel had a region of suspected porosity. A digital filter was applied to the fifth image from each end of the bar.

Figure 68 Thermograms of graphite/epoxy spar..
