# SNAP-8 ELECTRICAL GENERATING SYSTEM DEVELOPMENT PROGRAM

PROGRESS REPORT FOR JANUARY - JUNE 1966

NASA CR 72-1-03  
Aerojet Report No. 3233

SEMIANNUAL REPORT

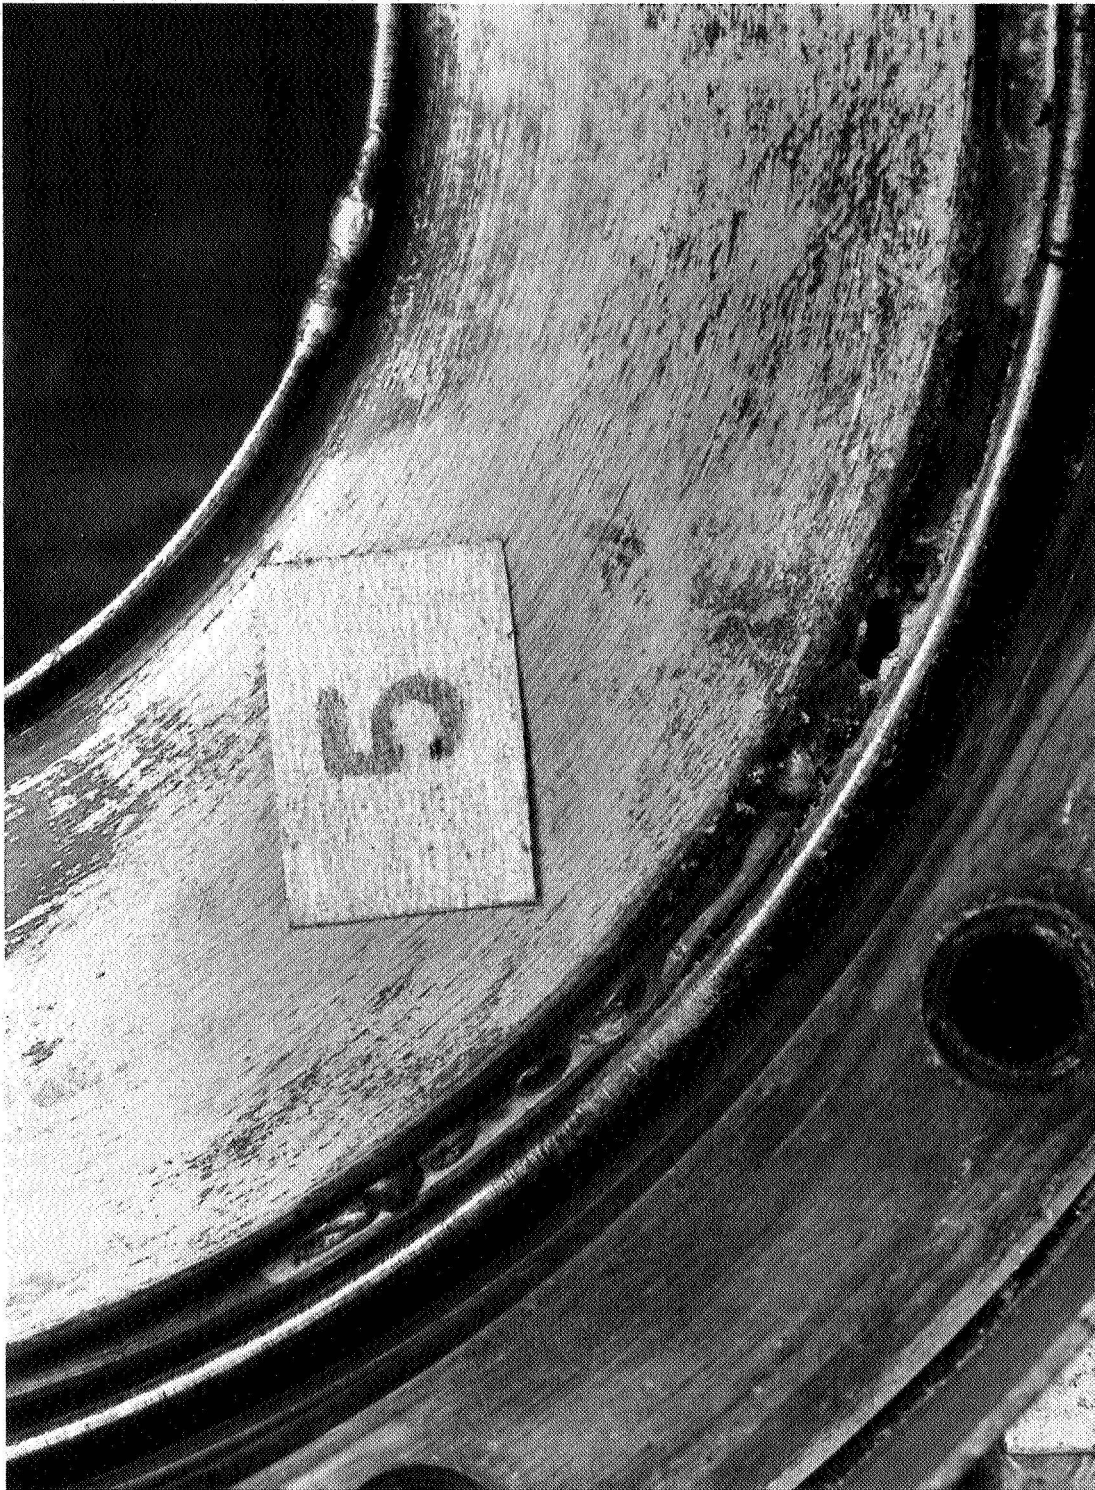
Figure V-44

Can Melt on Motor Stator End of NaK PMA Unit  
4/1 (P/N 093200-13C, S/N A-4)

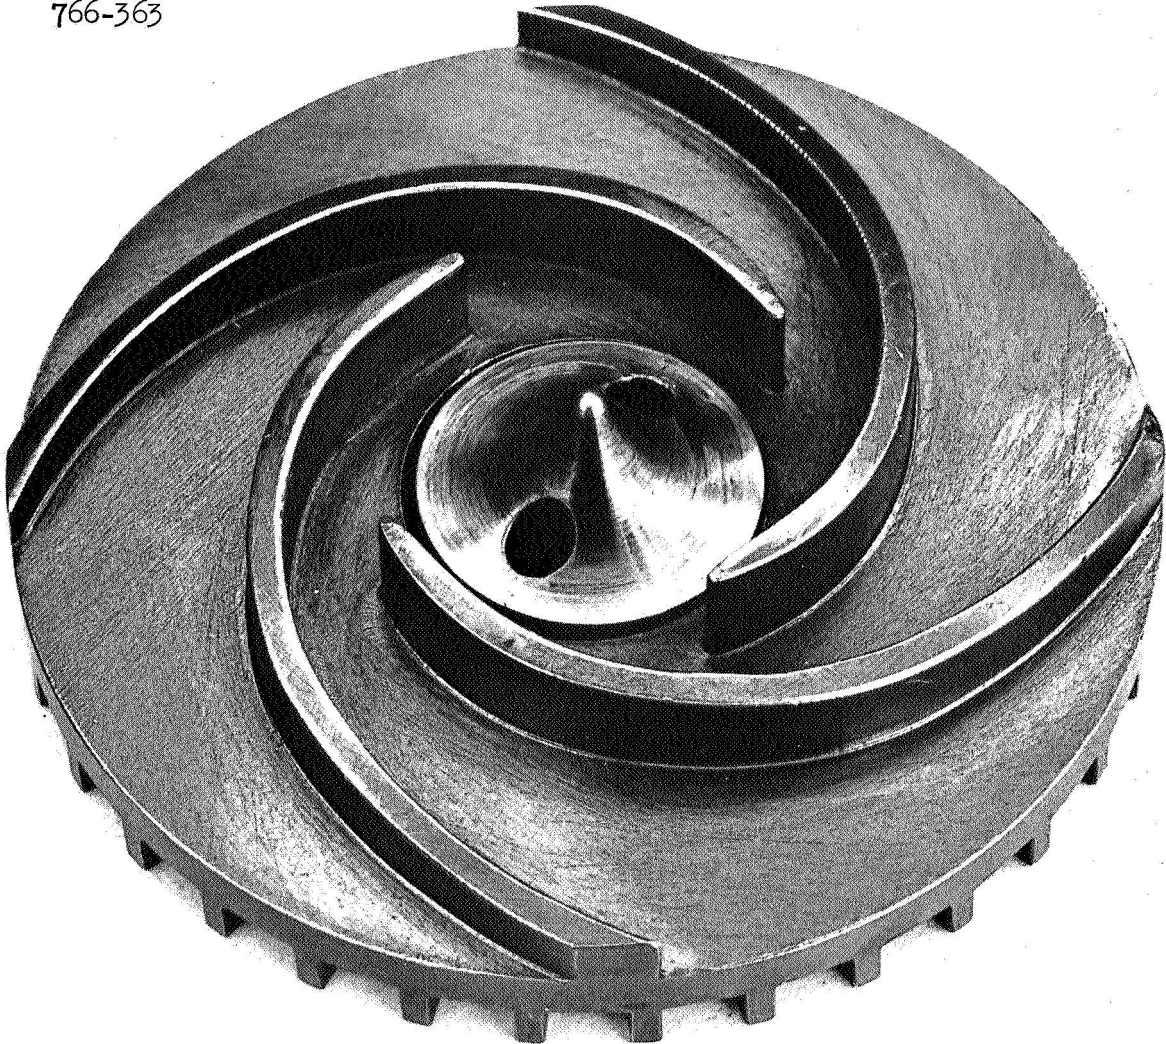
Impeller and Bolt From Mercury PMA (P/N 093347-5, S/N A-1)  
After 1099 Hours of Operation in PCS-1
