# NAVAL AIR PROPULSION TEST CENTER

NAPTC-AED-1869

ROTOR BURST PROTECTION PROGRAM  
INITIAL TEST RESULTS

PHASE IV - FINAL REPORT  
PROBLEM ASSIGNMENT NASA DPR R-105

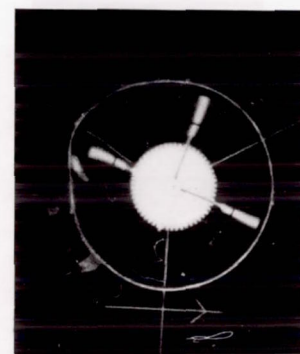
18. Experimental results illustrate that fragments from a flat disk rotate about their own center of mass as they move tangentially outward. This combined type of action produces a complex failure mode of the containment system.

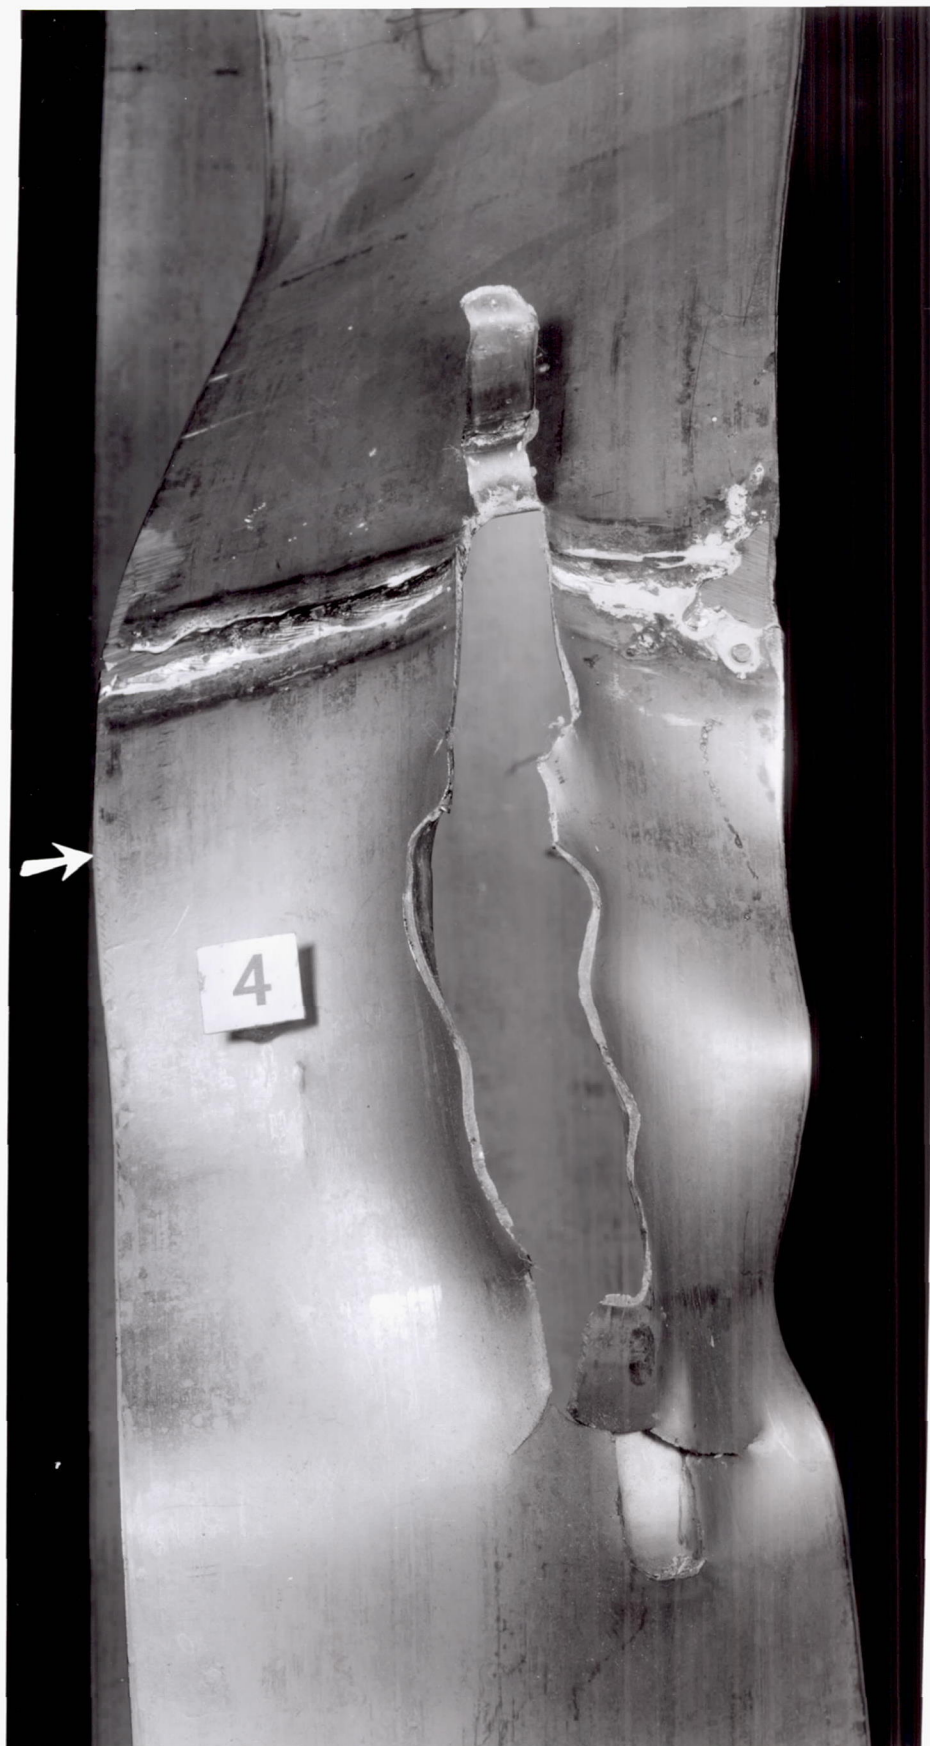
POST-TEST NO. 4  
CONTAINMENT RING- FRAGMENT B IMPACTED AREA

Bottom side of ring

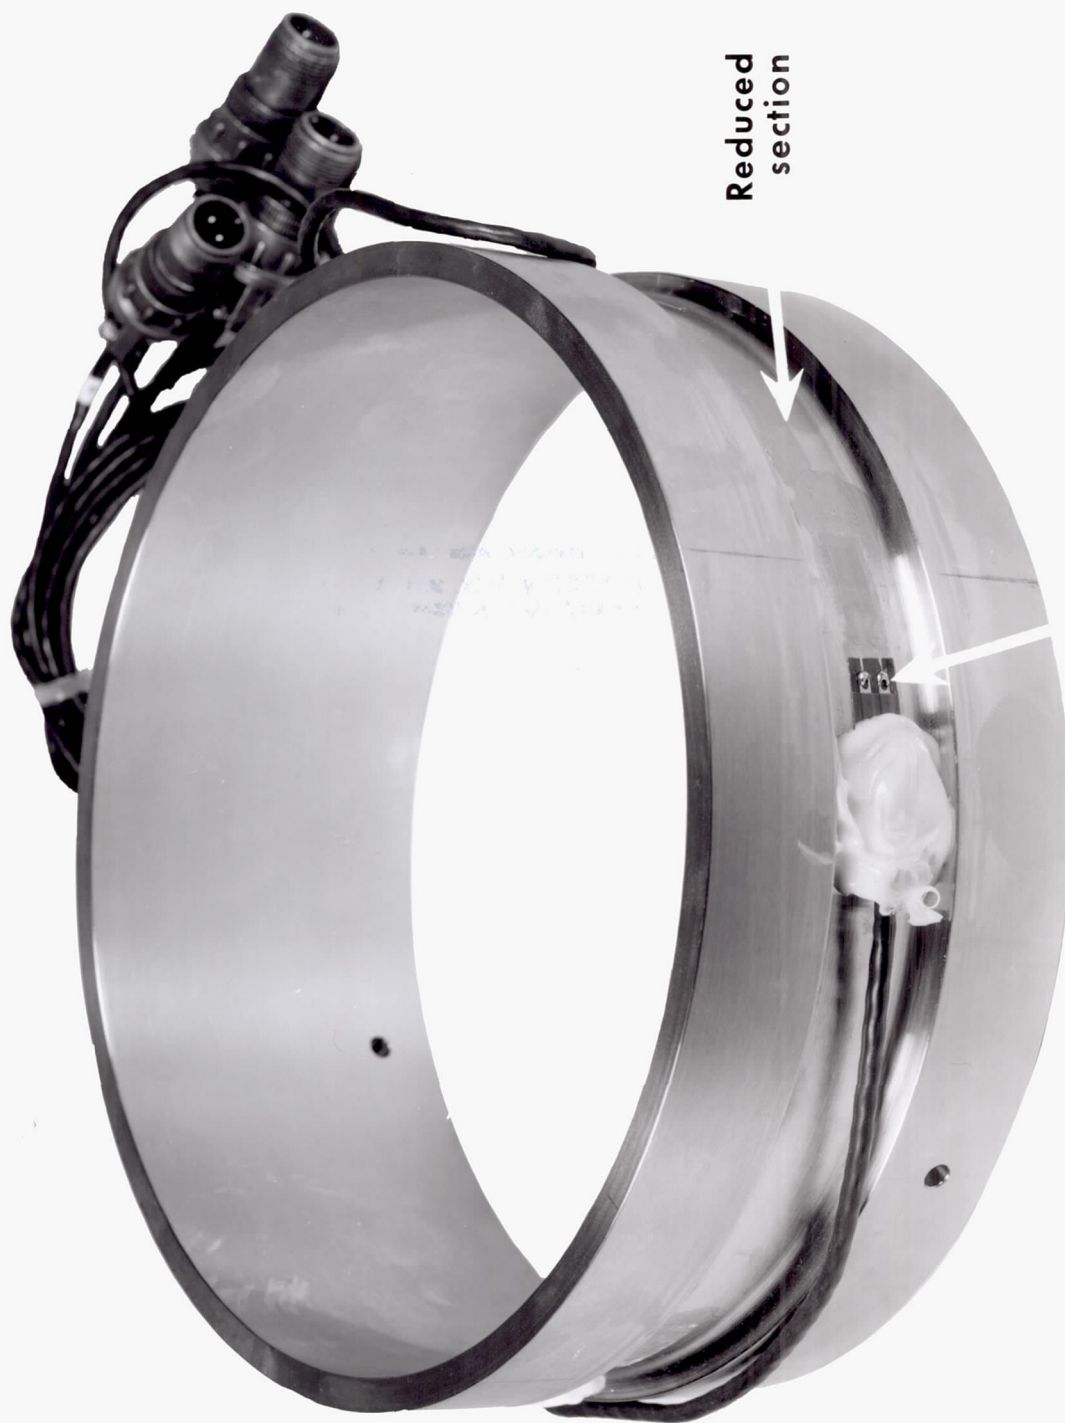
TEST NO. 12 CONTAINMENT RING

Reduced  
section

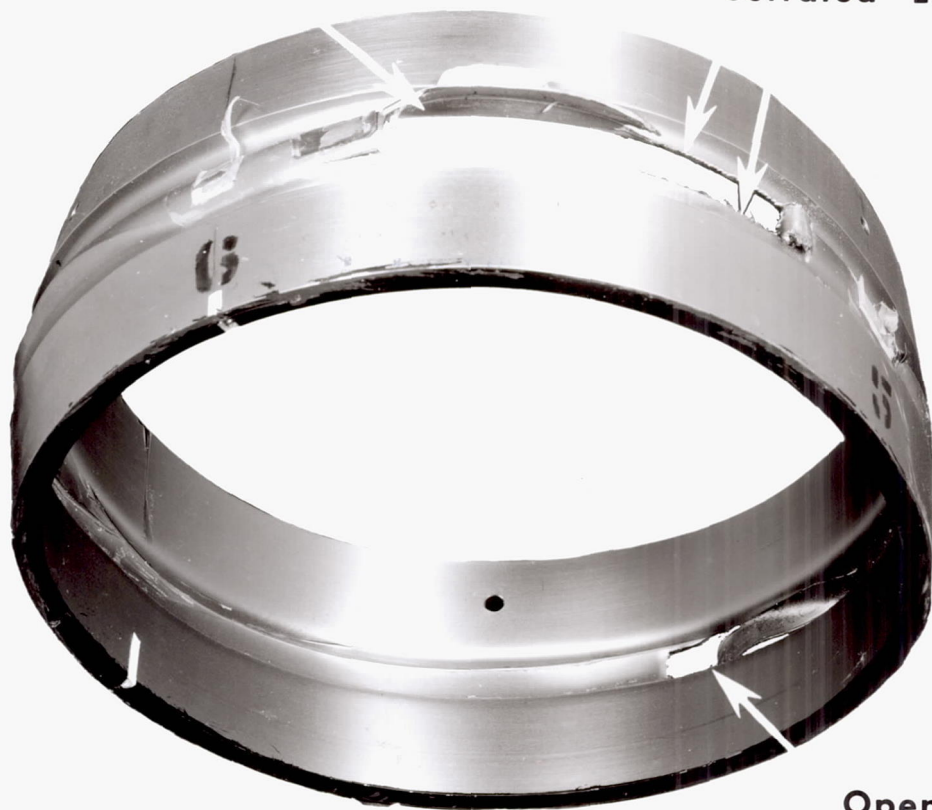
Opening "B"

Serrated Edges

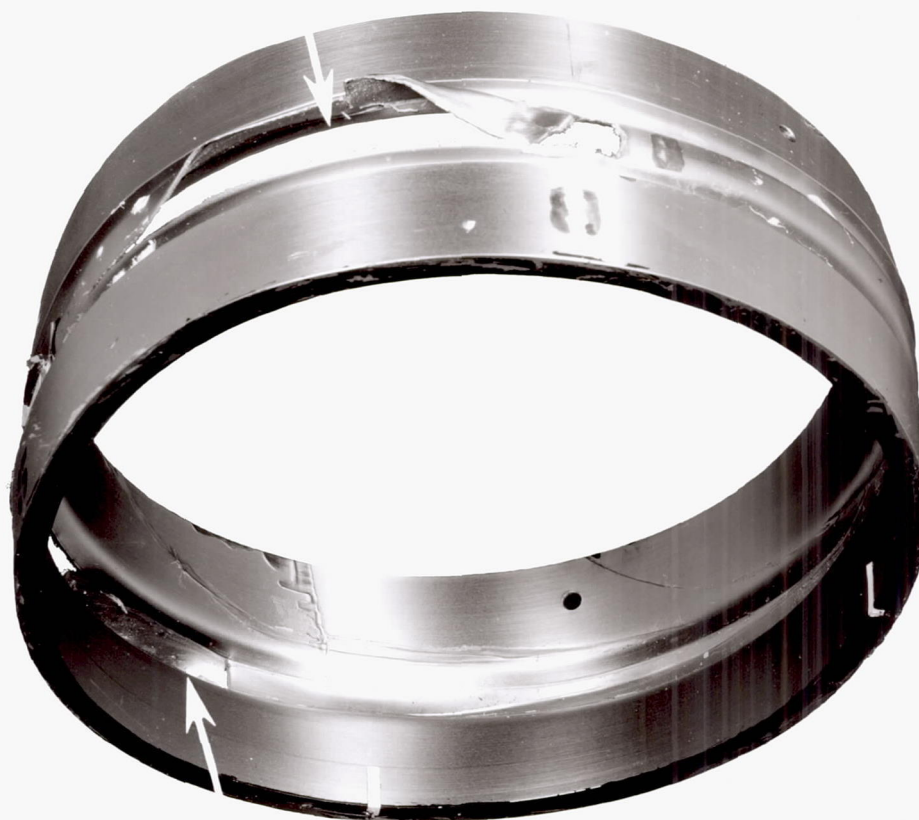
POST-TEST NO. 14    CONTAINMENT RING  
OPENING "A"    DETAIL

Opening "A"
