DIVISION	CR-72920
TM	3710:71-650
DATE	9 June 1970
W.O.	1475-80-201

TECHNICAL MEMORANDUM

TITLE: Evaluation of SNAP-8 Alternator P/N 094069, S/N 481490 after 23,130 Hours of Endurance Testing in the Electrical Component Test Facility (ECTF).

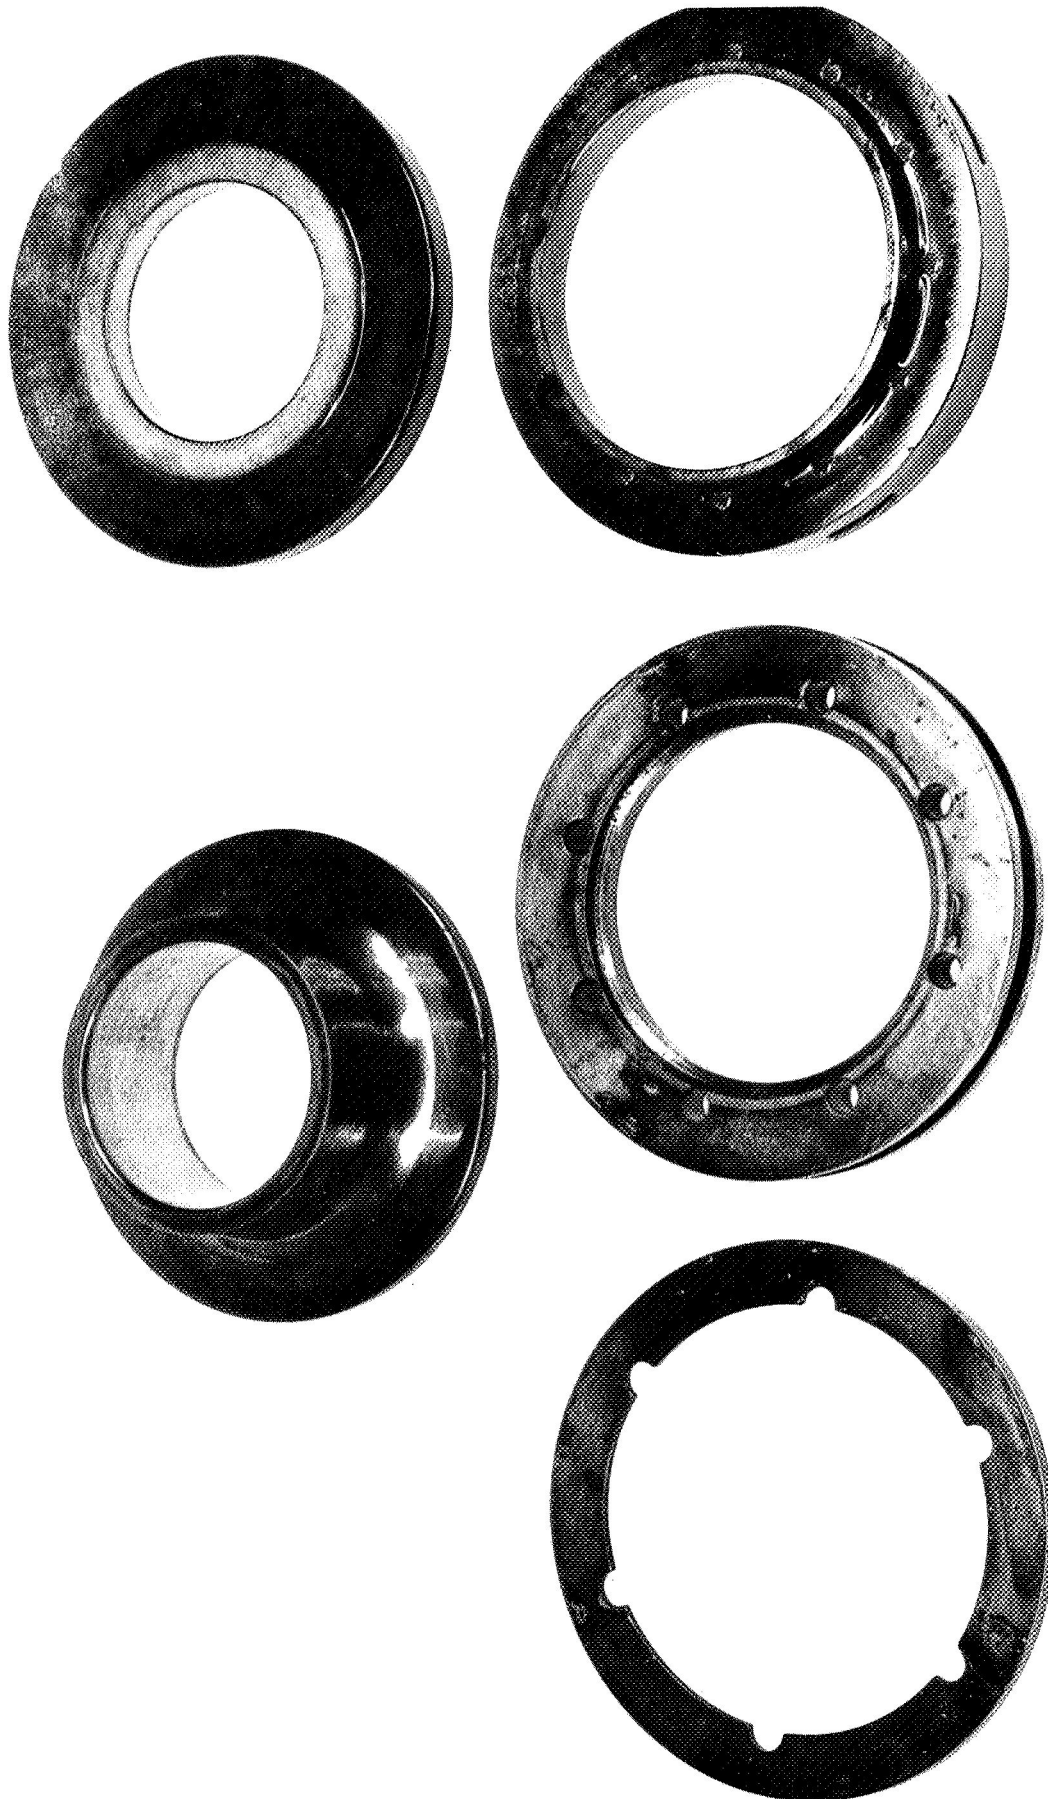
SNAP-8 ALTERNATOR P/N 094069 S/N 481490 AFTER 23130 HOURS IN ECTF
INBOARD SCREW SEAL FOR D.E. SHOWING OUTBOARD FACE AND DAMAGED THREADS
AOC

2. Remove the Teflon coating on the screw seal threads. This coating is difficult to apply to threads uniformly, and to measure accurately. Also it is subject to damage during assembly and tends to ball up when rubbed during high speed contact with the rotor.
