PROCEEDINGS
OF THE
SMRM DEGRADATION STUDY WORKSHOP

Organized by:
The Satellite Servicing Project
Goddard Space Flight Center

May 9-10, 1985

**SUMMARY OF THE SMRM DEGRADATION
STUDY WORKSHOP**

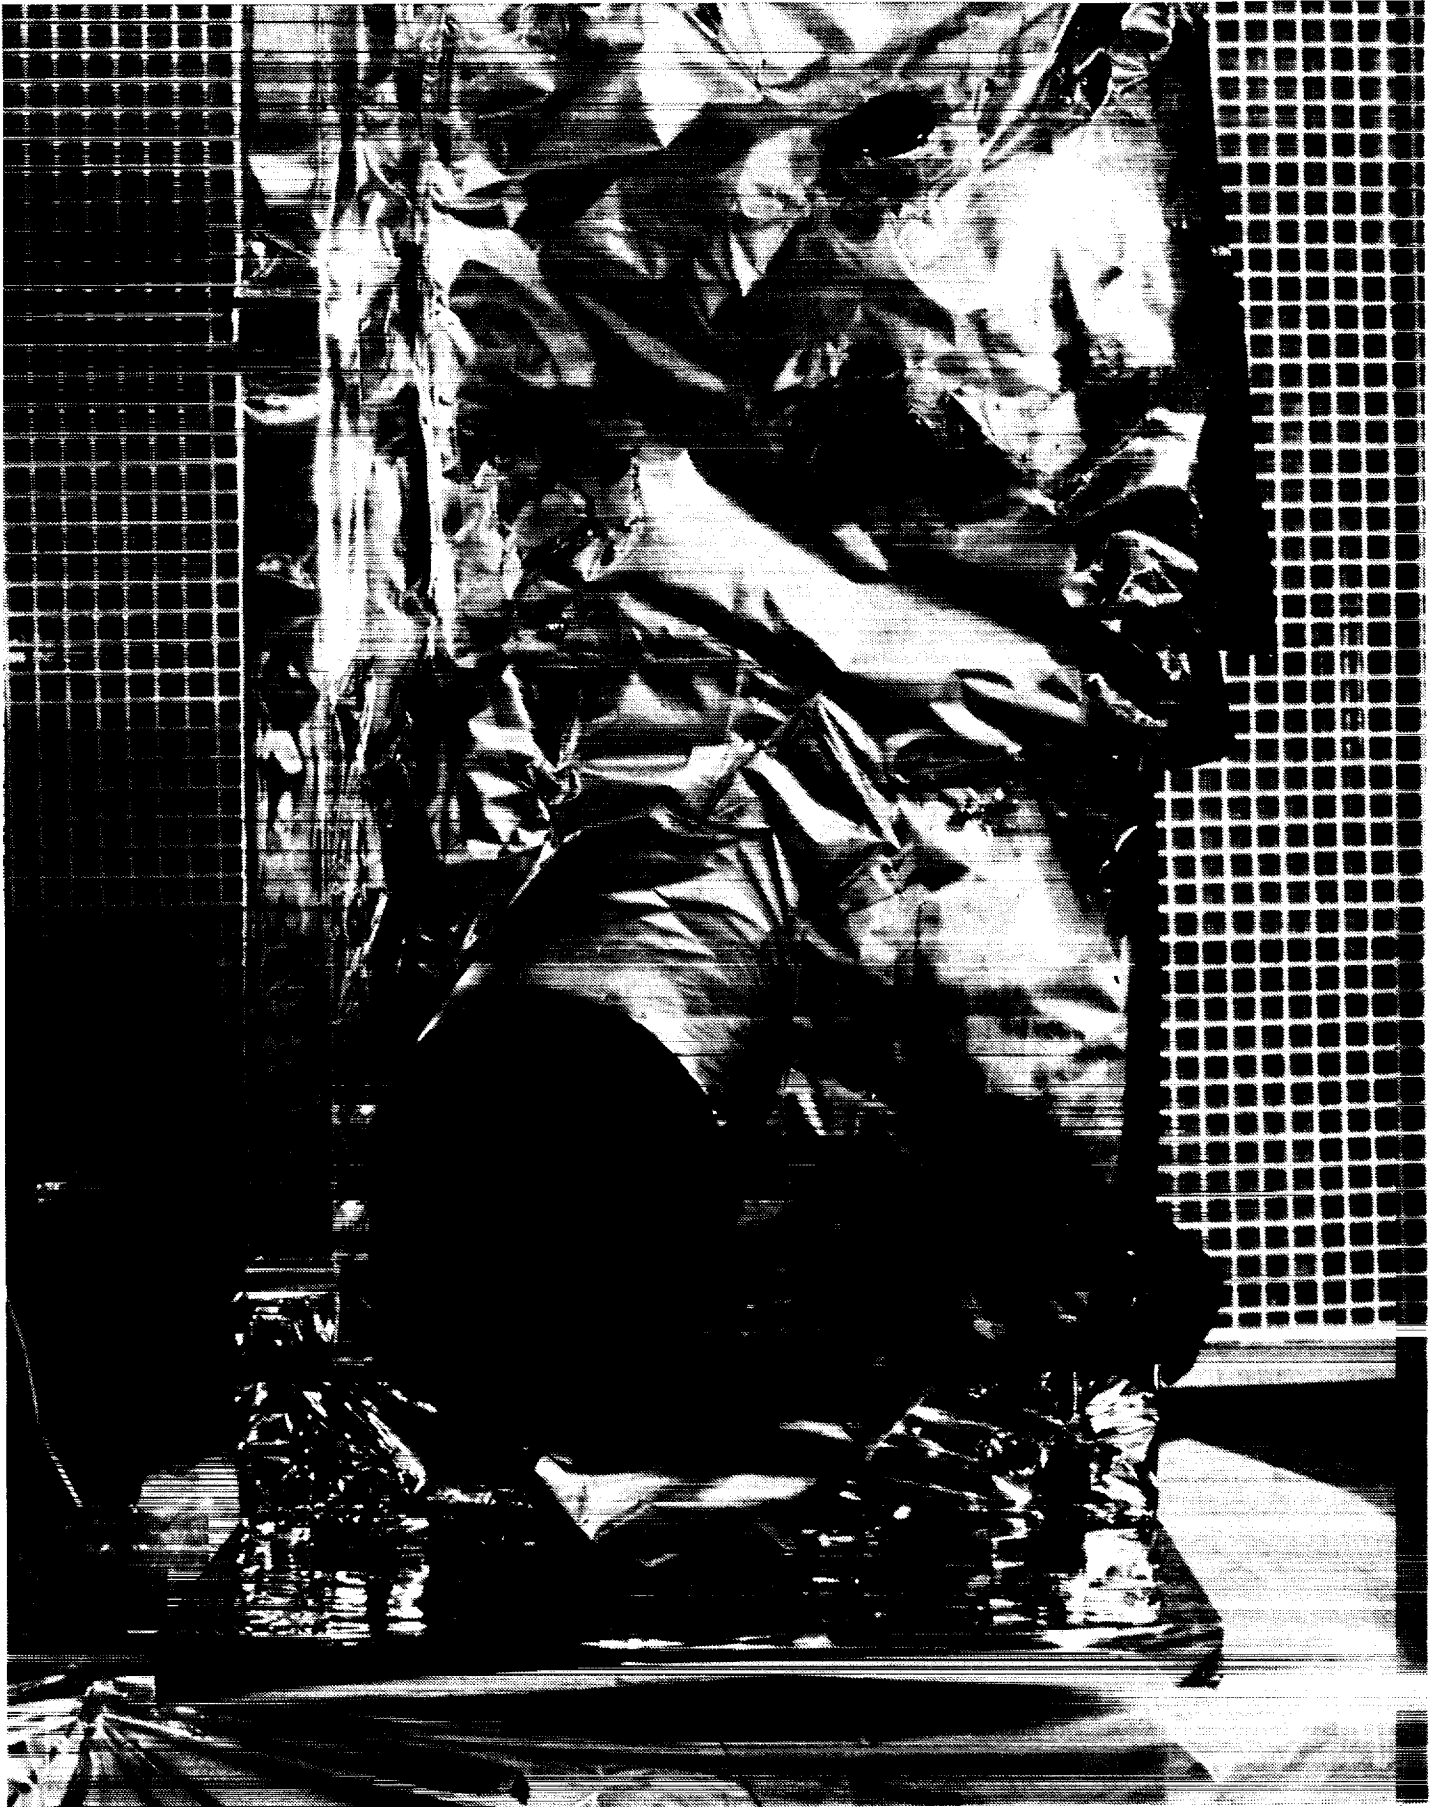
Star-tracker side of the module shows “wash” pattern on the blanket at top center of the photo.

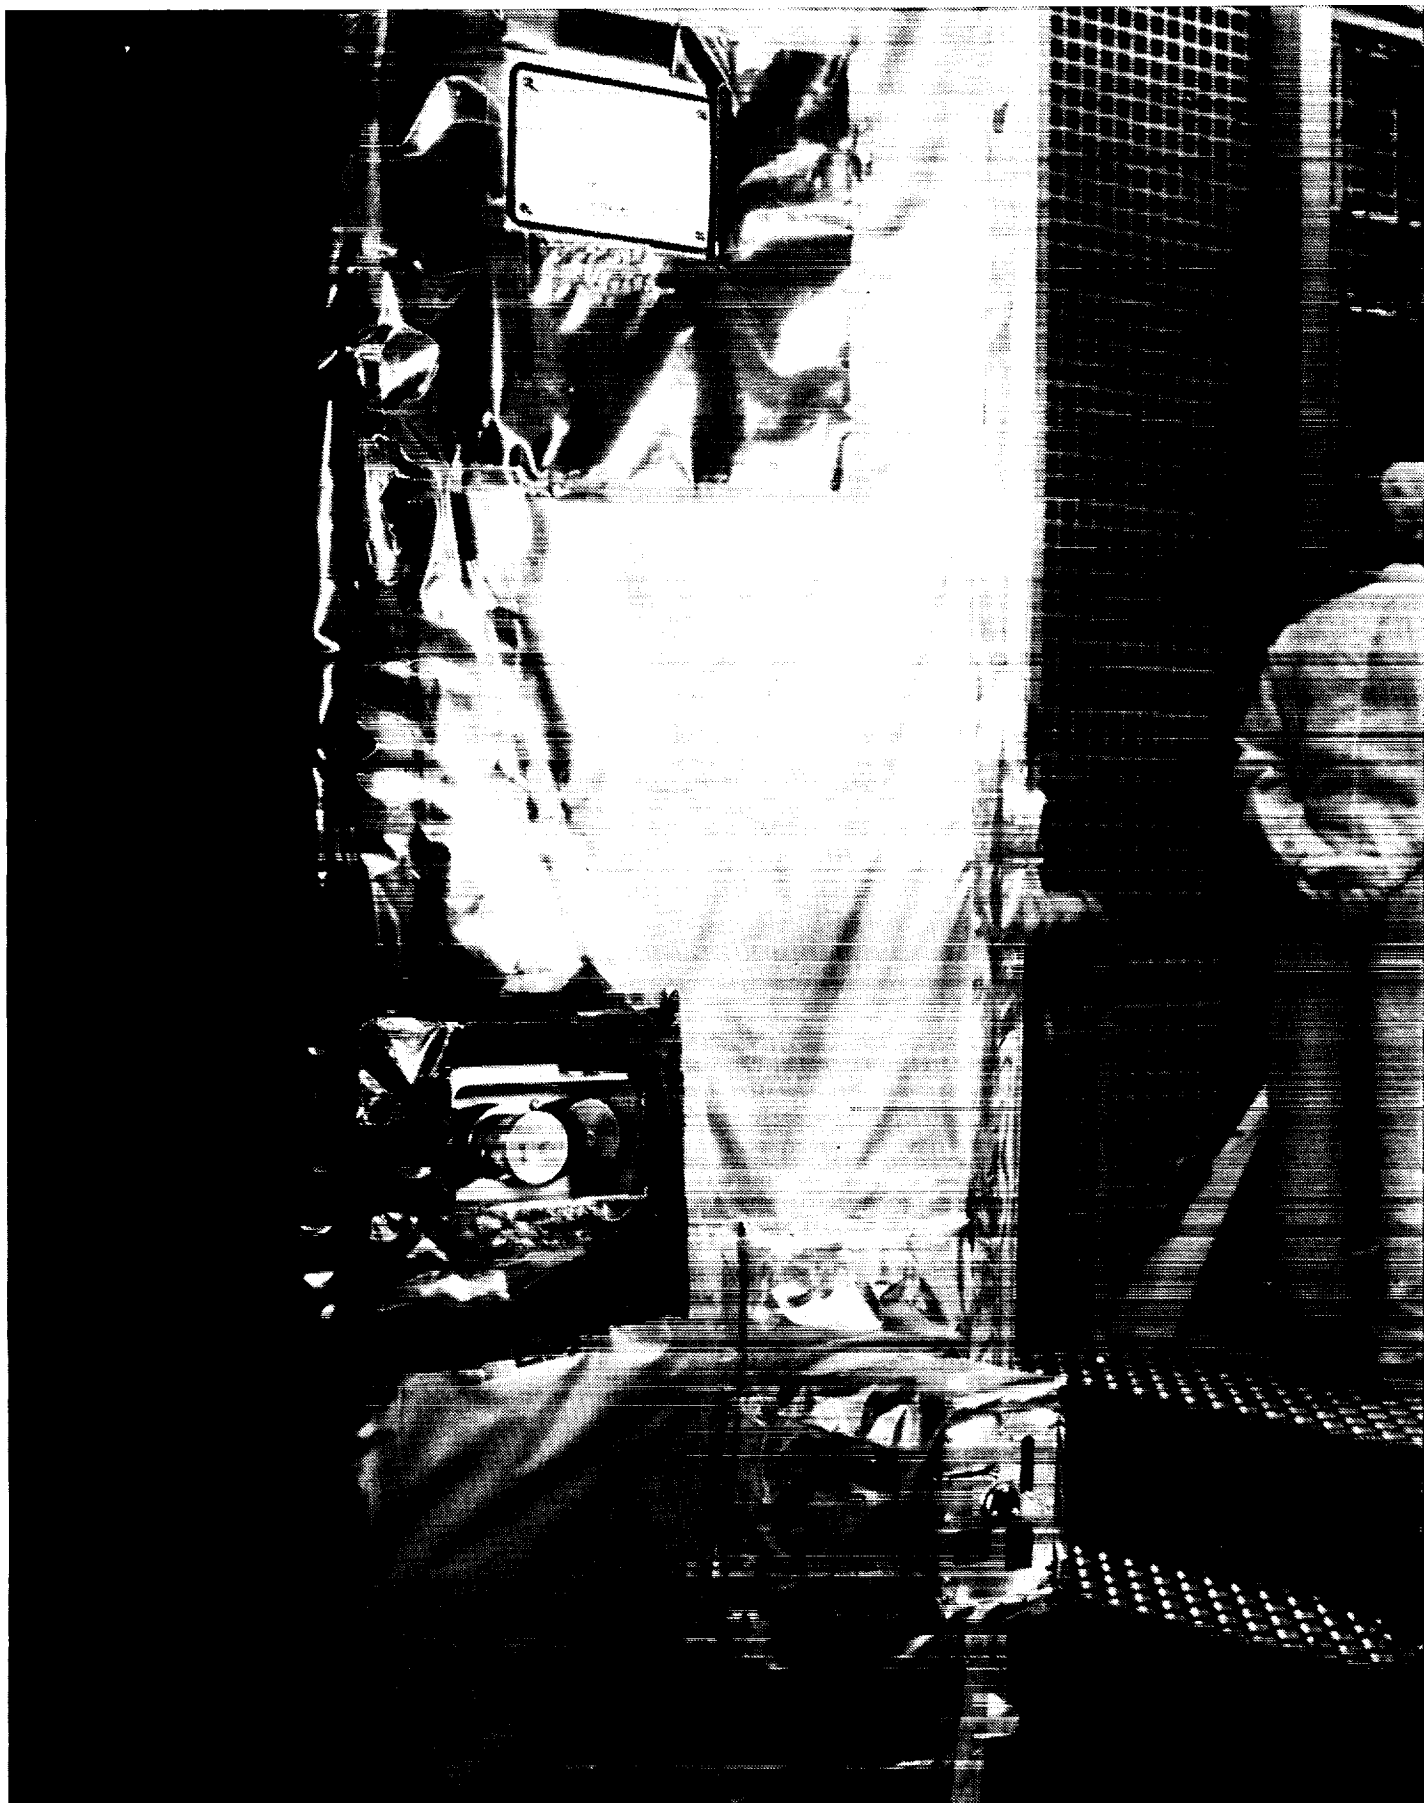
Sun-sensor side of module. Small MLI cover removed from test connector plugs (center) shows unexposed Kapton compared to that exposed to oxygen fluence. The Fine Sun Sensor (upper right) has some white deposits on the radiator surface. These were formed by outgassing from the module interior.

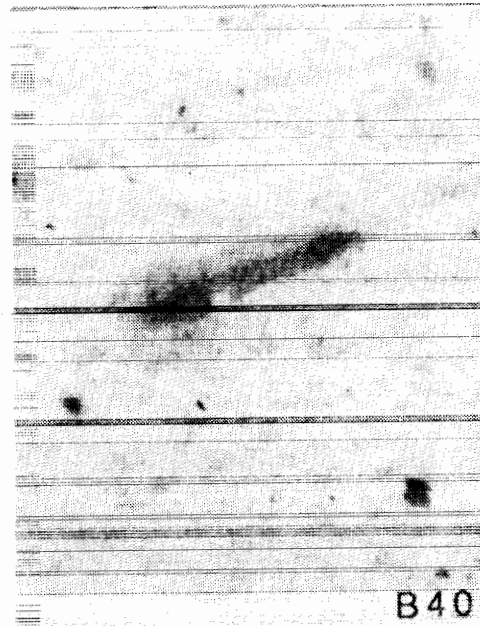
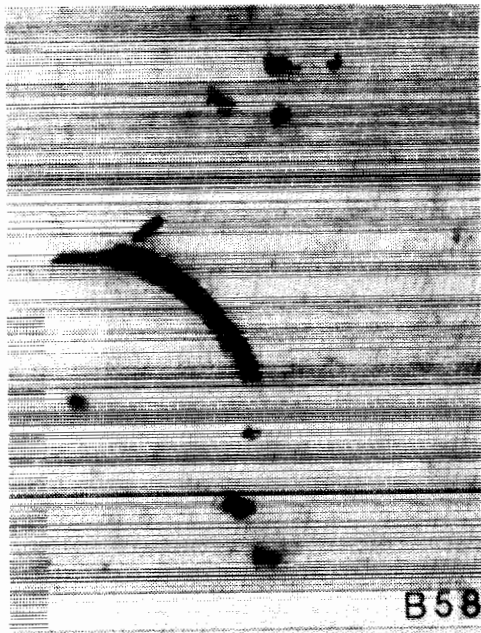
Figure 5. Typical particles collected off of B40, top, and B58, bottom. 56x.

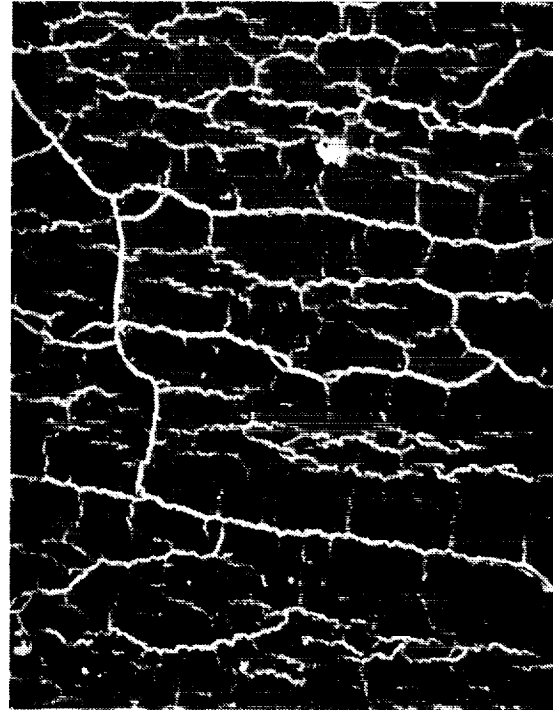
Figure 3. Scanning Electron Microscope images of Inconel surface, showing "grain boundaries" of Ag_2O .

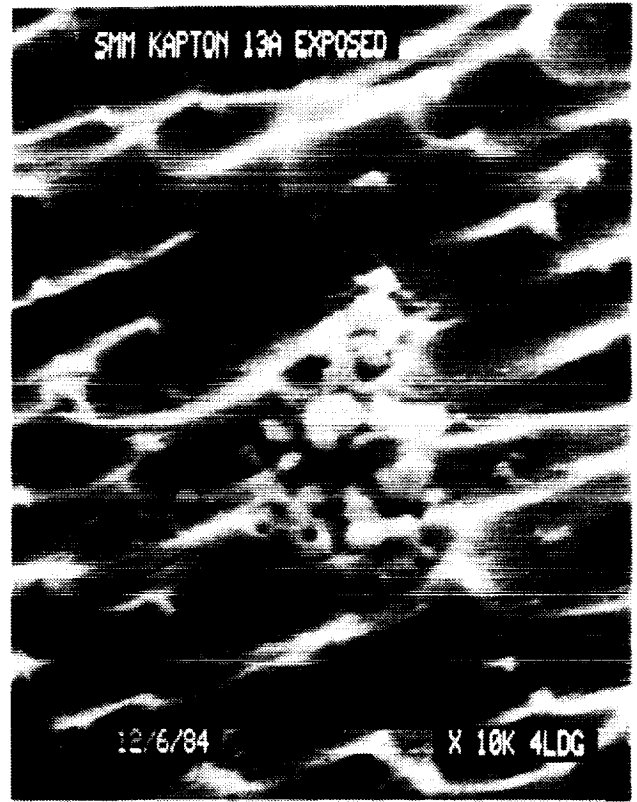
13A KAPTON TOP LAYER

Figure 8 13A Kapton Top layer. The Surface Morphology is Similar to that of the Laboratory Exposed Specimen, but More Erosion Has Taken Place

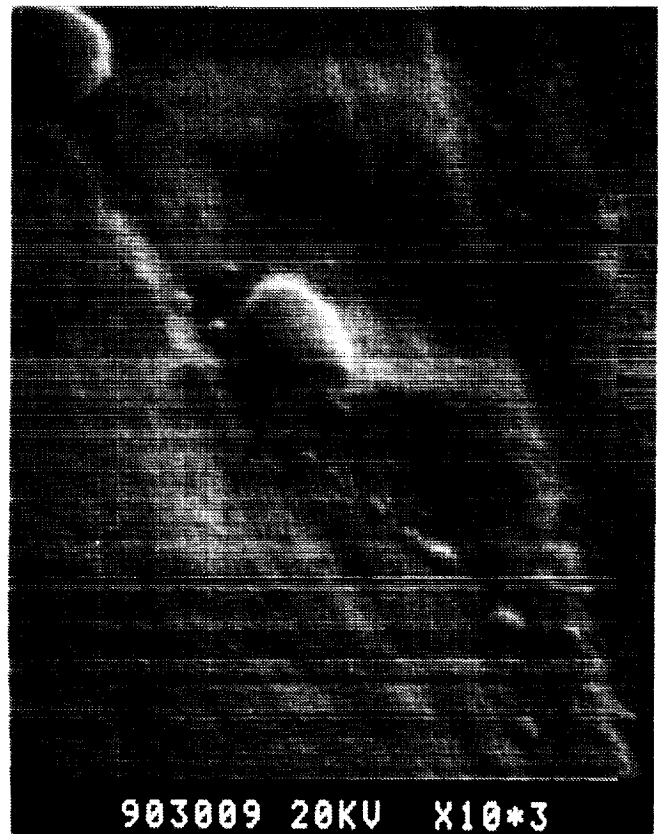
Figure 9 FEP Teflon After 2 Hours Plasma Exposure. Surface Has Granular Texture and Beginnings of Polygonization with Eroded Striations Remaining from Original Texture

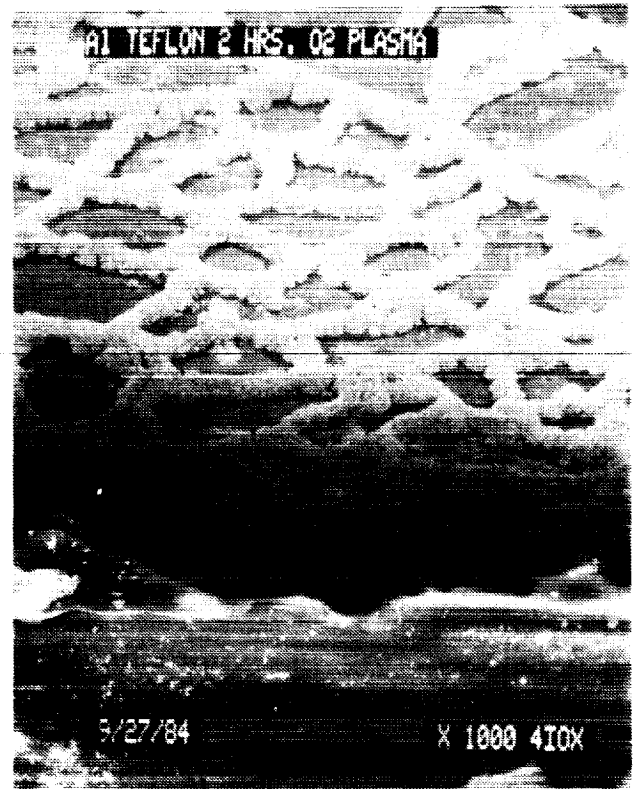
FEP TEFLON
INCONEL/Ag SIDE
PLASMA EXPOSURE
2 HOURS

Figure 10 FEP Teflon After 2 Hours Plasma Exposure on the Ag/Inconel Surface. Growth of Ag along Grain Boundaries and Cracks in the Inconel Over Coat Has Occurred.

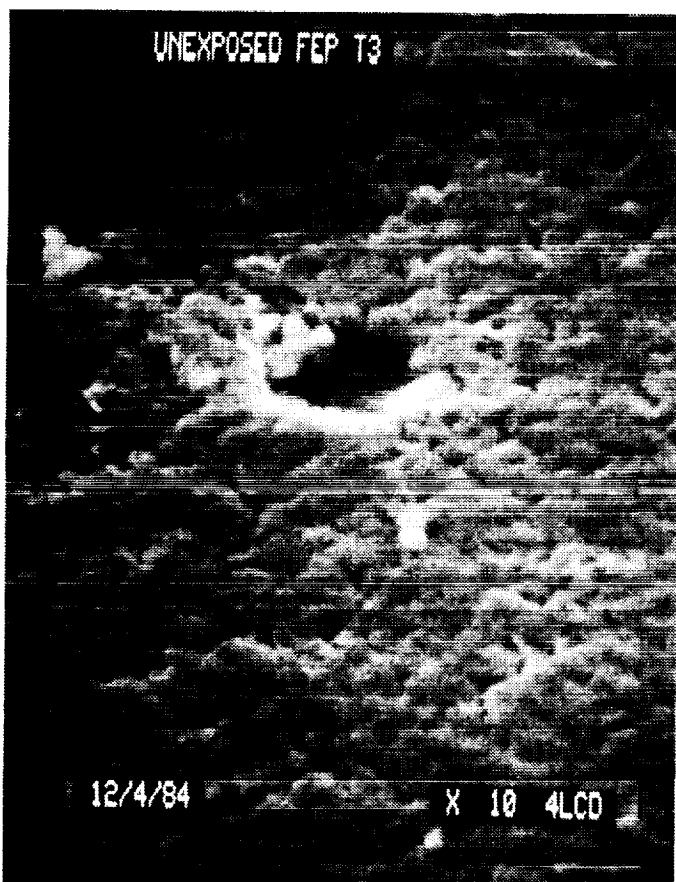
13A KAPTON TOP LAYER

Figure 17 13A Kapton Top layer possible impact.

Crater on eroded Kapton surface. These are generally not visible because of erosion texture on the Kapton surface.

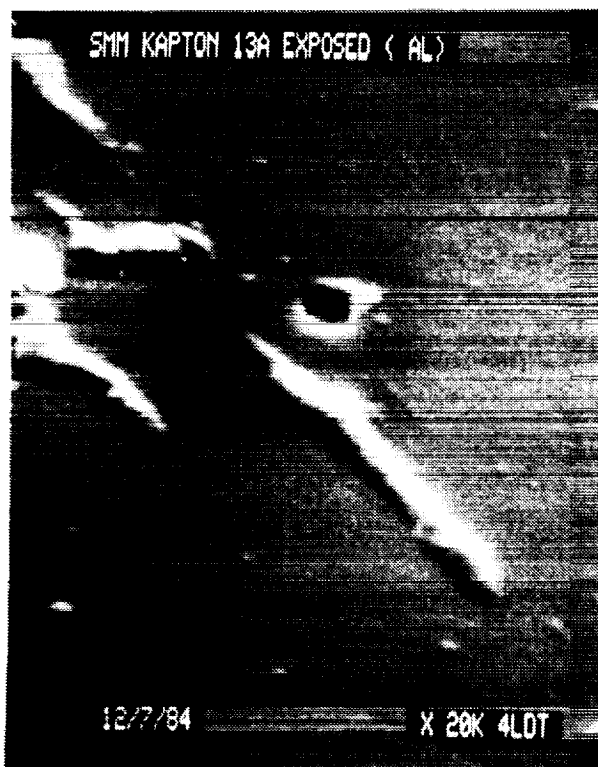
13A MICRO METEORITE CRATERS

Figure 19 13A Kapton Al side of top layer. Exit impact craters on Al side
of top layer of Kapton.

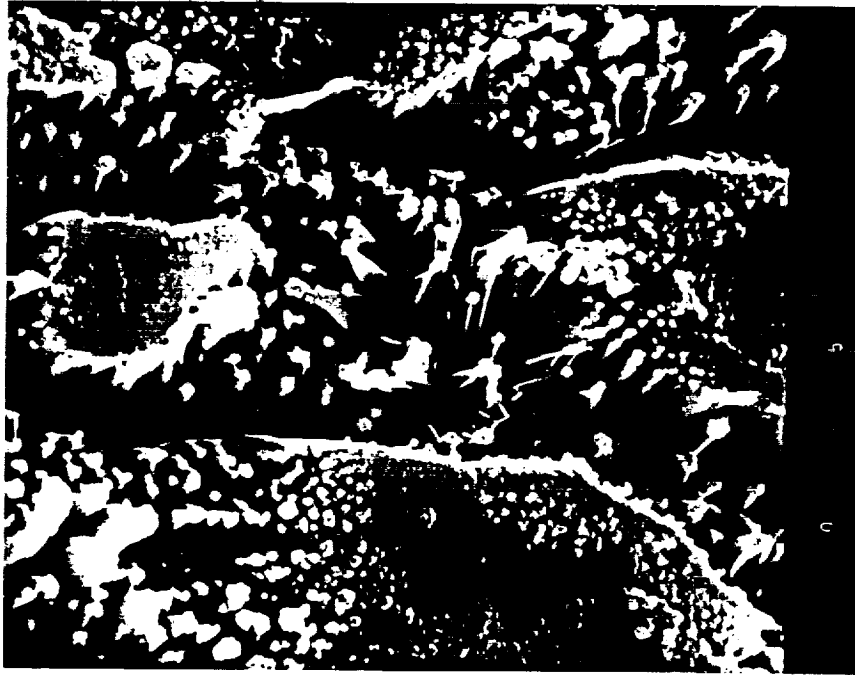
FIGURE 3
325

C. EXPOSED REGION

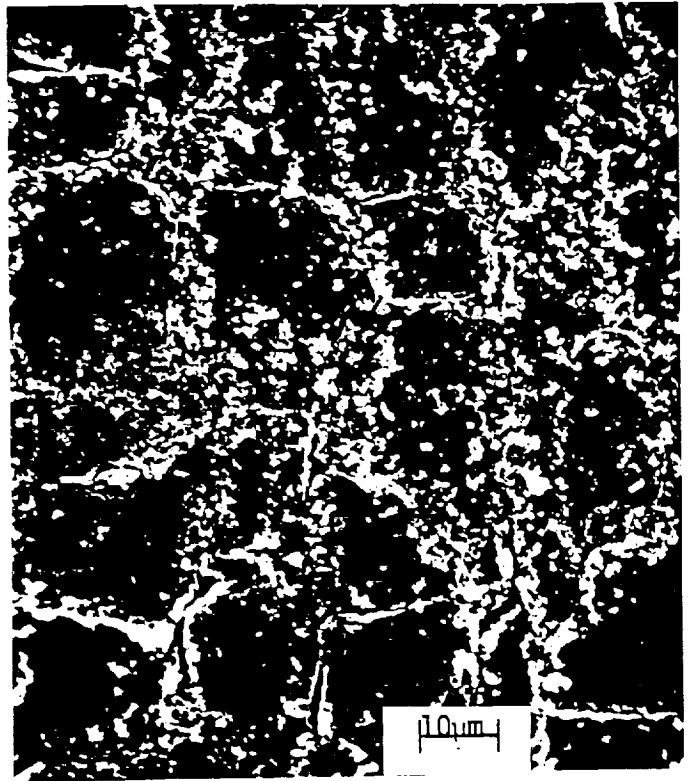
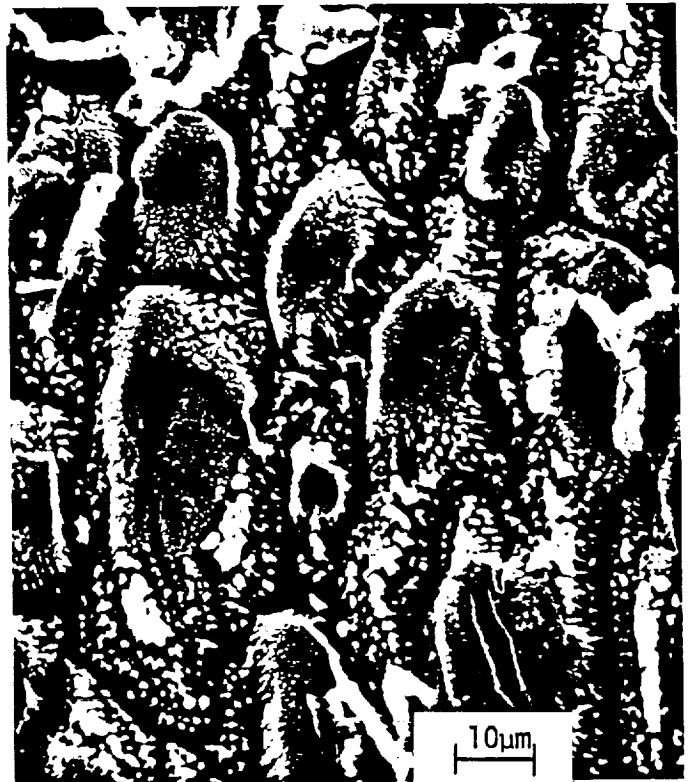
SURFACE DEGRADATION OF EXPOSED MATERIAL
