NASA Technical Memorandum 100987

Ice/Frost/Debris Assessment For Space Shuttle Mission STS-26R

November 7, 1988

Charles G. Stevenson
Gregory N. Katnik
Scott A. Higginbotham
The John F. Kennedy Space Center, NASA

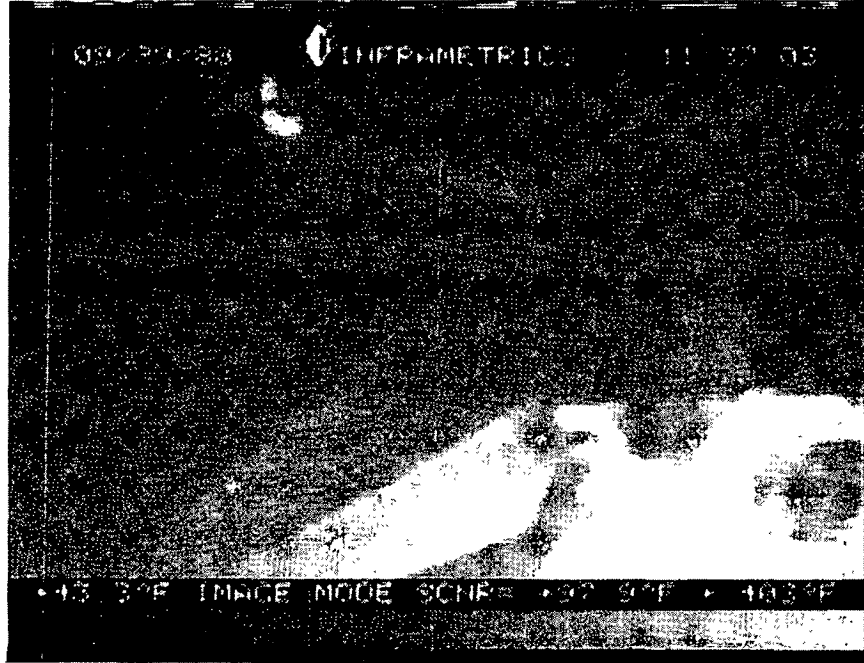
THERMAL IMAGES OF ORBITER AFT END JUST BEFORE TOWER CLEAR.
VERTICAL STABILIZER AND BASE HEAT SHIELD HEATED BY SSME PLUME.
