NASA/TM-2011-217072/Volume II  
NESC-RP-09-00506

# Space Shuttle Program (SSP) Orbiter Main Propulsion System (MPS) Gaseous Hydrogen (GH<sub>2</sub>) Flow Control Valve (FCV) Poppet Eddy Current (EC) Inspection Probability of Detection (POD) Study

## *Appendices*

<b>NASA Engineering and Safety Center Technical Assessment Report</b>	<b>Document #:</b> <b>NESC-RP- 09-00506</b>	<b>Version:</b> <b>1.0</b>
<b>Title:</b> <b>STS-126 MPS#2 GH<sub>2</sub> Flow Control Valve Broken Poppet</b>			<b>Page #:</b> <b>1 of 538</b>

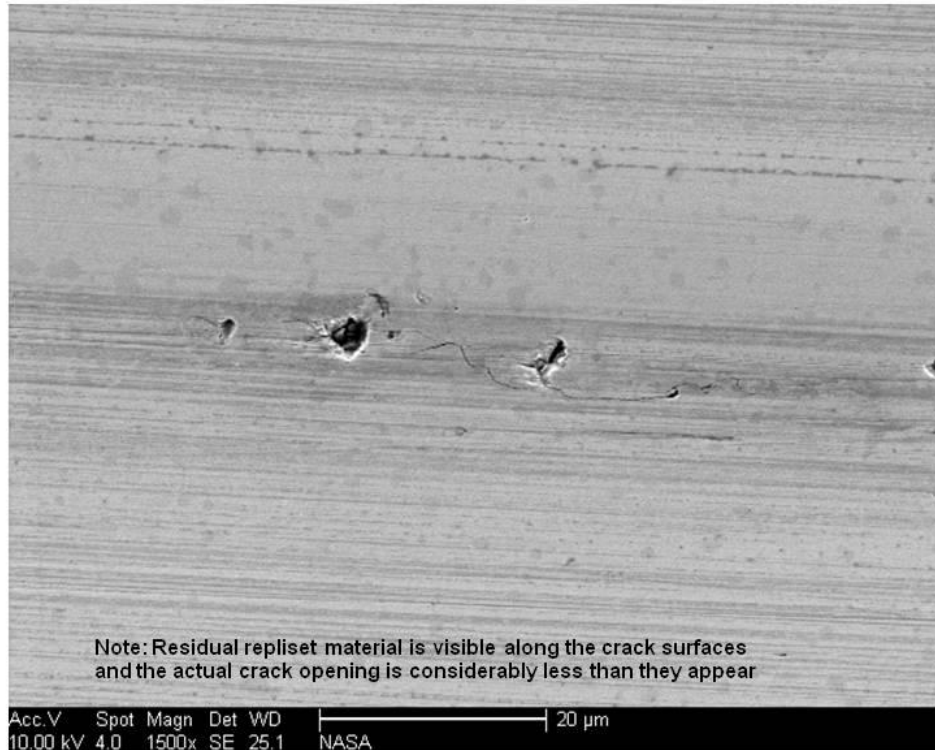
## Poppet #37

Crack #4

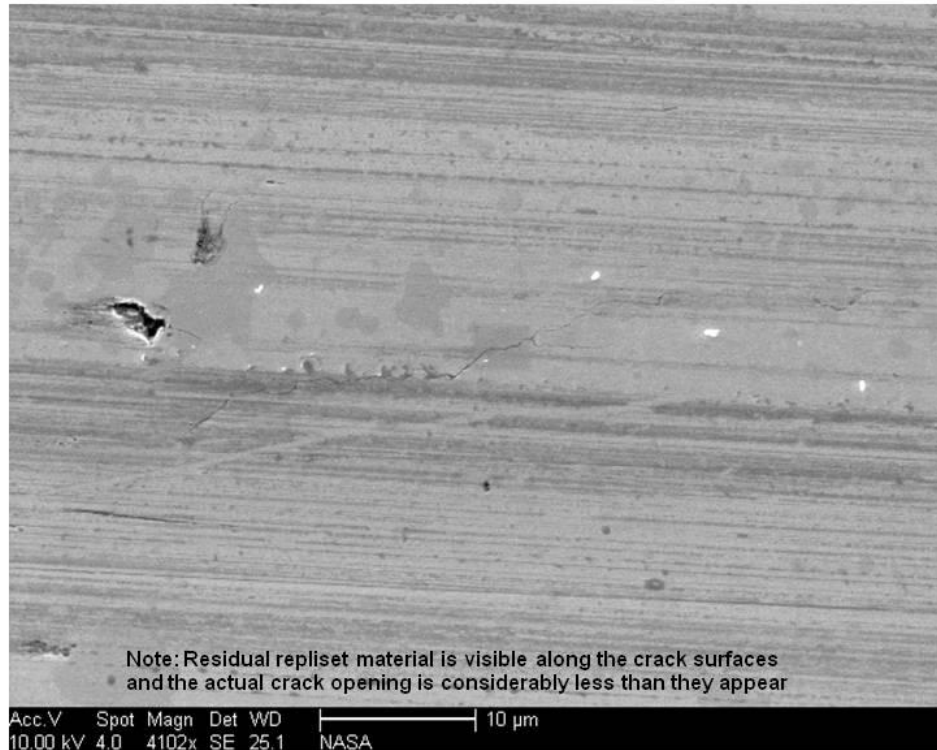
## Poppet #37

Crack #5

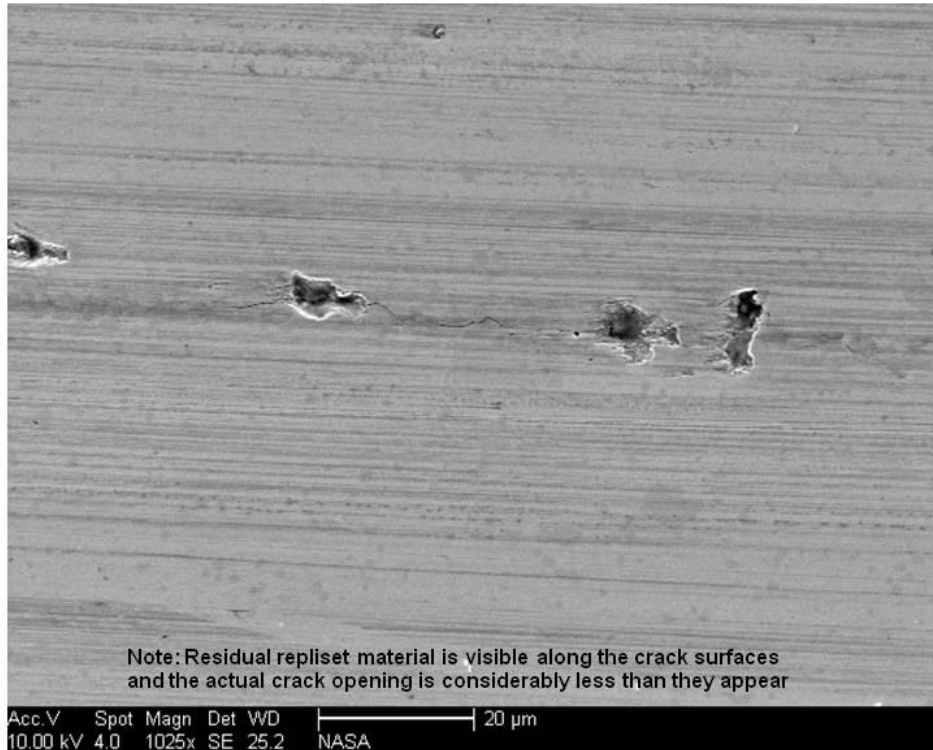
## Poppet #37

Crack #6

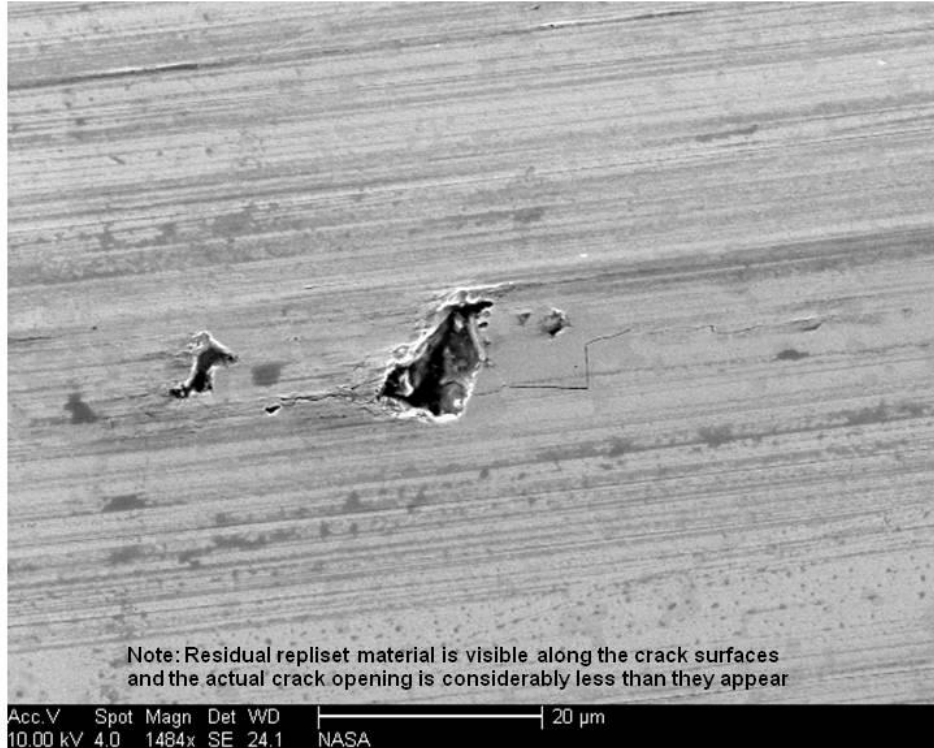
## Poppet #37

Crack #10

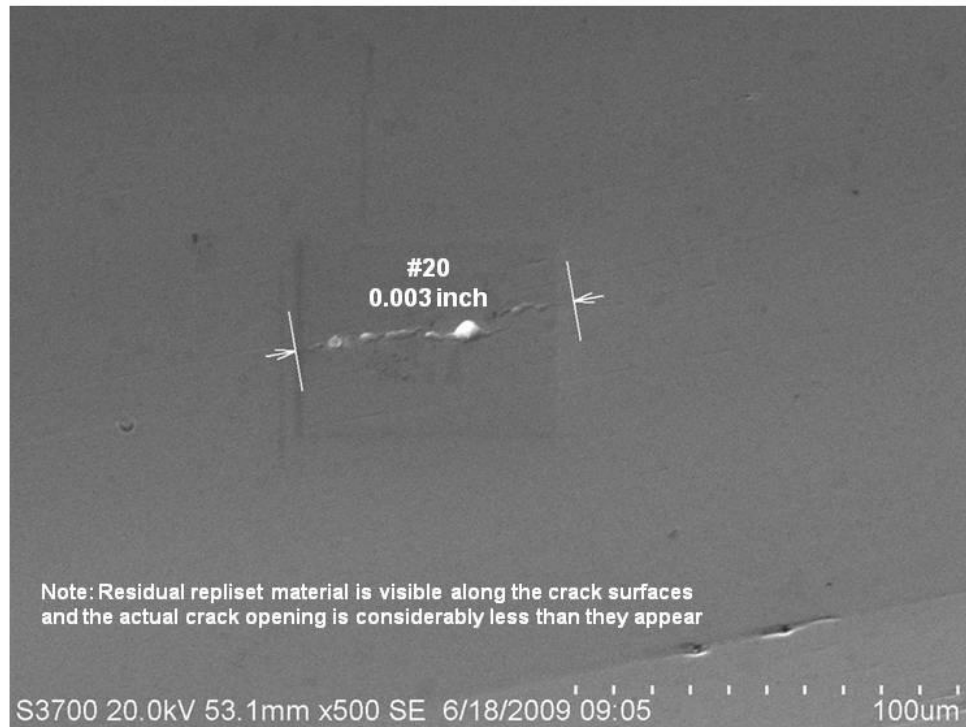
Size of Crack #20

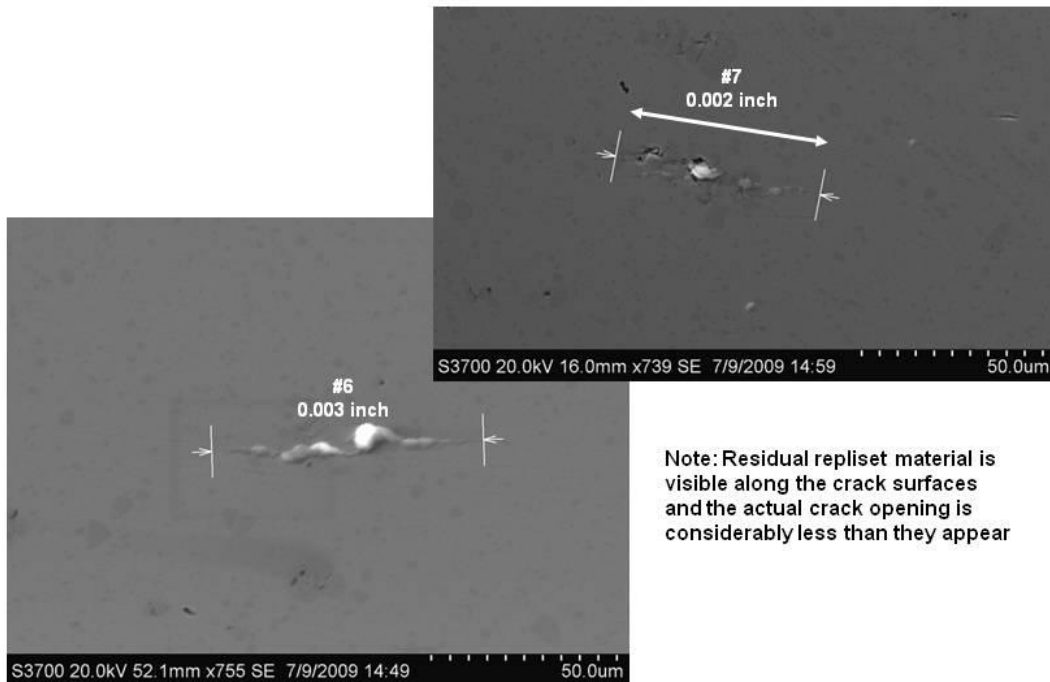
### Size of Cracks #6 and 7

Note: Residual replet material is visible along the crack surfaces and the actual crack opening is considerably less than they appear

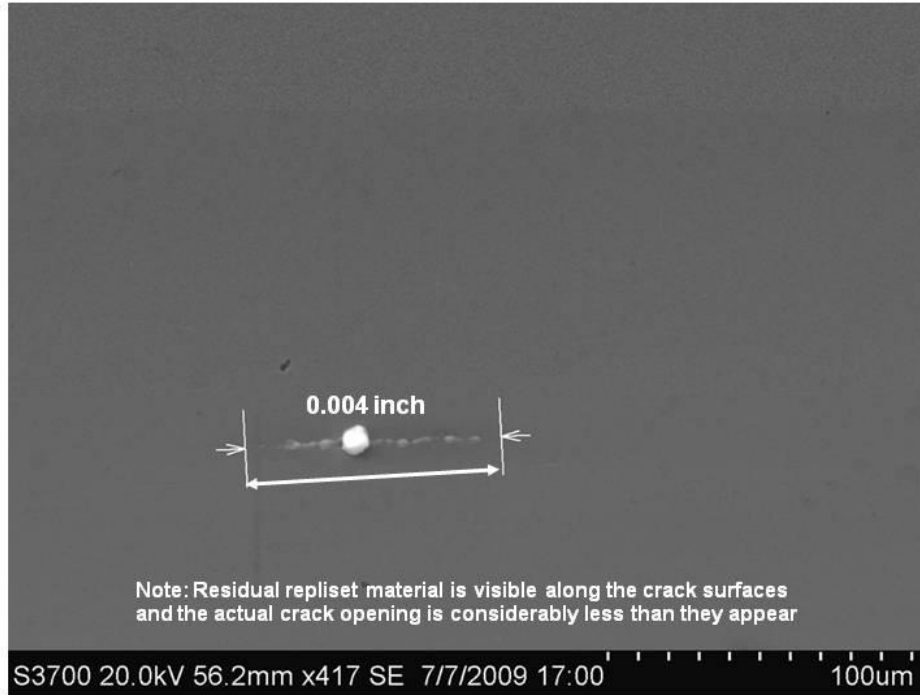
## Poppet #61

Size of Crack #28

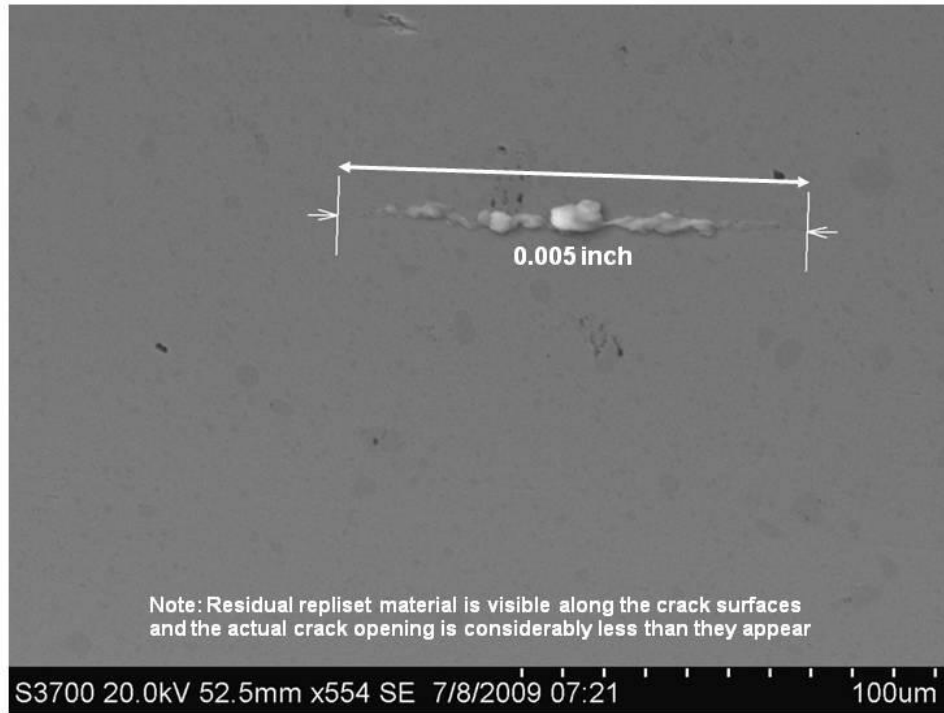
## Poppet #63

Size of Crack #1

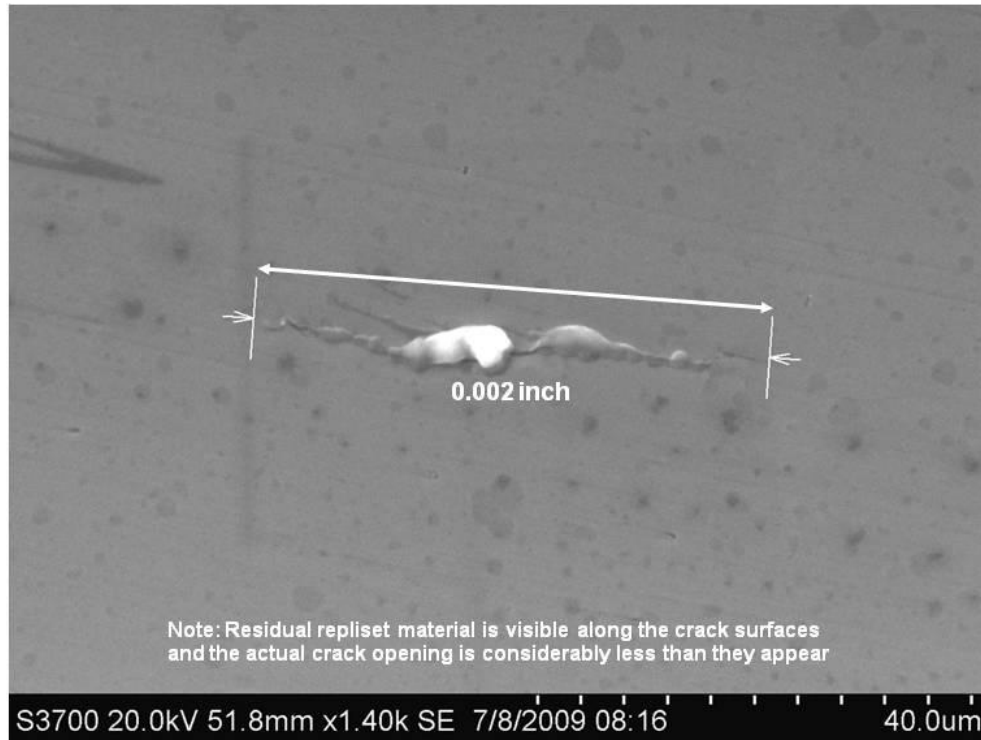
## Poppet #63

Size of Crack #10

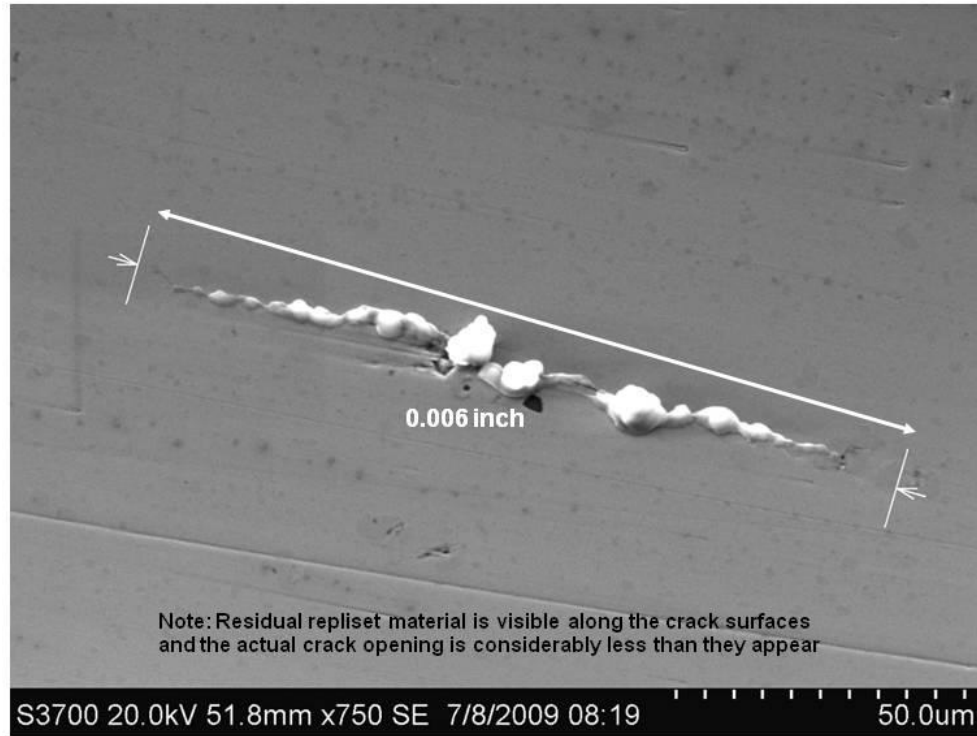
## Poppet #63

Size of Crack #11

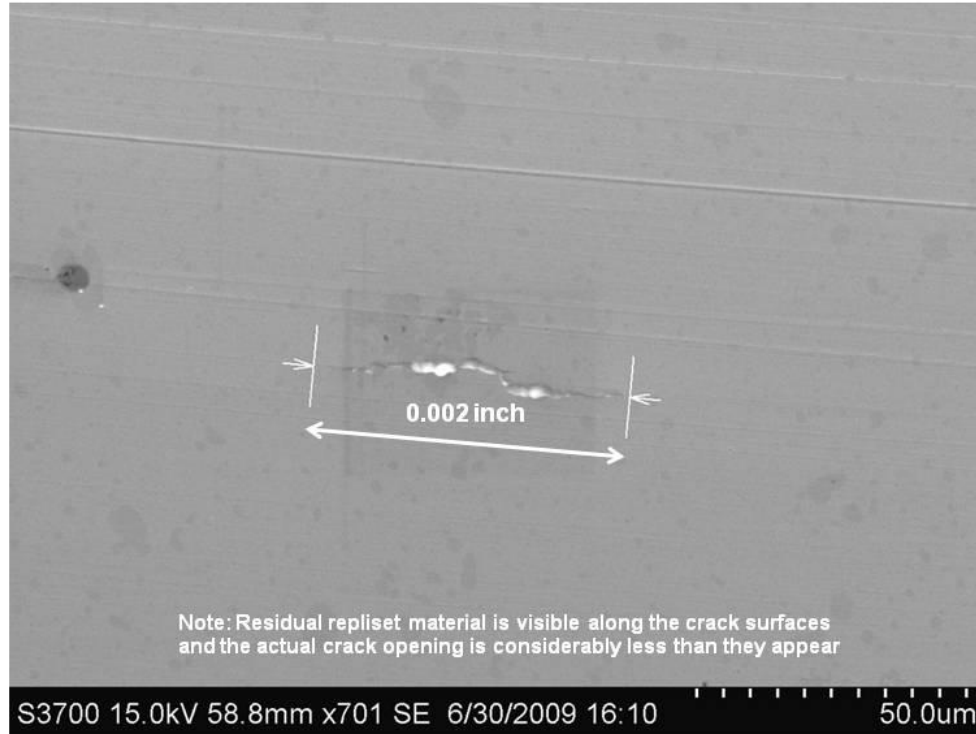
## Poppet #64

Size of Crack #9

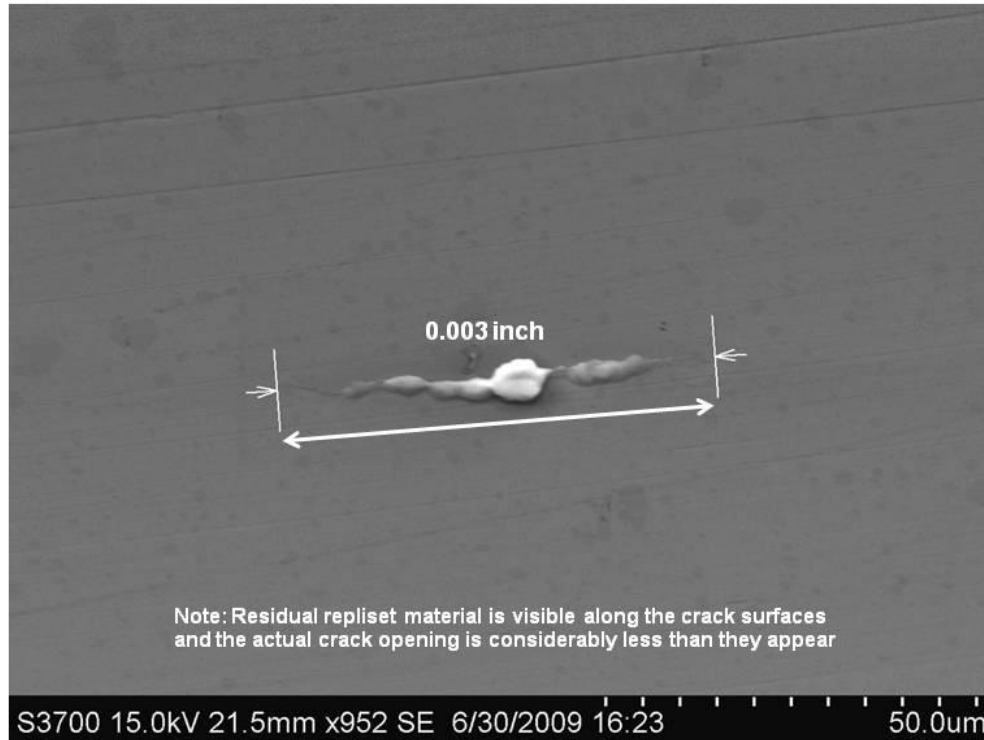
## Poppet #64

Size of Crack #17

Note: Residual replet material is visible along the crack surfaces  
and the actual crack opening is considerably less than they appear

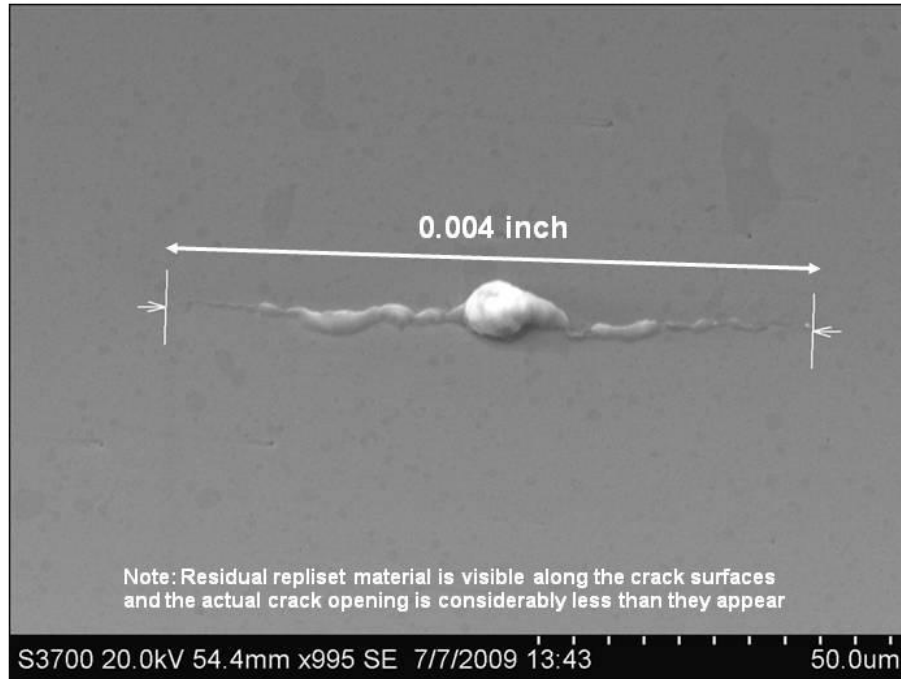
## Poppet #70

Size of Crack #5
