DETERMINE ISS SOYUZ ORBITAL MODULE BALLISTIC LIMITS FOR STEEL PROJECTILES HYPERVELOCITY IMPACT TESTING

Hypervelocity Impact Technology Group (HVIT)
Astromaterials Research and Exploration Science (ARES) Directorate
Human Exploration Science Office, KX

July 2013

Prepared for the
ISS Systems Engineering and Integration Office

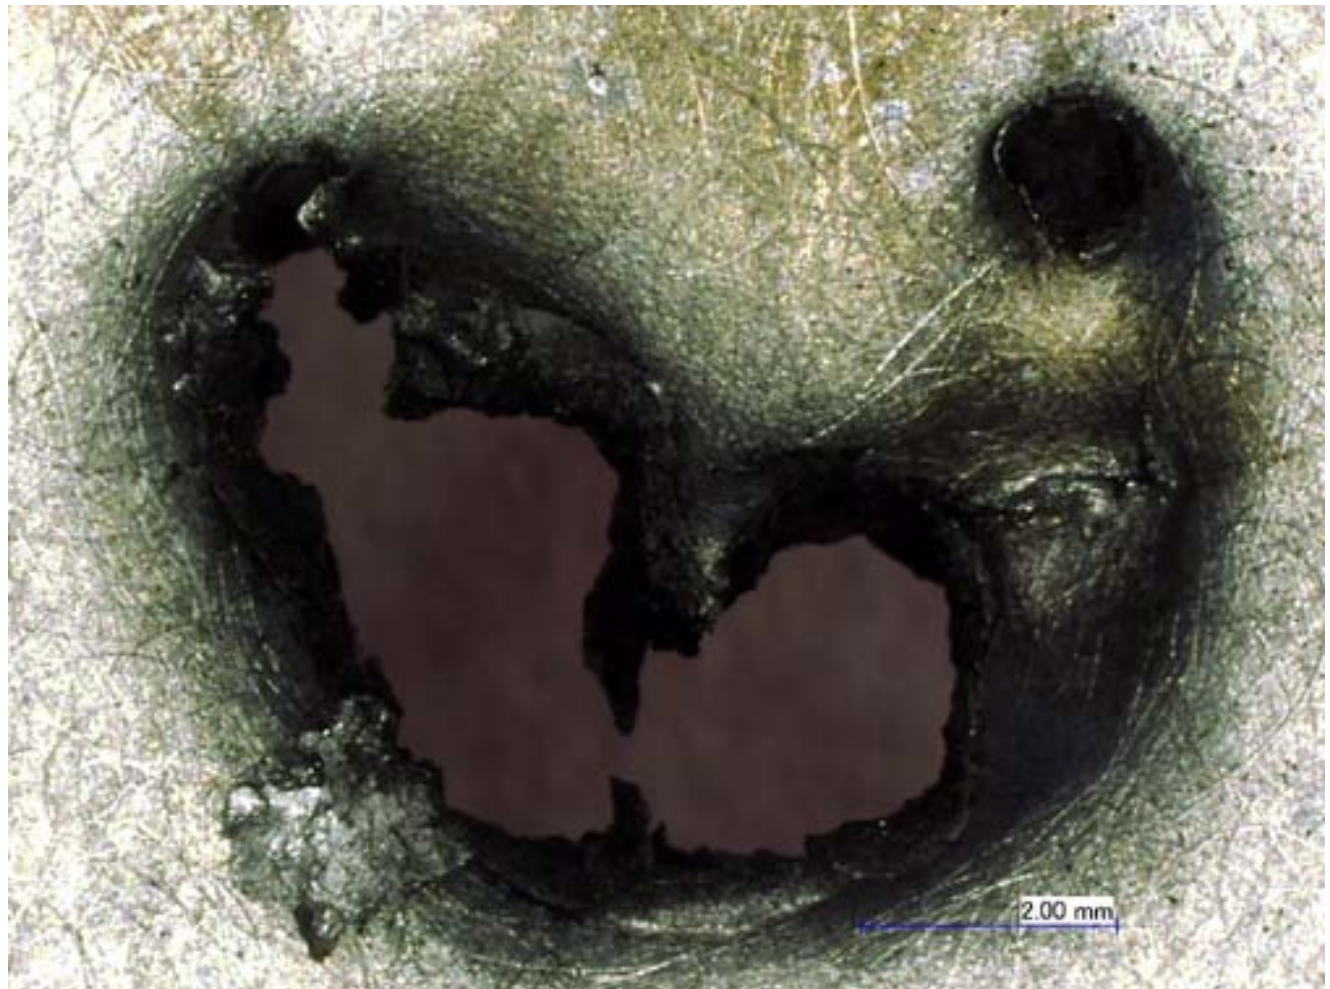
Test #2, HITF12258

**Figure 45: Al 5456-0 Rear Wall Layer 8 Back of ISS Soyuz OM Test #2
(Keyence 3D Microscope Image)**

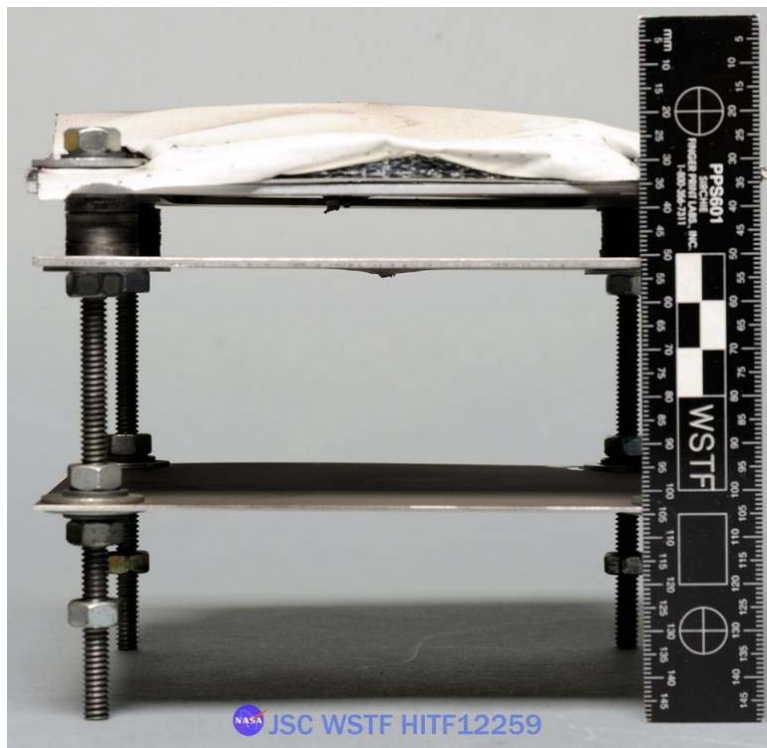
Figure 51: Side View of ISS Soyuz Orbital Module Test #3

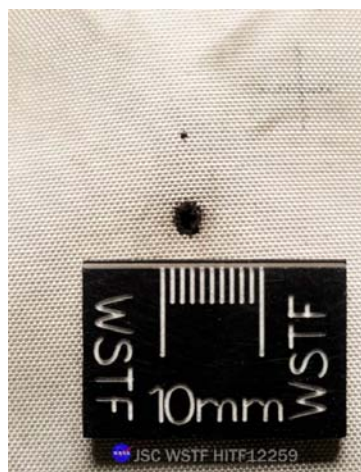
Figure 53: Beta Cloth Bumper of ISS Soyuz Orbital Module Test #3

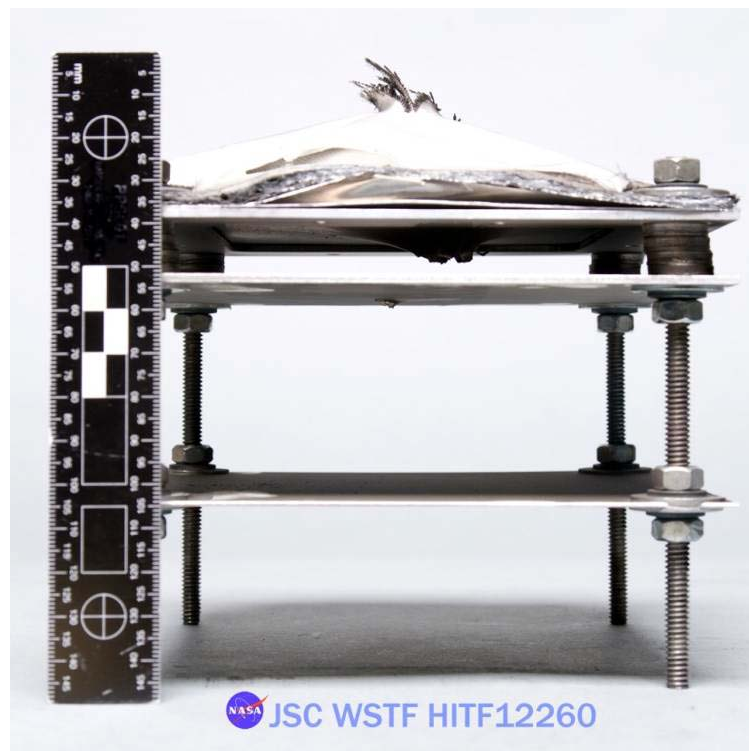
Figure 68: Side View of ISS Soyuz Orbital Module Test #4

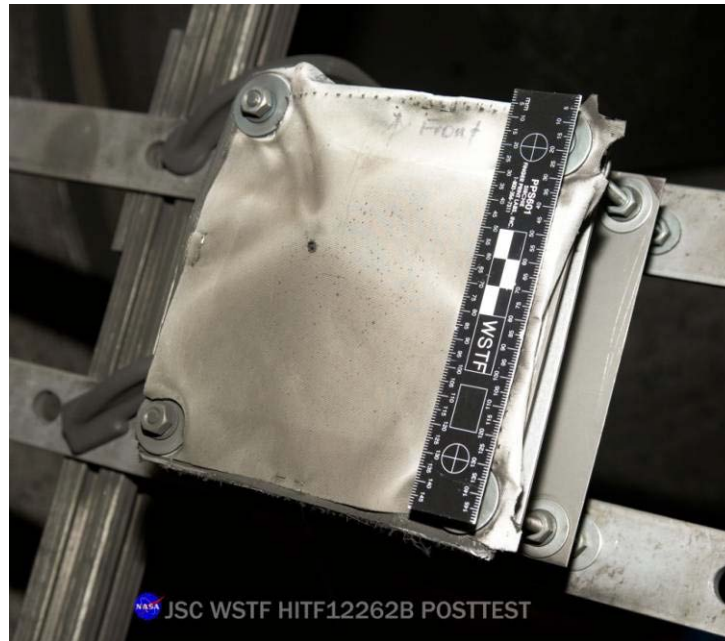
Test #6B, HITF12262

Figure 98: Post-test of ISS Soyuz Orbital Module Test #6B (HITF12262) article mounted in 0.50-caliber target tank.

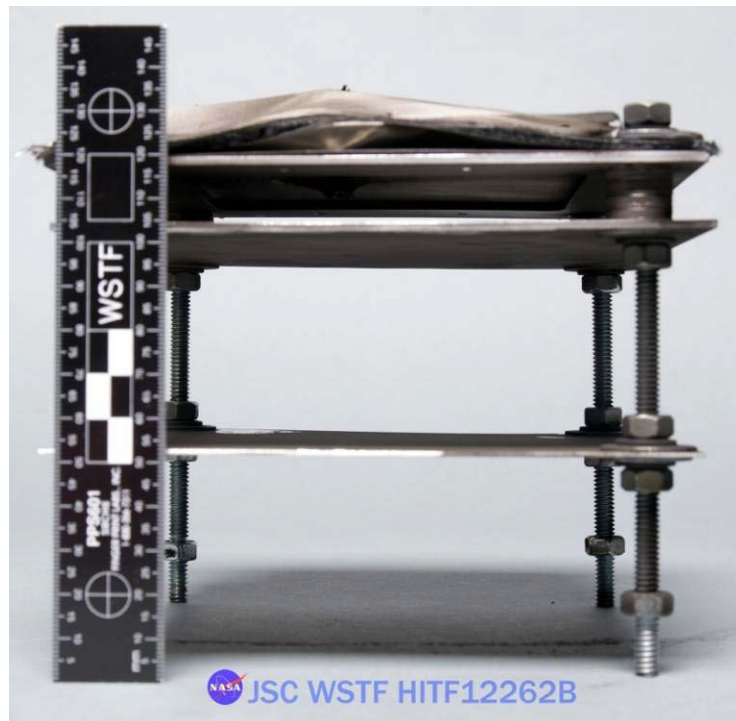
Figure 99: Side View of ISS Soyuz Orbital Module Test #6B

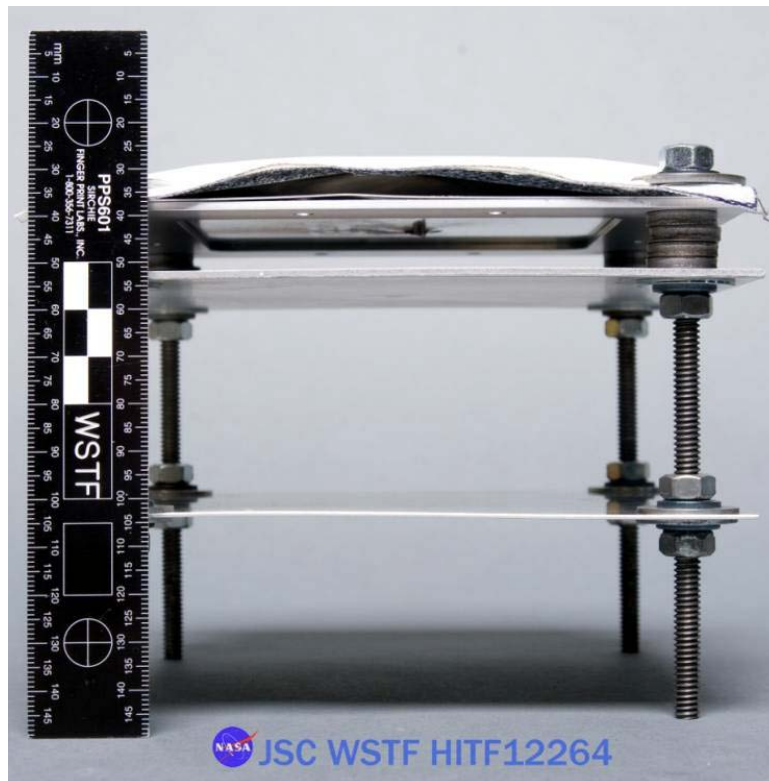
Figure 132: Side View of ISS Soyuz Orbital Module Test #8

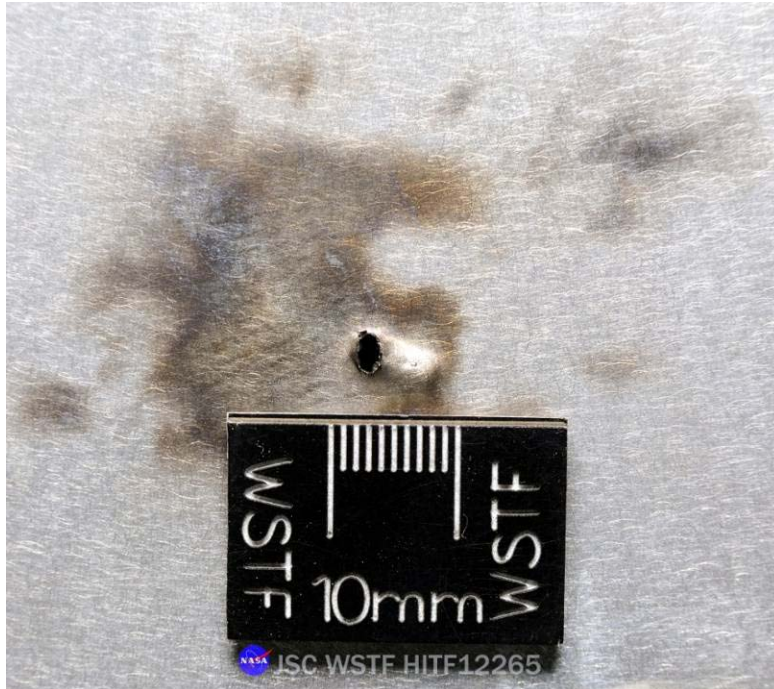
Figure 160: Al 5456-0 Rear Wall (Back) for ISS Soyuz Orbital Module Test #9

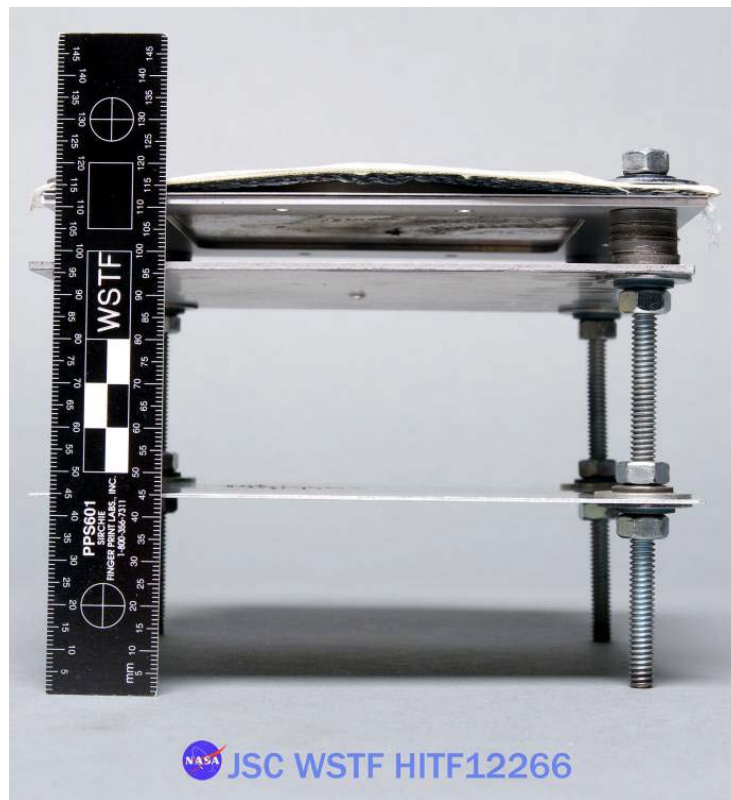
Figure 163: Side View of ISS Soyuz Orbital Module Test #10

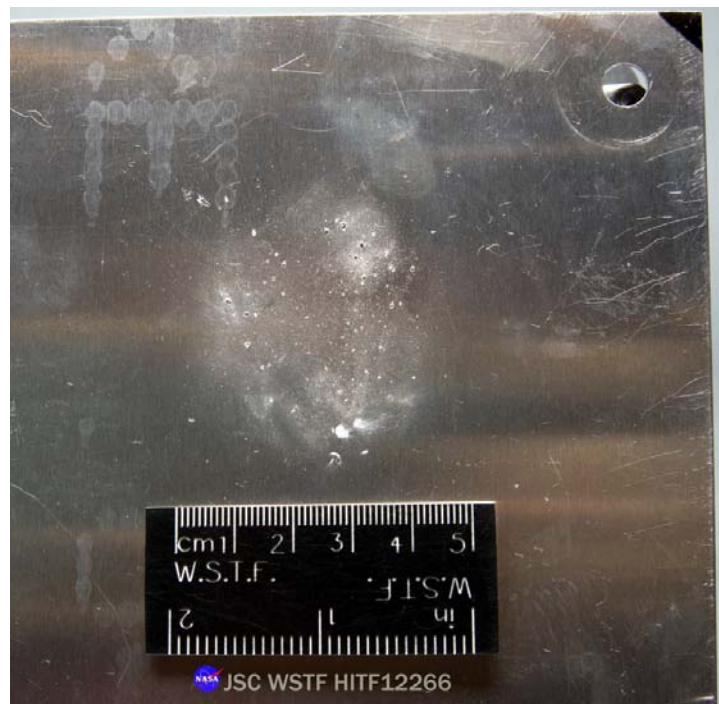
Figure 179: Front Witness Plate View of ISS Soyuz Orbital Module Test #10

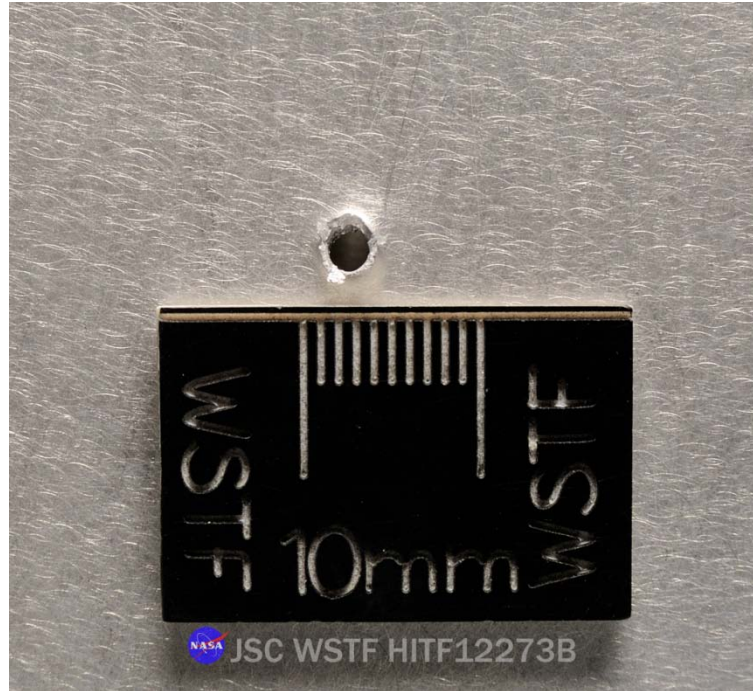
Figure 230: Al 5456-0 Rear Wall (Back) for ISS Soyuz Orbital Module Test #13B
