# Image Analysis Overview

## Multilateral Imagery Working Group Technical Interchange Meeting

NASA Johnson Space Center  
Image Science and Analysis Group (ISAG) (XI4)

May 2018

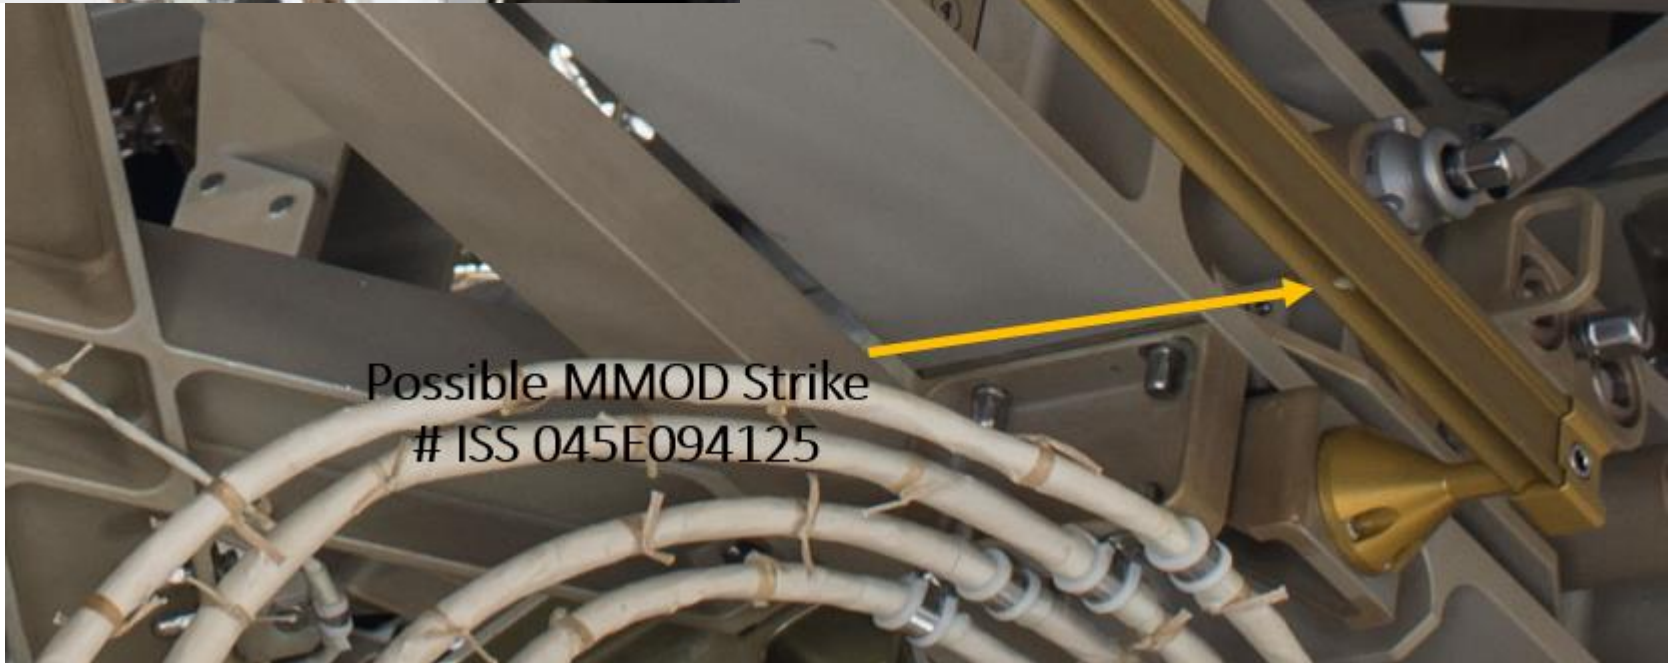
EVA Handrail Sharp Edge Risk

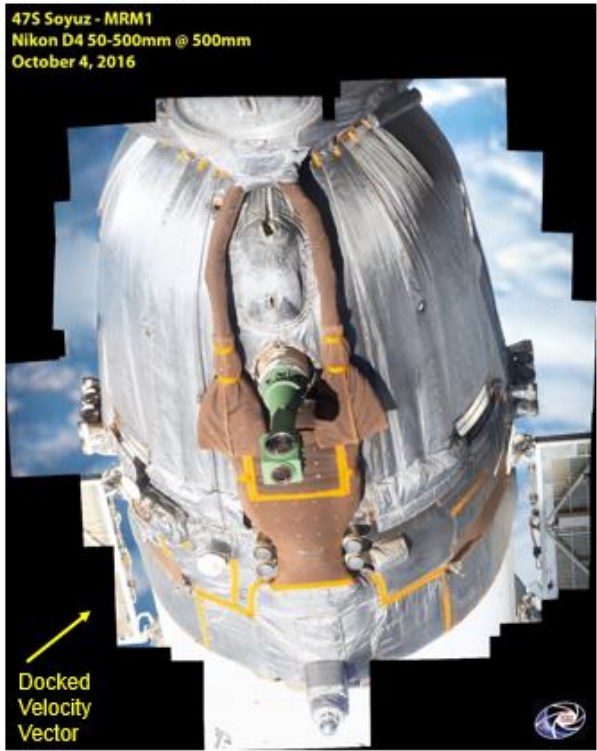
Cupola Window 5

MRM1 docked Soyuz descent module is surveyed with crew and EHDC photos

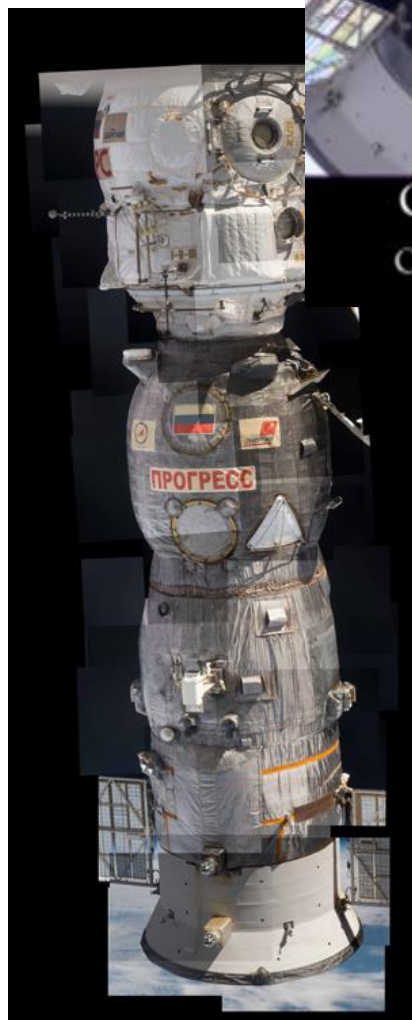
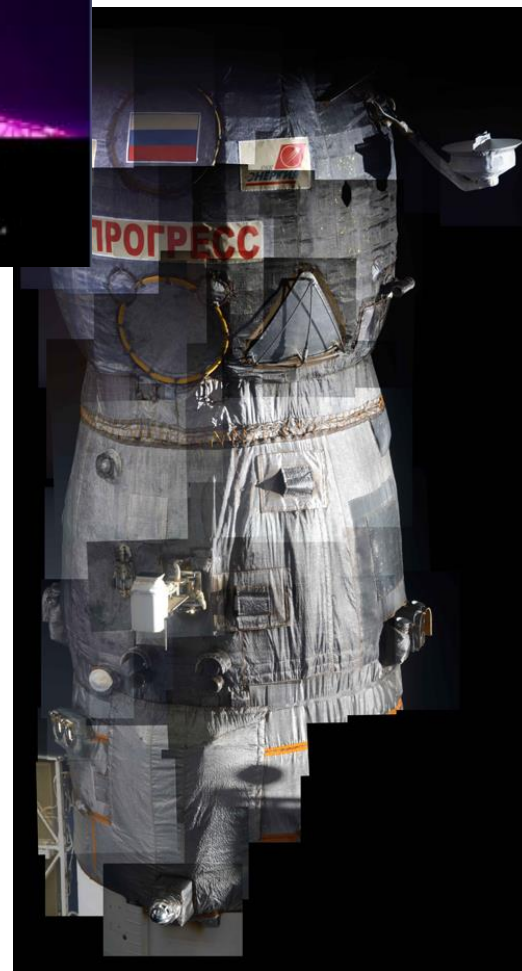
# Leak Source Investigation

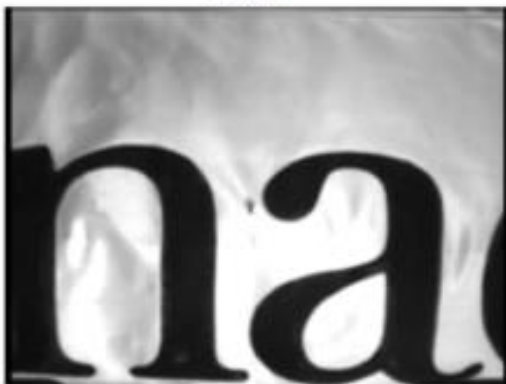
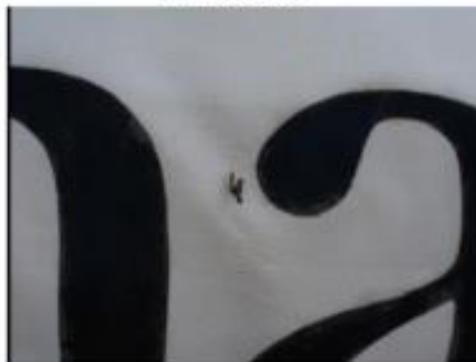
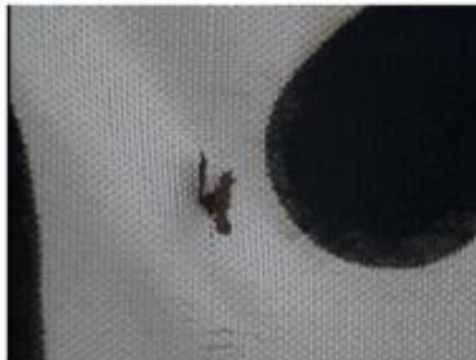
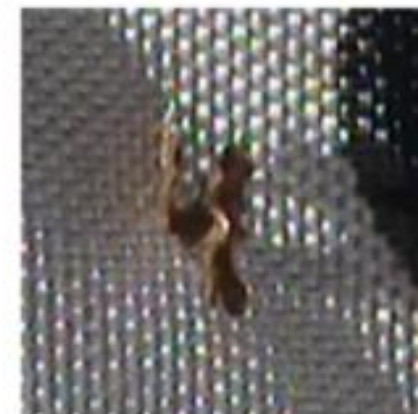
- CSA had a desire to image an old potential MMOD strike on the SSRMS
- ISAG developed a plan to use the SPDM arm OTCM camera and DTO VIPIR camera.
- Video of the area of interest was acquired from several different arm positions and wrist rotations to allow creation of stereo imagery for analysis.
- Provided a valuable test of focused inspection capability using existing and planned ISS cameras (VIPIR2 and “Dextre Deployable Vision System” a.k.a. “Dextre Operated Camera”).
