# Full-Scale Test and Analysis Results of a PRSEUS Fuselage Panel to Assess Damage-Containment Features

Andrew Bergan<sup>1</sup>, John G. Bakuckas, Jr.<sup>2</sup>, Andrew Lovejoy<sup>3</sup>,  
Dawn Jegley<sup>3</sup>, Kim Linton<sup>4</sup>, Albert Neal<sup>4</sup>, Greg Korkosz<sup>5</sup>,  
Jonathan Awerbuch<sup>6</sup>, Tein-Min Tan<sup>6</sup>

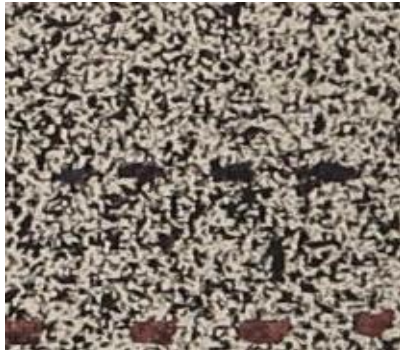
After Second Impact

Exterior

Stitch

Flange Edge

Broken  
fiber

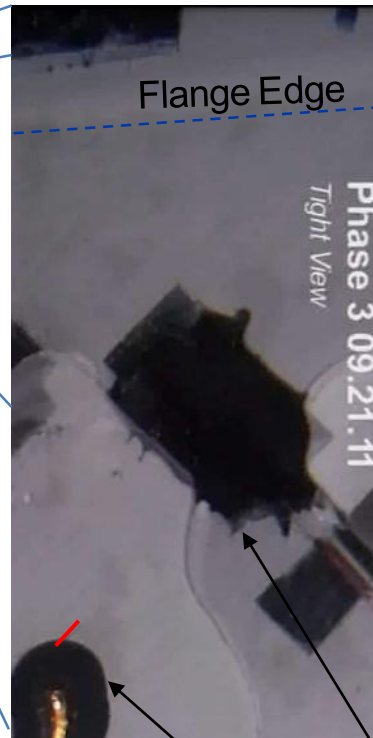
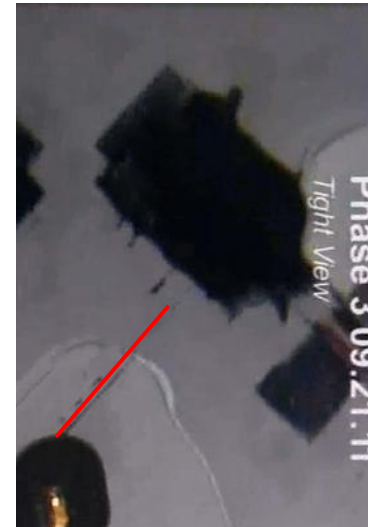
- Damage initiation: 1P + 54% DLL (interior first)
- Damage propagation slow and stable at 45° (surface ply dir.)
- Failure by matrix splitting
