KSC Ice/Frost/Debris Assessment For Space Shuttle Mission STS-30R

May 1989

KSC
ICE/FROST/DEBRIS ASSESSMENT
FOR
SPACE SHUTTLE MISSION
STS-30R
MAY 4, 1989

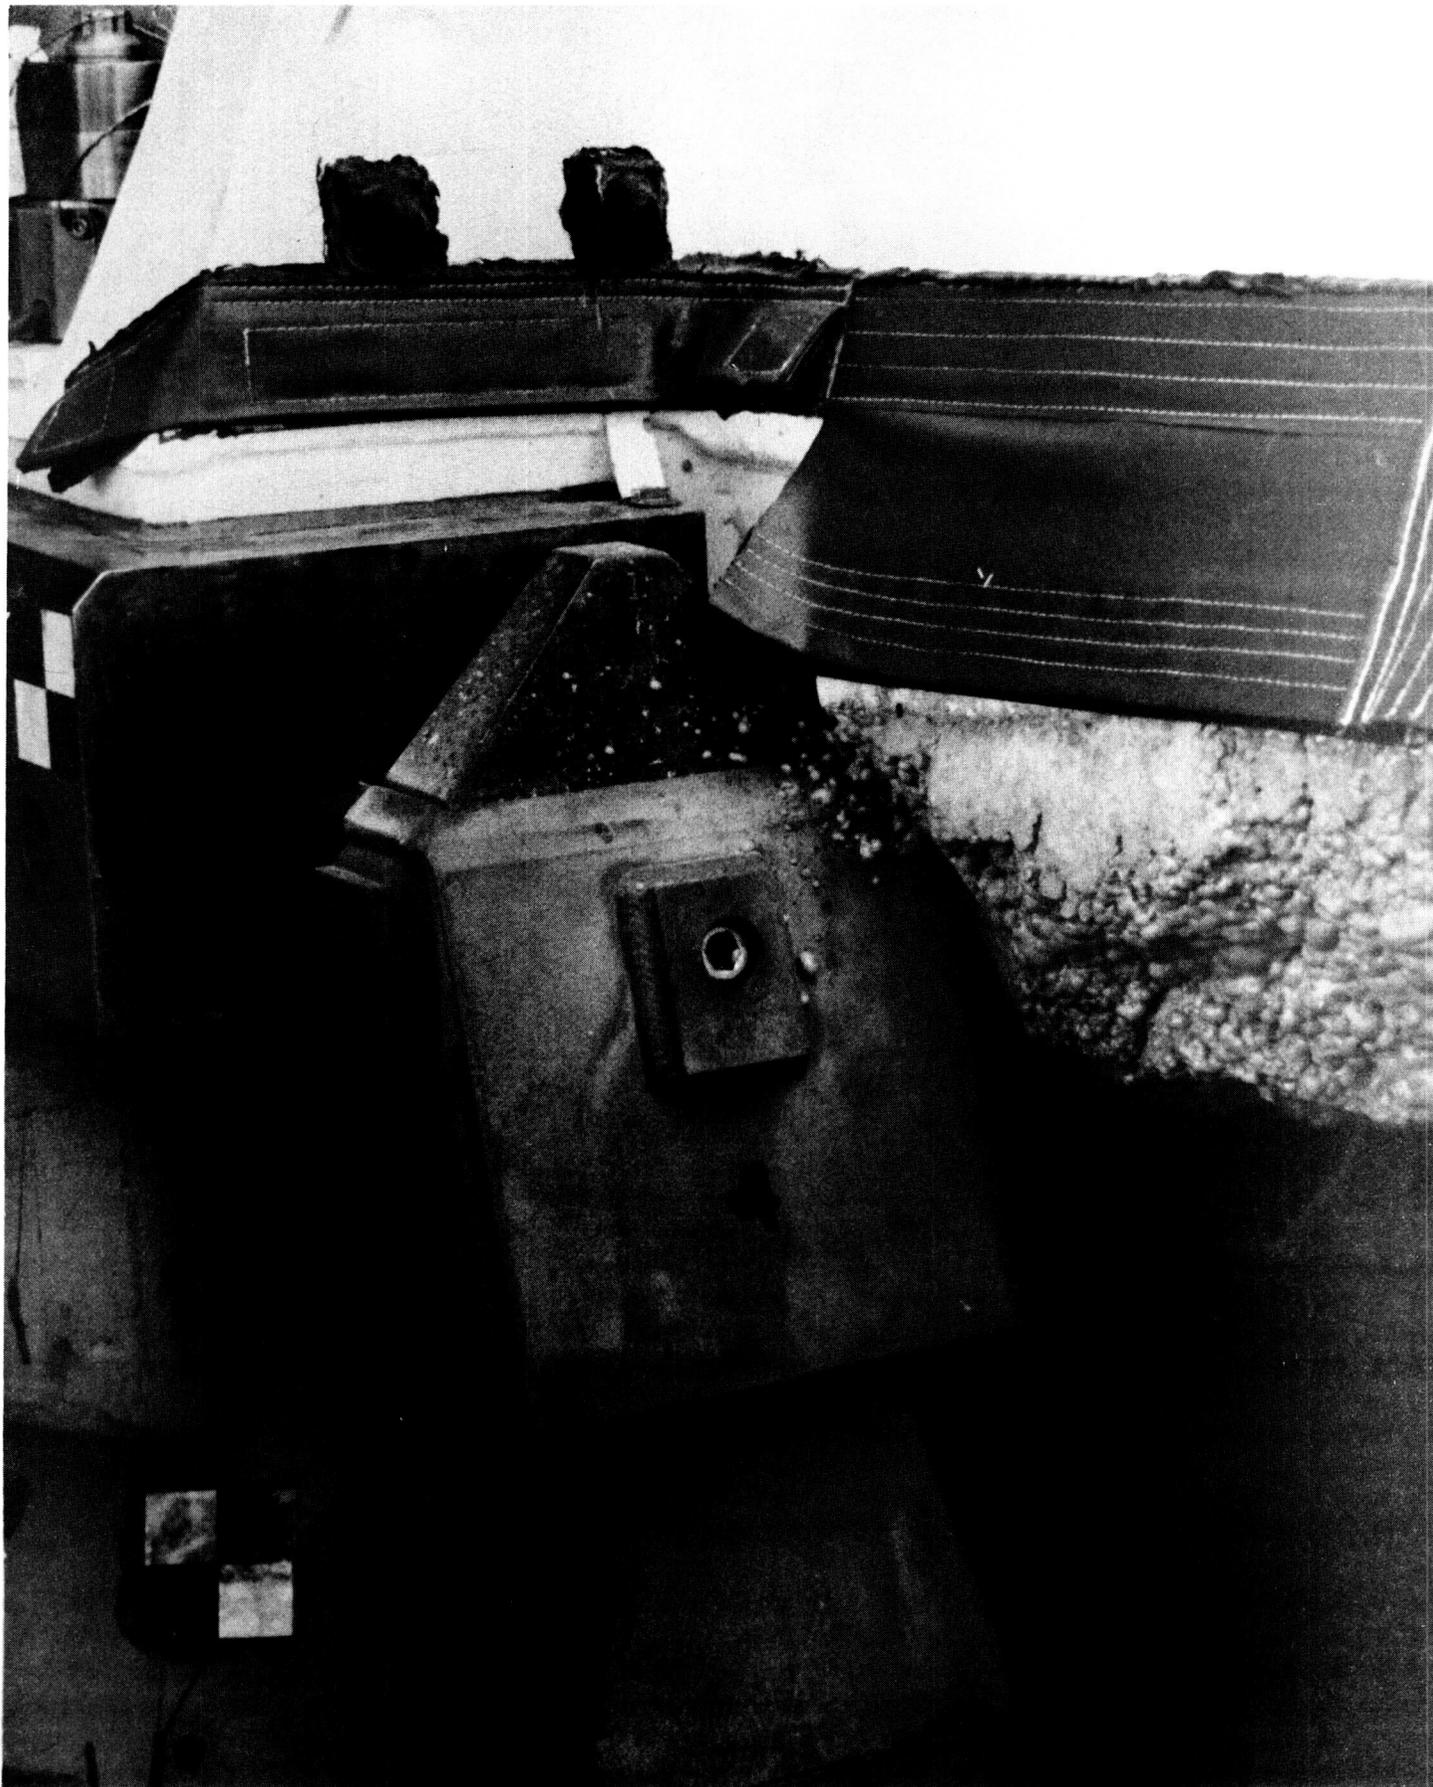
SRB AFT SKIRT INSTAFOAM SHOULD BE TRIMMED TO
ALLOW CLEARANCE AROUND HOLDDOWN POST

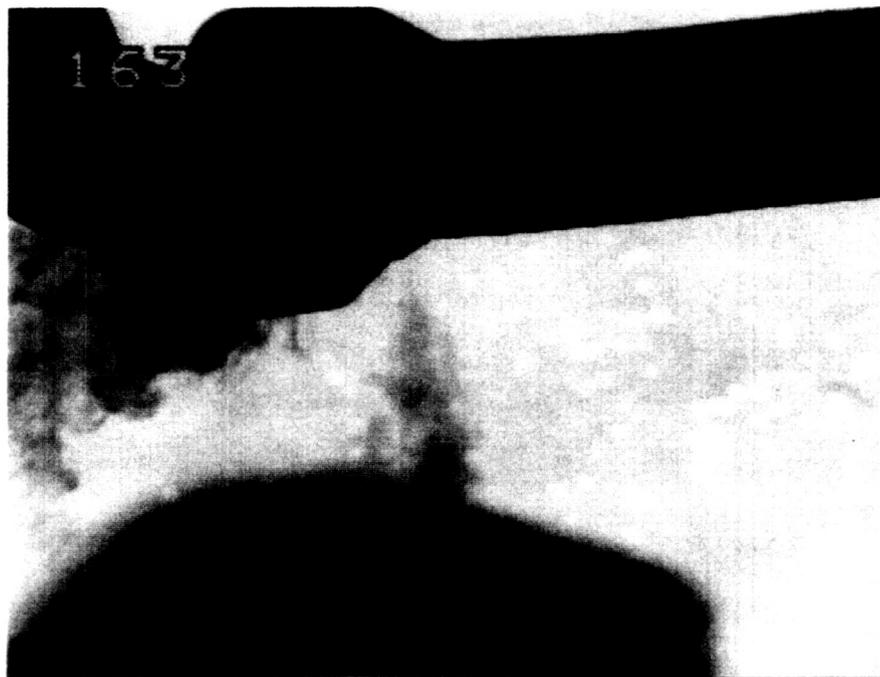
CRYOPUMPING OCCURS ON LH2 RECIRCULATION LINE DURING TANK DRAIN

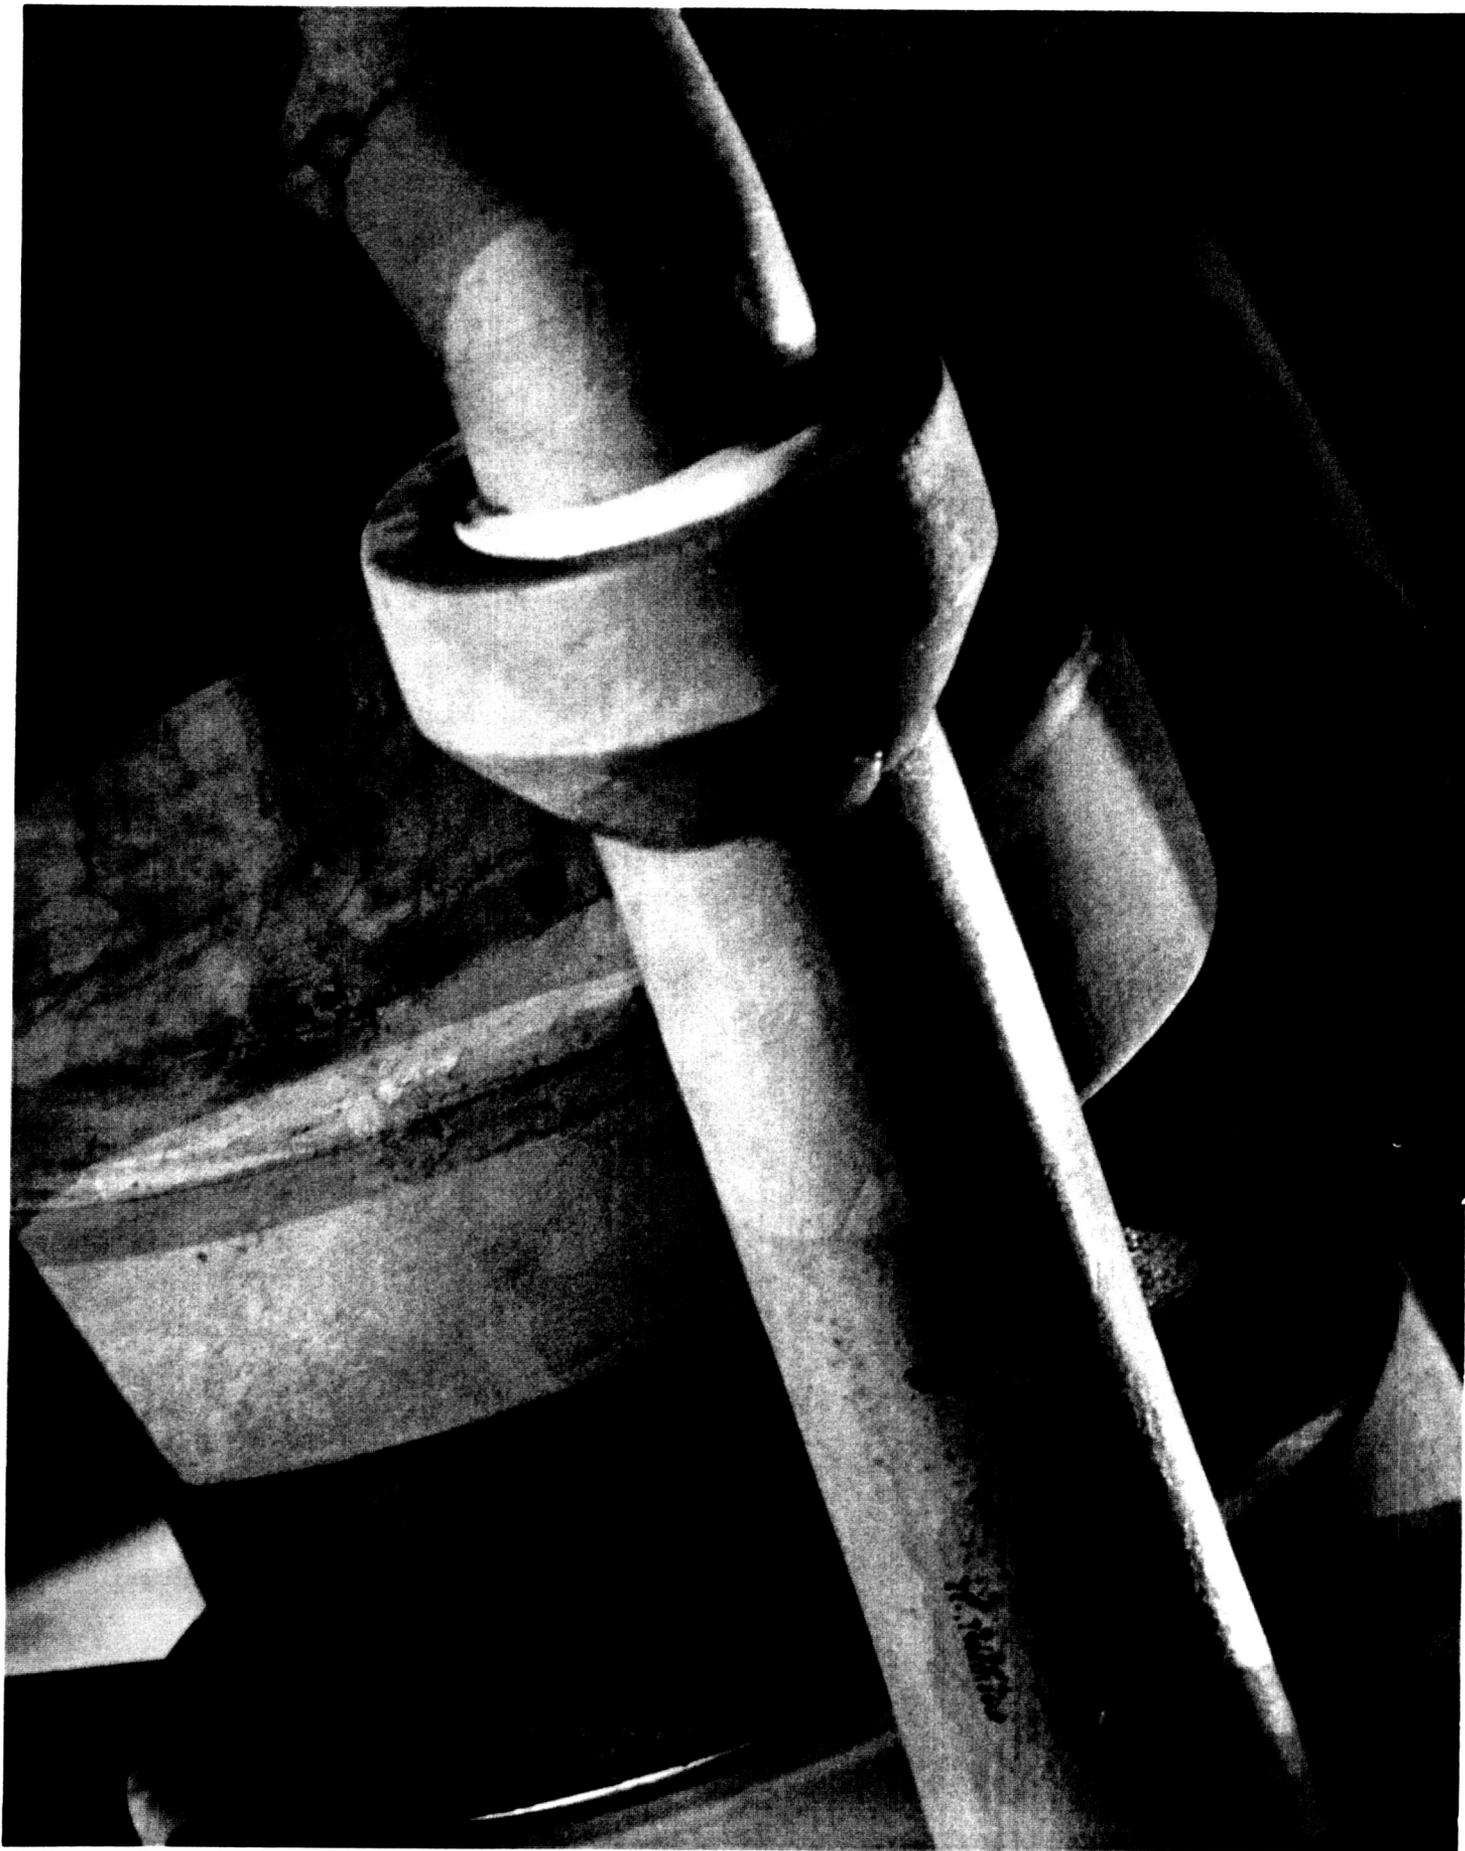
HARD ICE IS PRESENT IN LH2 RECIRCULATION
LINE BELLOWS AND BURST DISC AFTER DRAIN

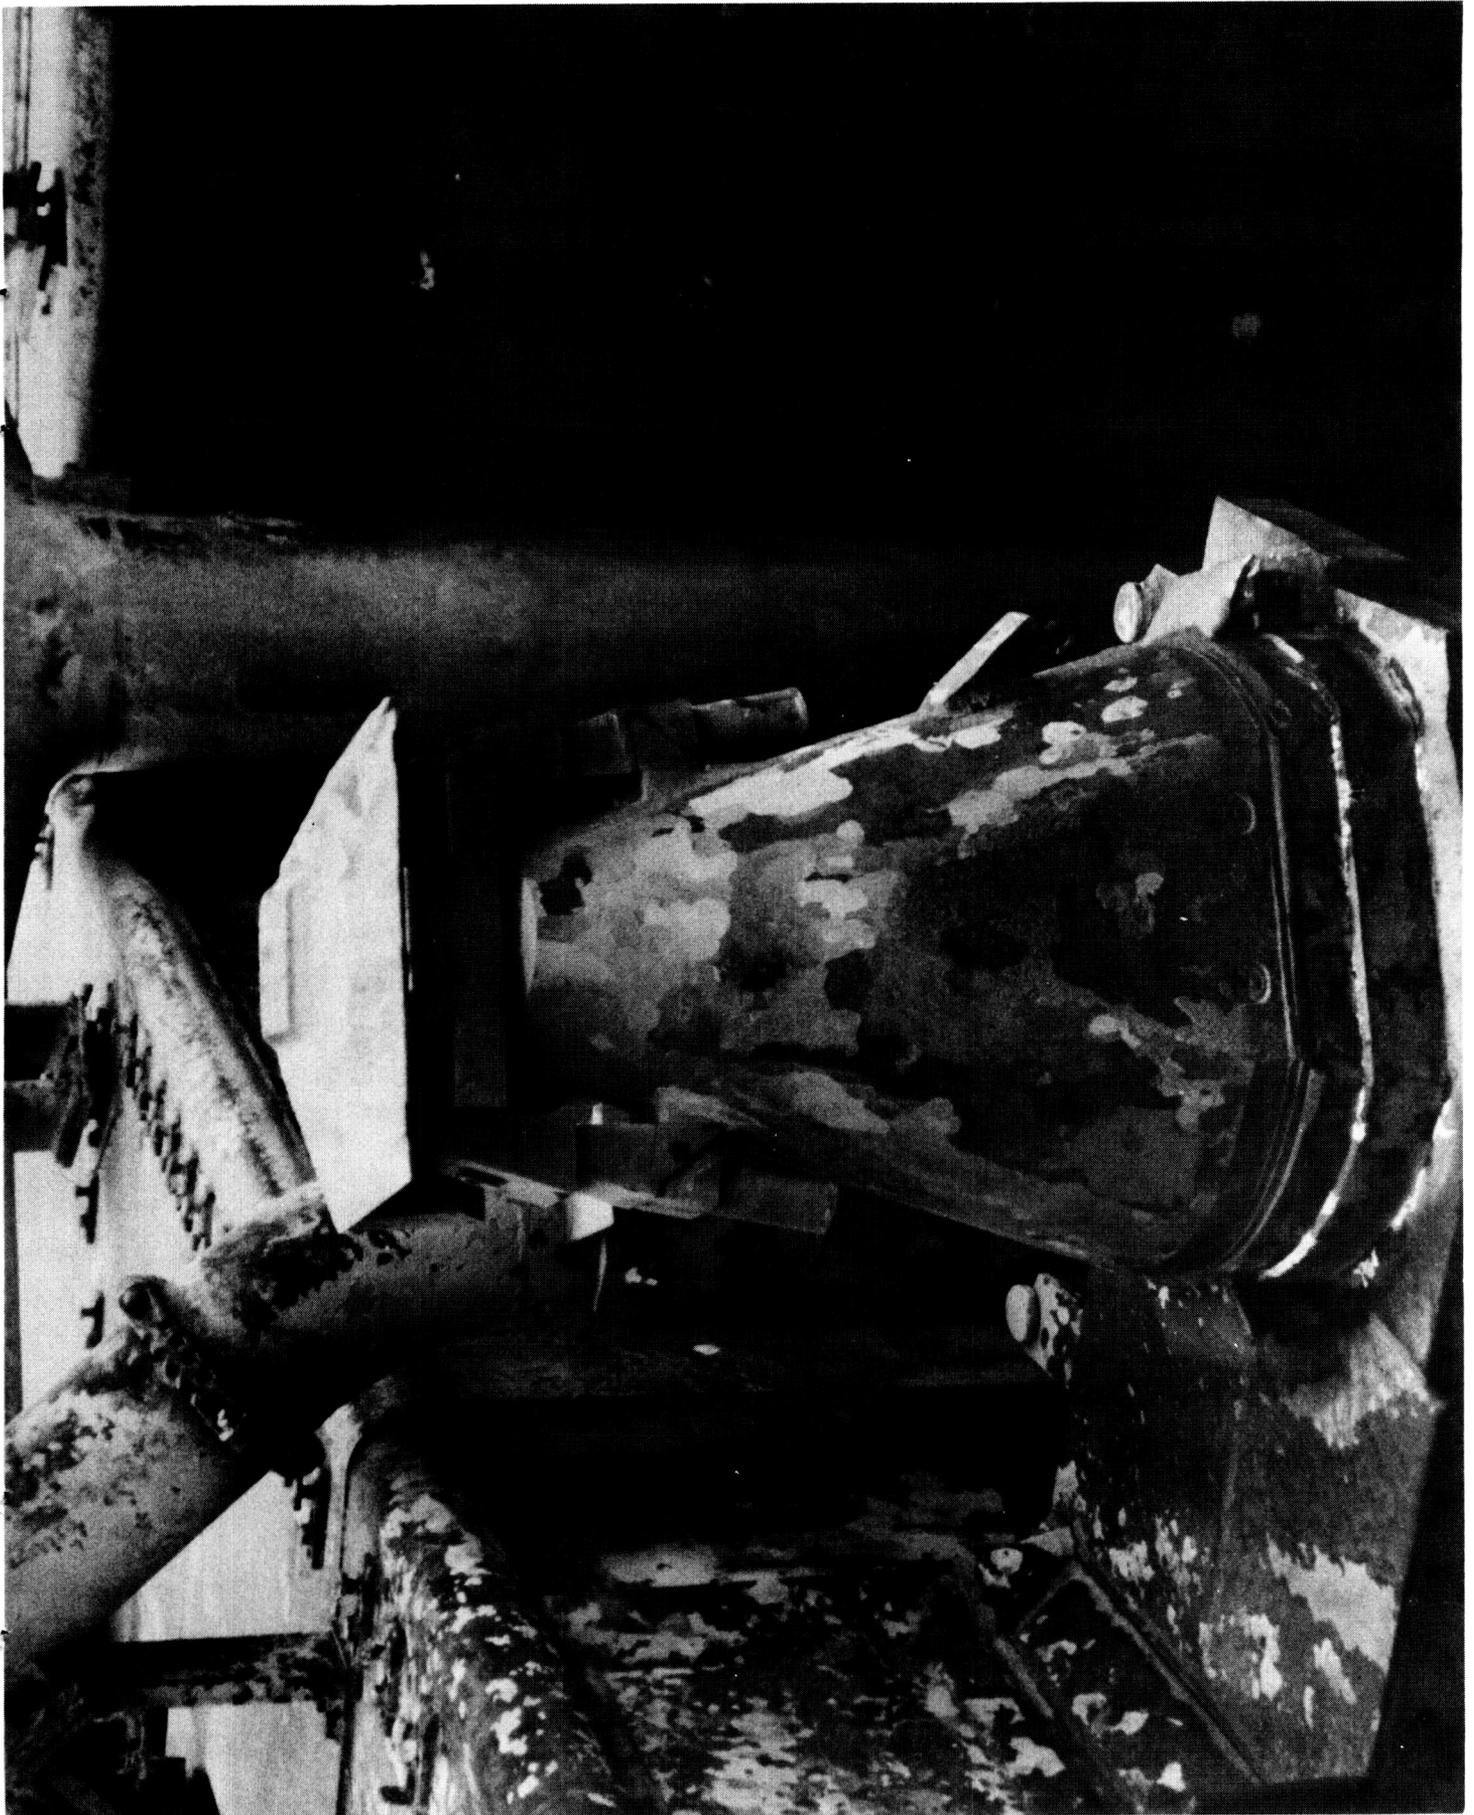
NEGLIGIBLE NORTH HOLDDOWN POST EROSION

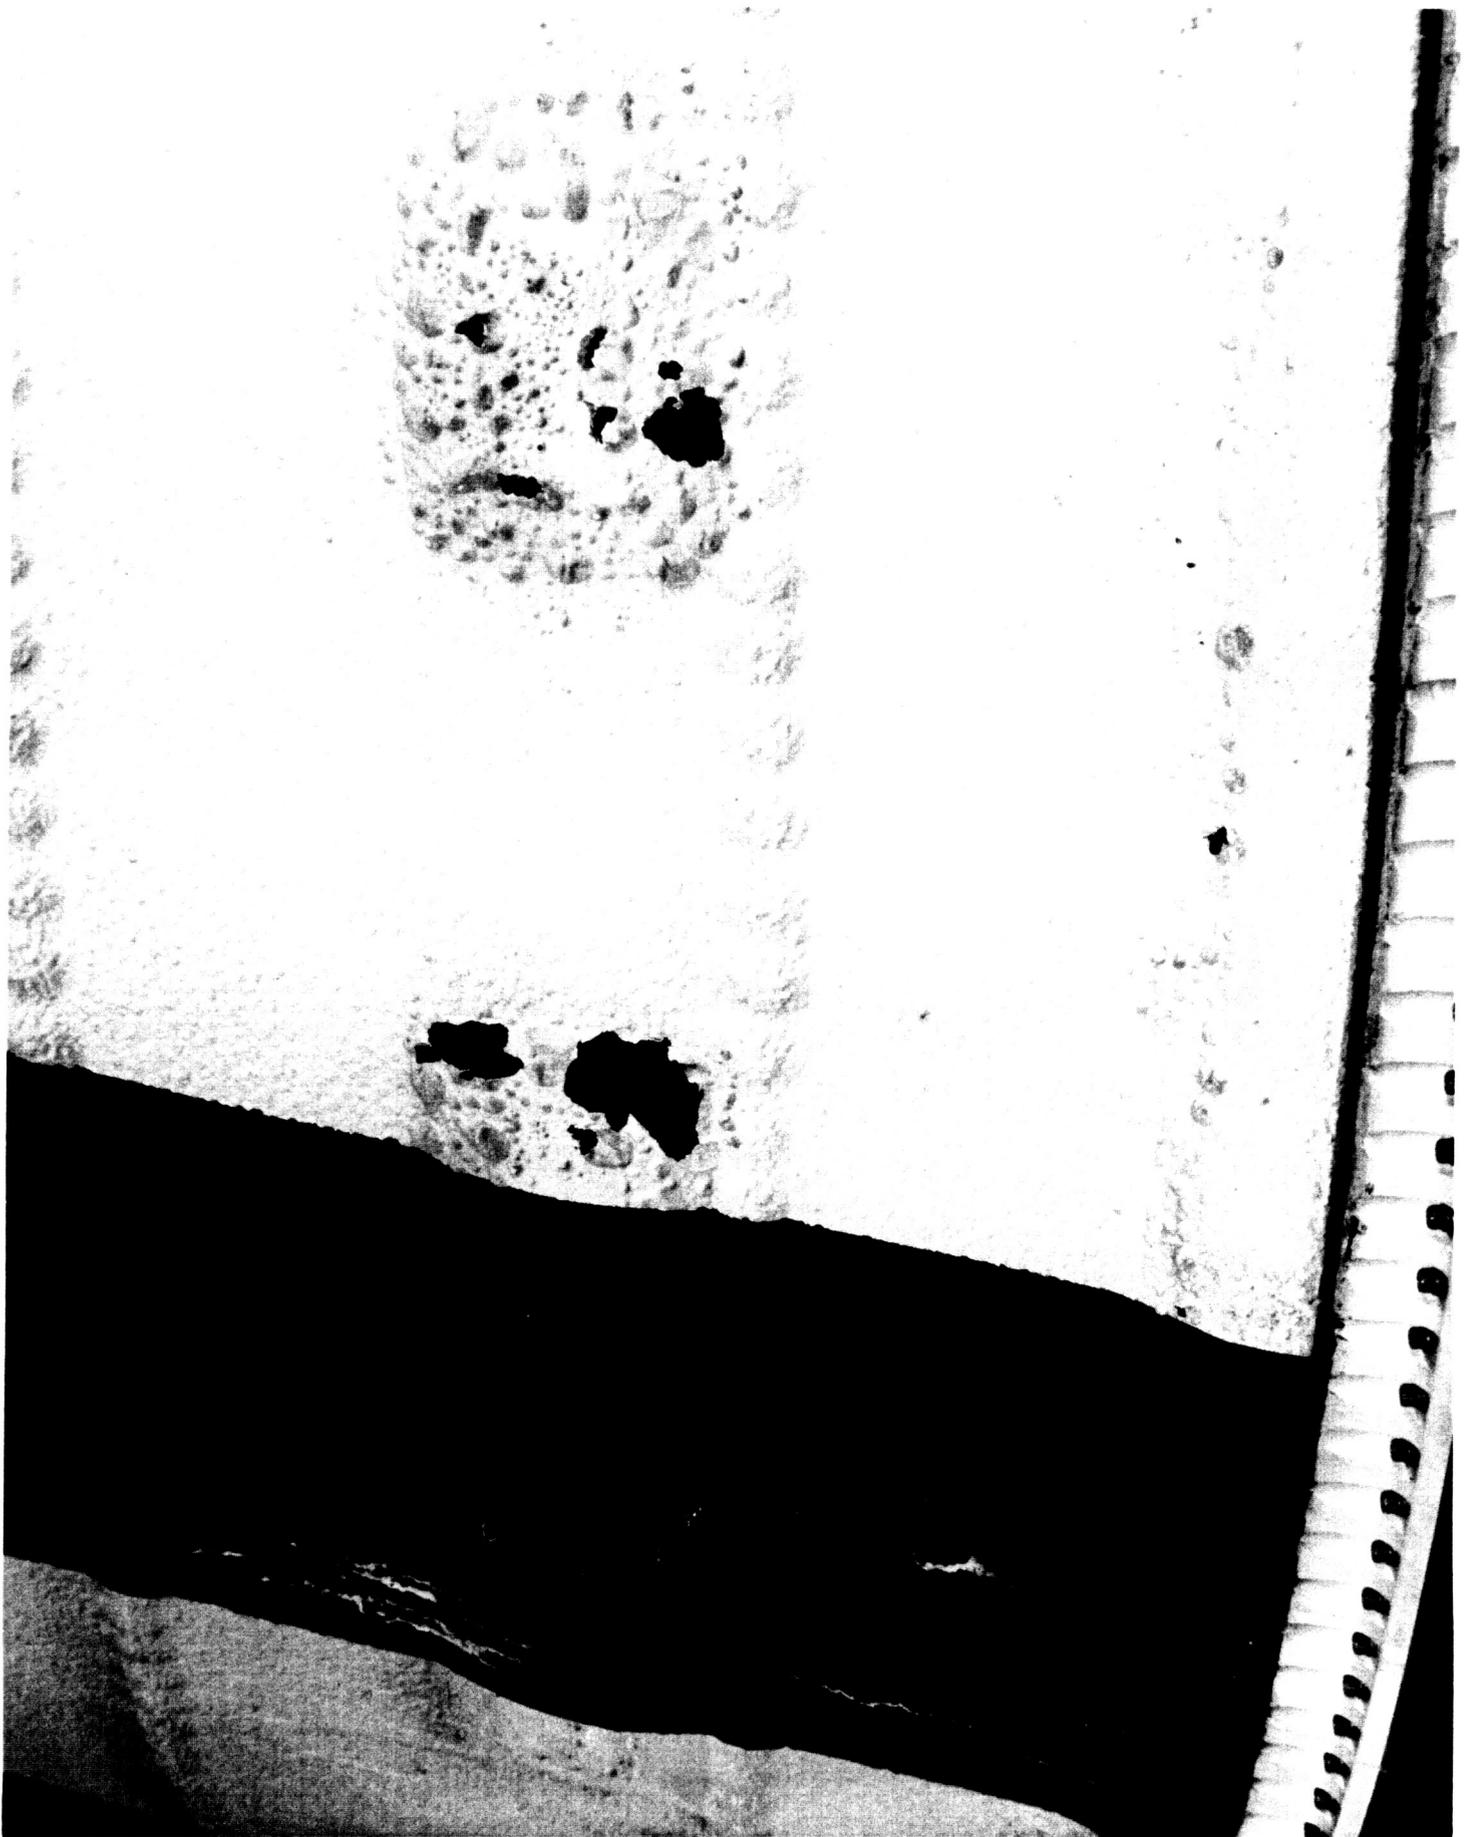
HYPALON PAINT BLISTERS TYPICALLY HAVE
MSA-2 ABLATOR ATTACHED TO THE PAINT

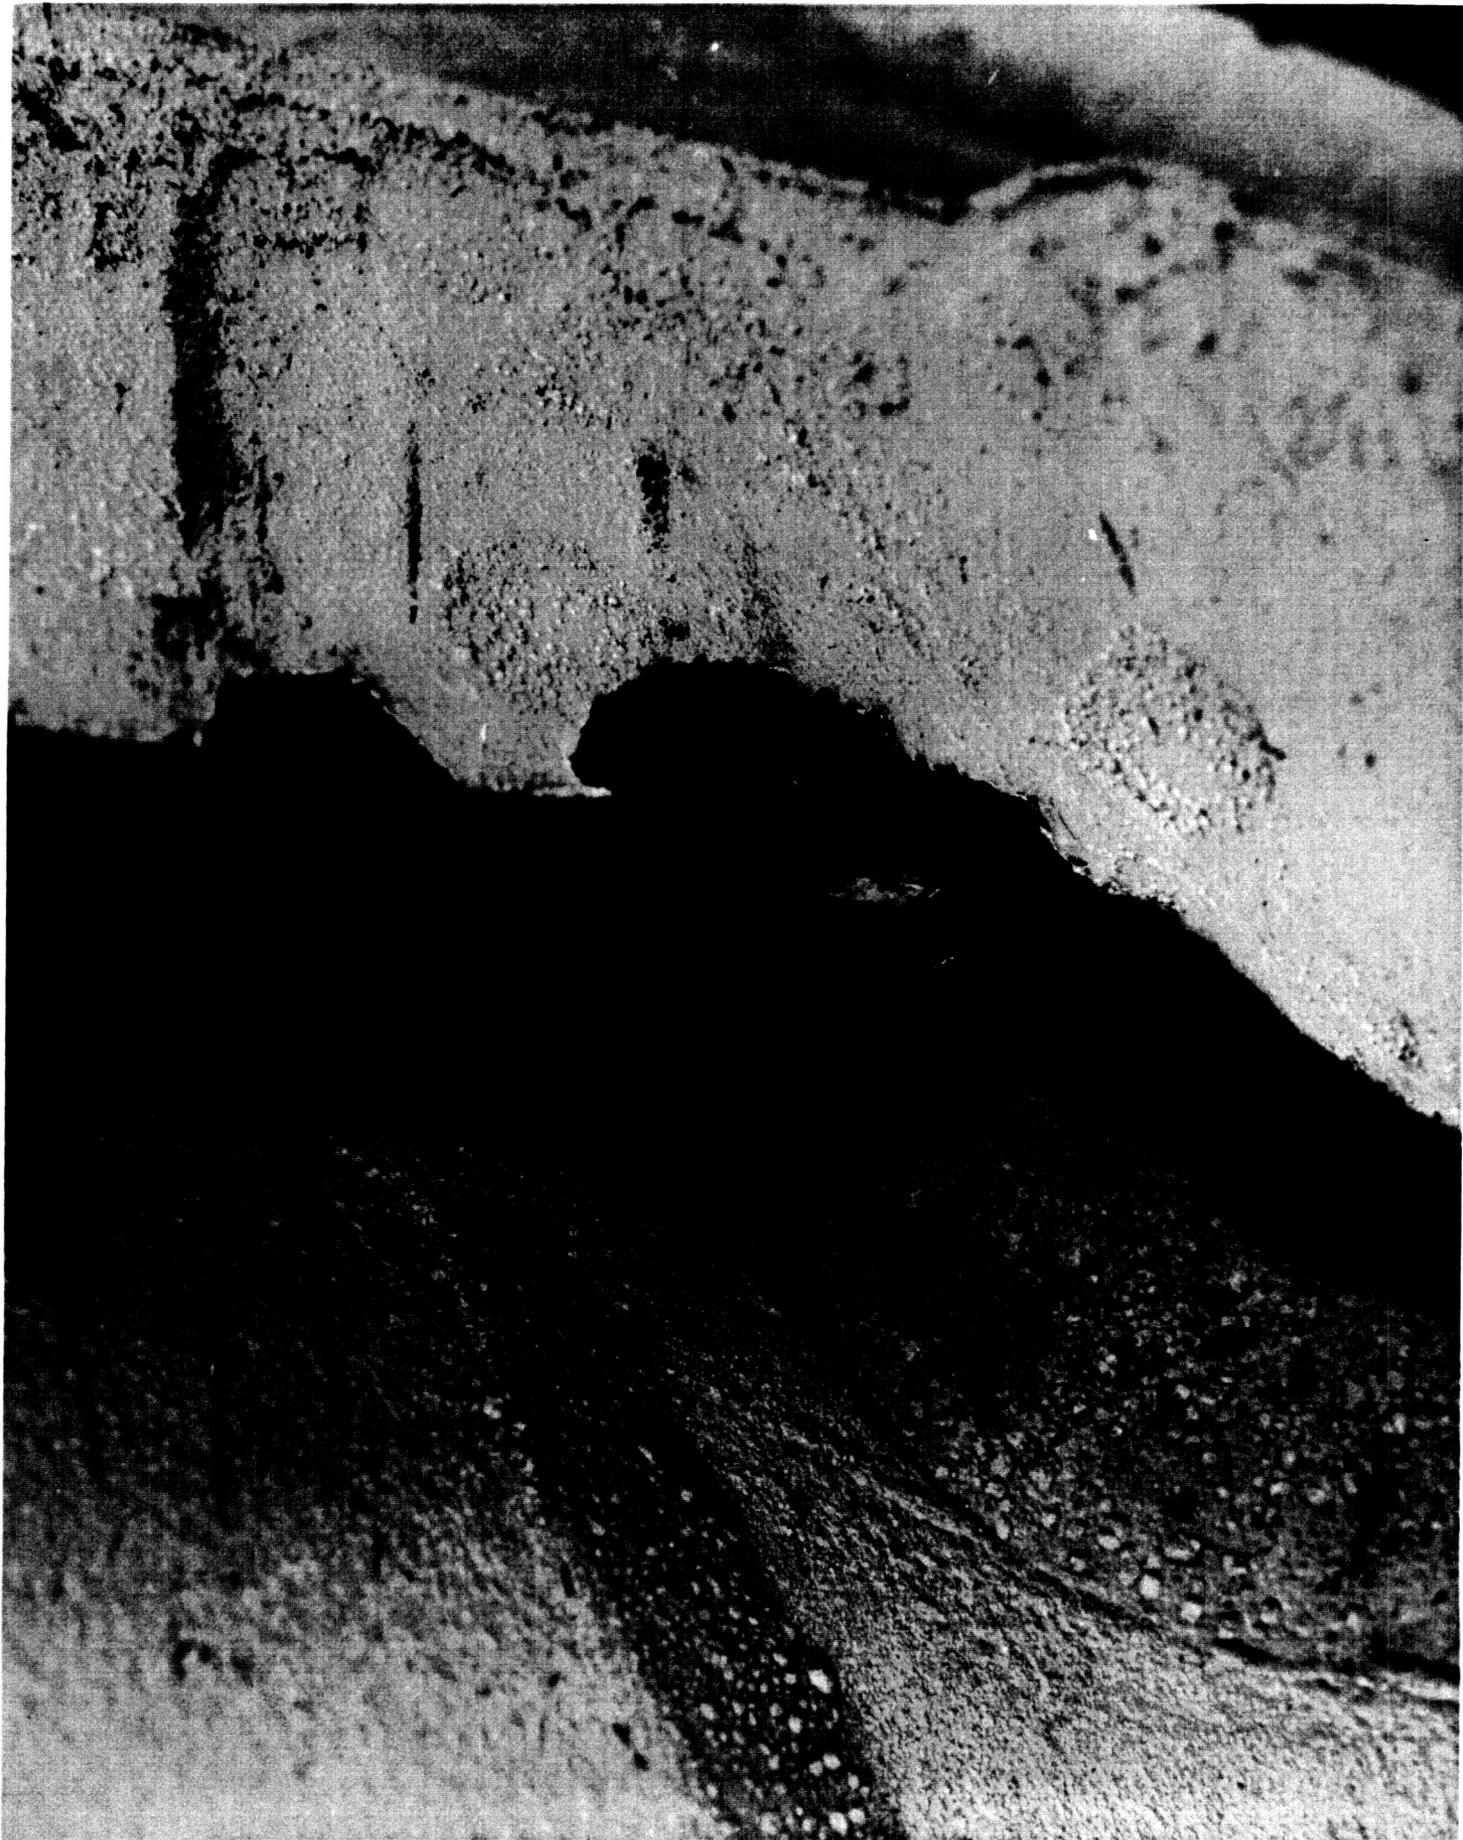
TWO INCH BY ONE INCH DIVOT ON AFT SIDE
OF LH SRB FORWARD SKIRT BANJO FITTING
154

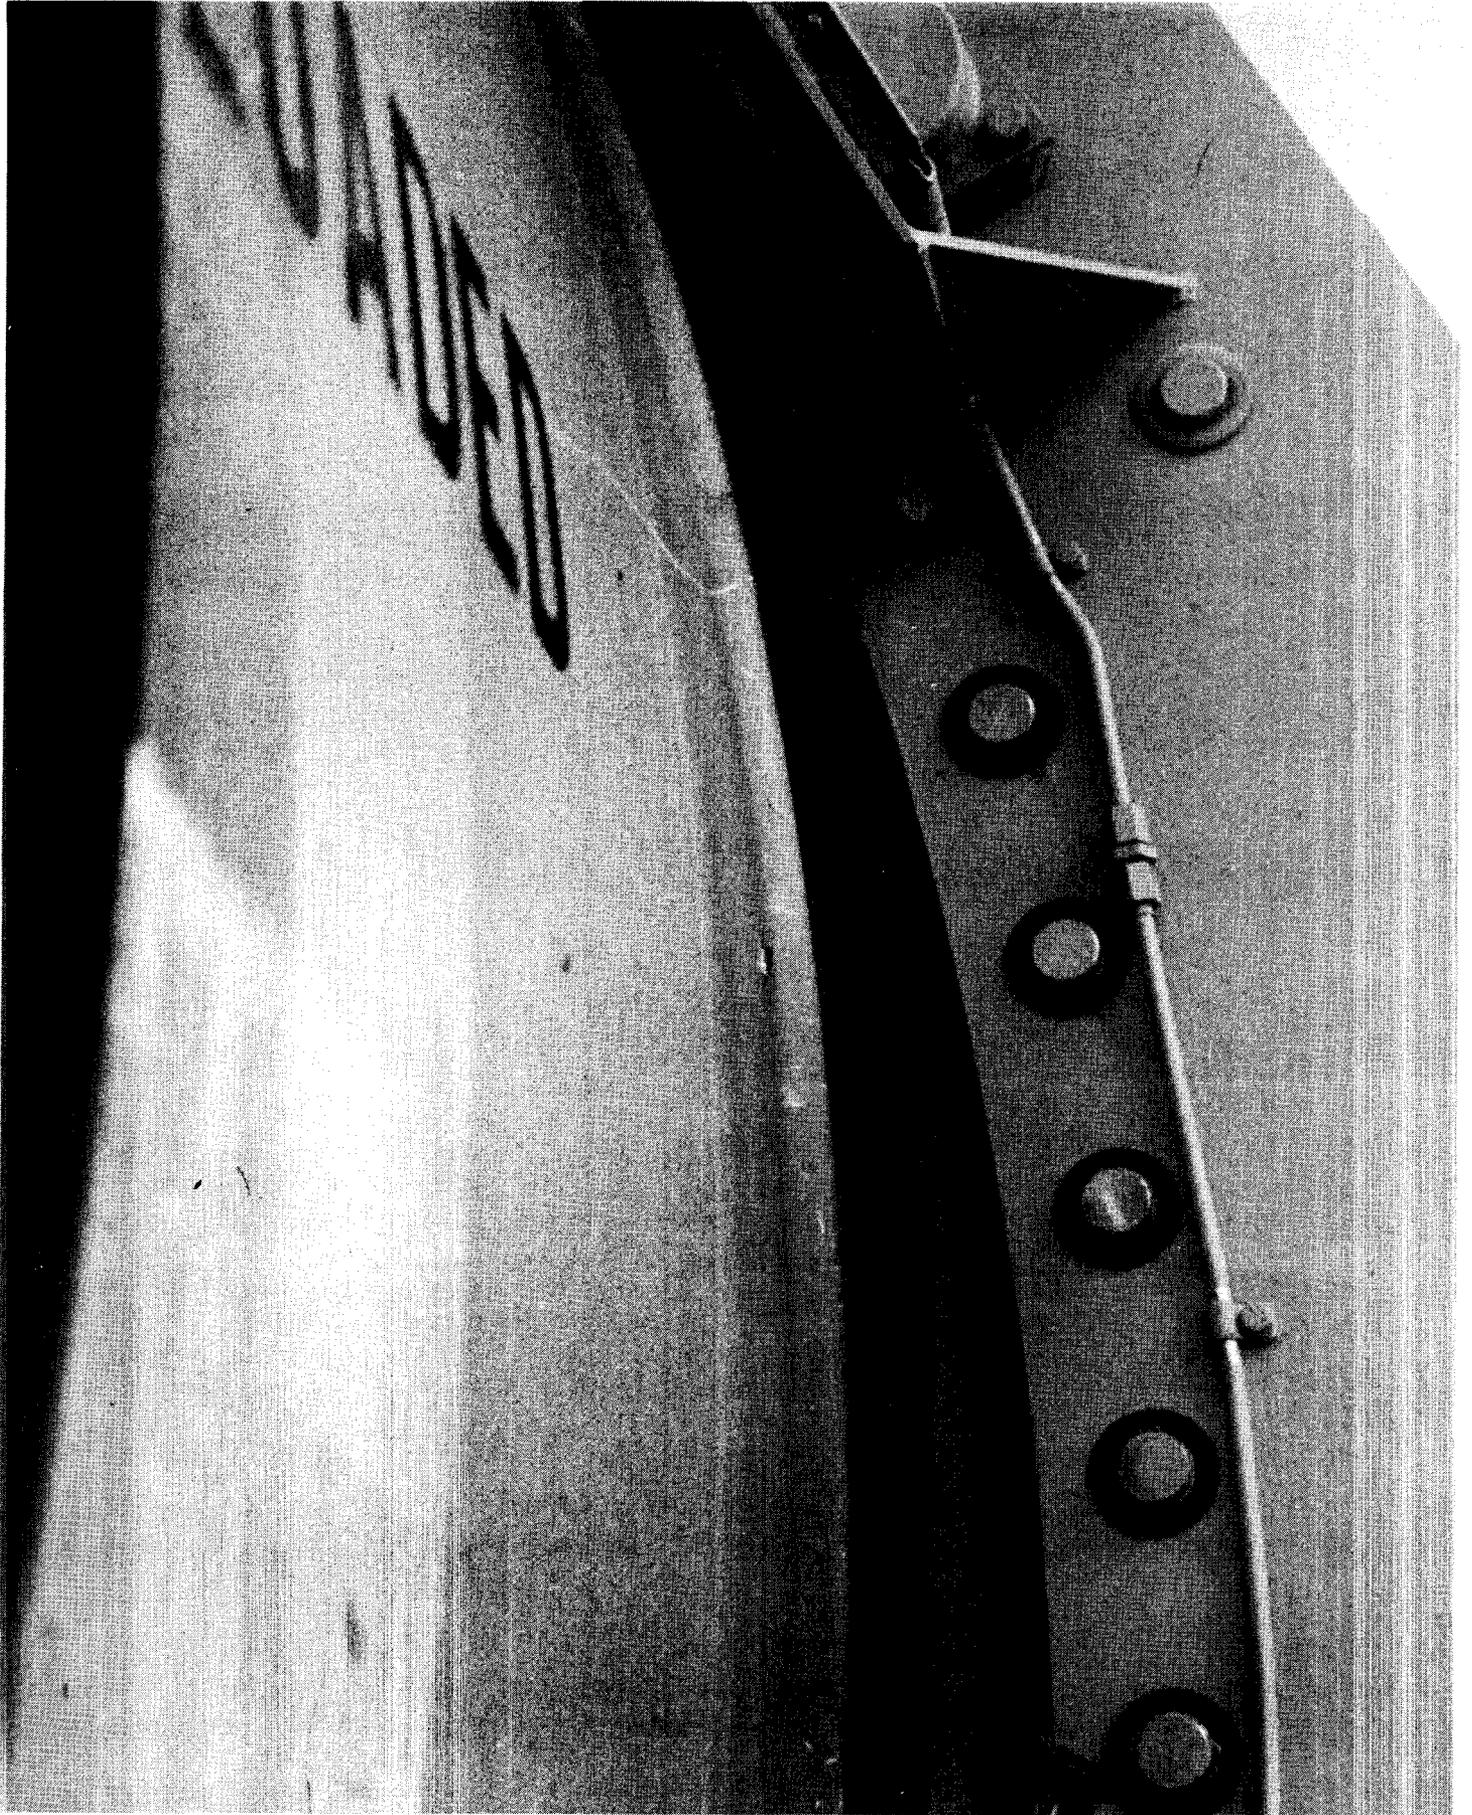
Three factory joint EPDM weather seals showed aft edge debond regions on the LH Aft segment allowing sea water intrusion into the joint. No evidence of sooting was found under these debonds. This failure is a corrosion concern.

AFT EDGE DEBOND OF LH AFT FACTORY JOINT EPDM WEATHER SEAL

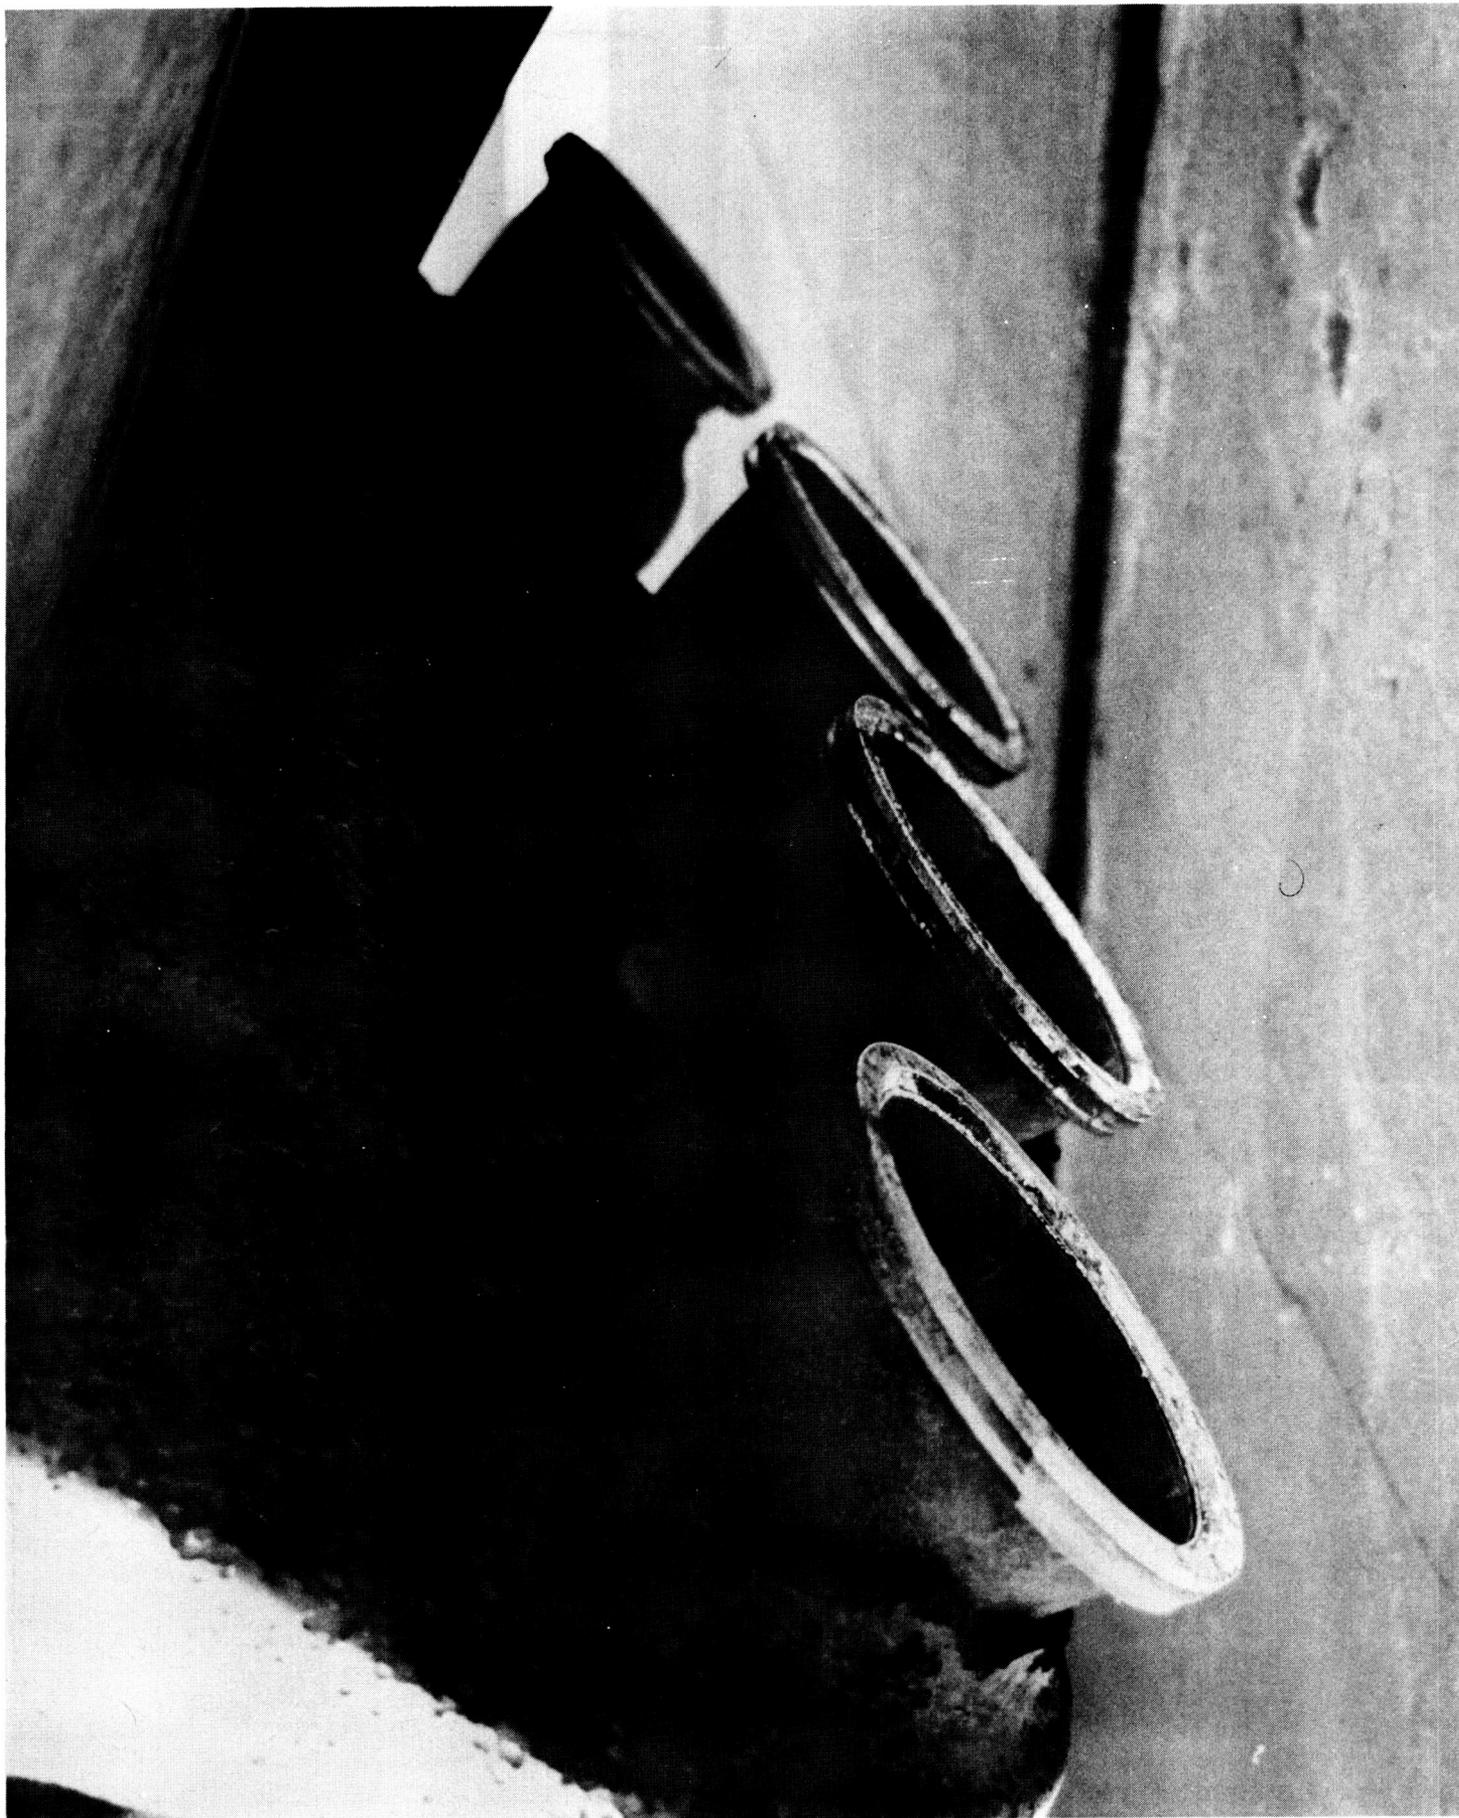
LOSS OF K5NA FROM BSM NOZZLES

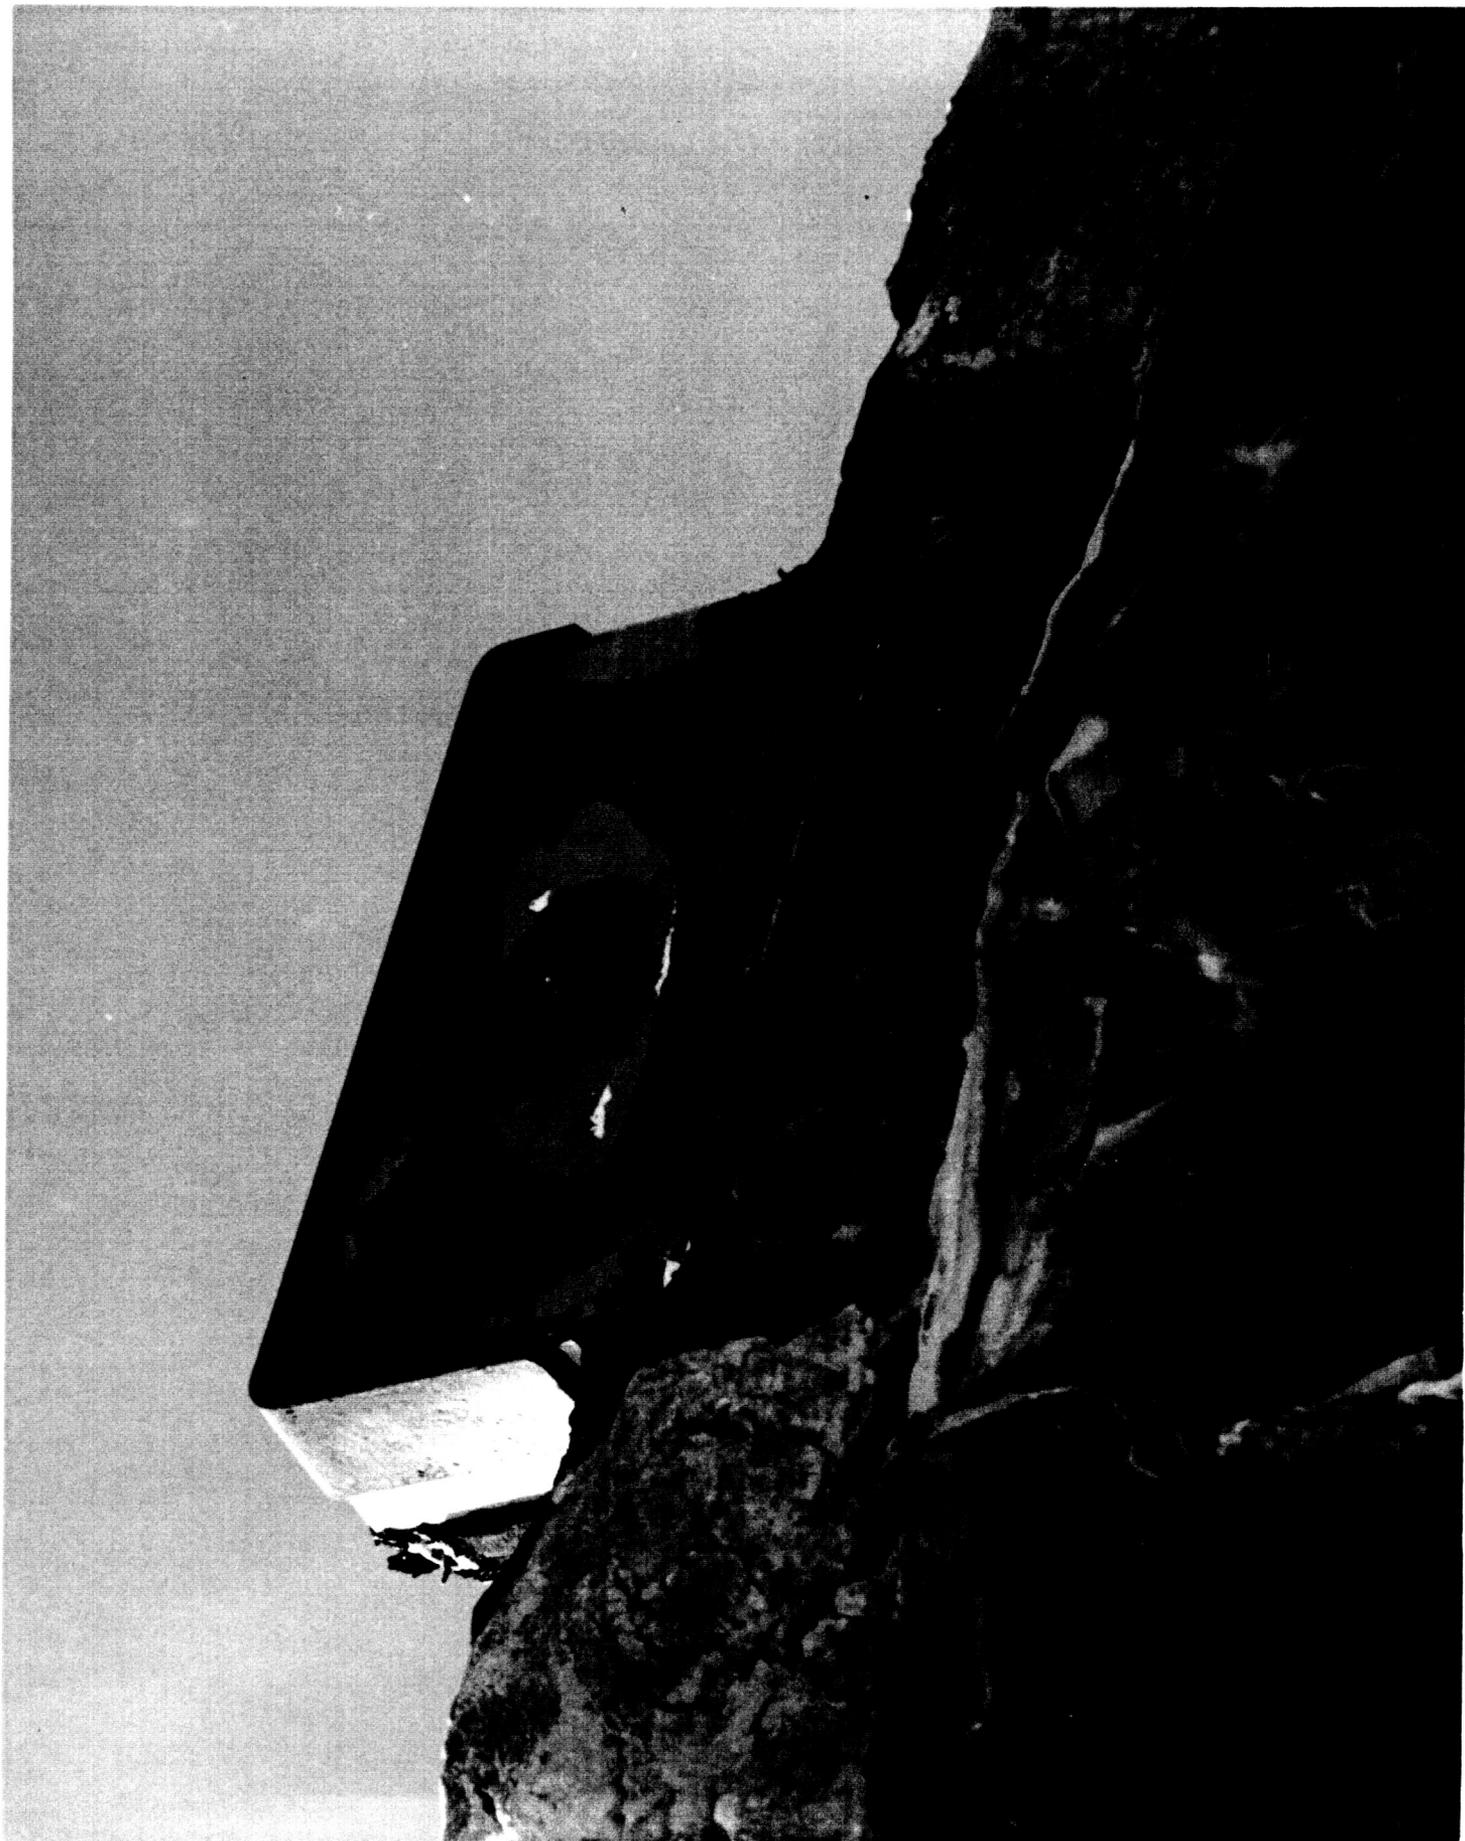
LOSS OF HOLDDOWN POST SHIM MATERIAL PRIOR TO SPLASHDOWN

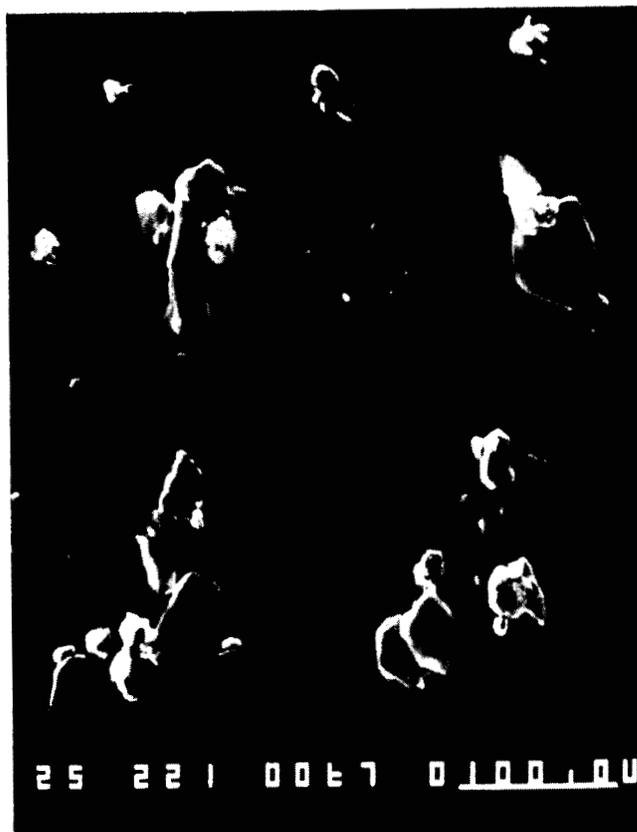
Figure 2
SEM Photomicrograph of Orange Colored
Flakes. #3. 220X

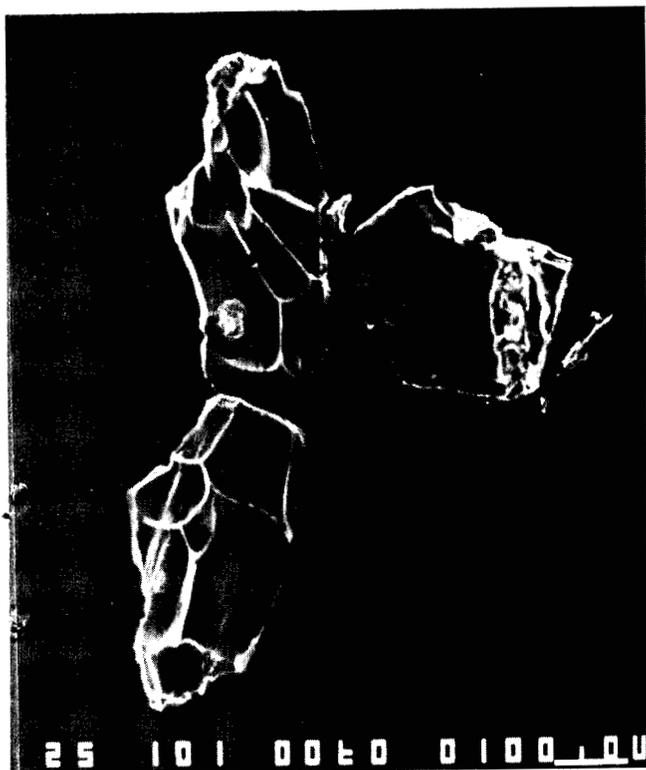
2.2.5 Figure 3 is SEM photomicrograph of black shiny materials to show a combination of the mud-crack patterns and concoidal fracture surfaces.

Figure 3
SEM Photomicrograph of Black Shiny
Materials. #11. 120X
