Debris/Ice/TPS Assessment And Photographic Analysis For Shuttle Mission STS-36

April 1990

DEBRIS/ICE/TPS ASSESSMENT
AND
PHOTOGRAPHIC ANALYSIS
OF
SHUTTLE MISSION STS-36

February 28, 1990

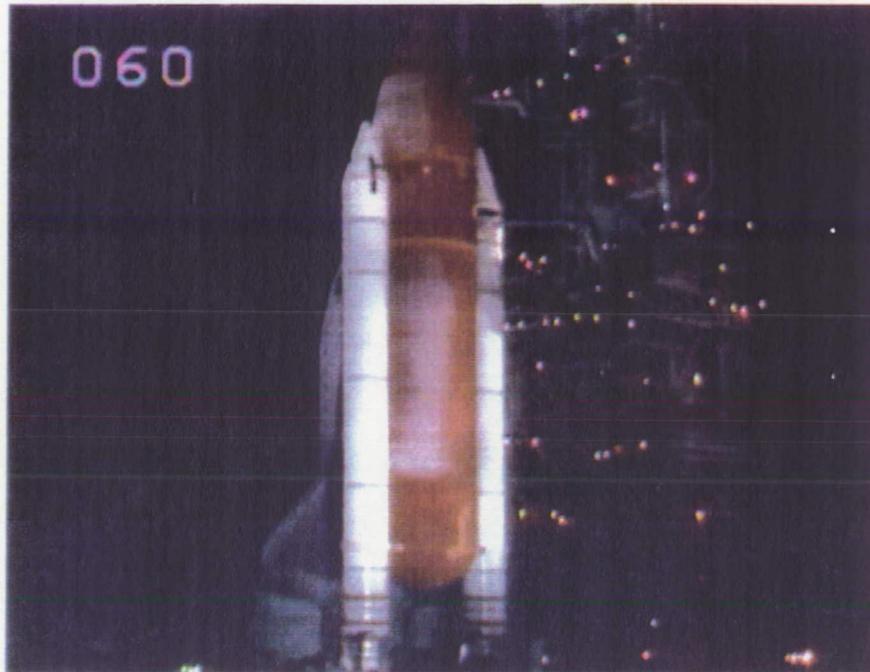
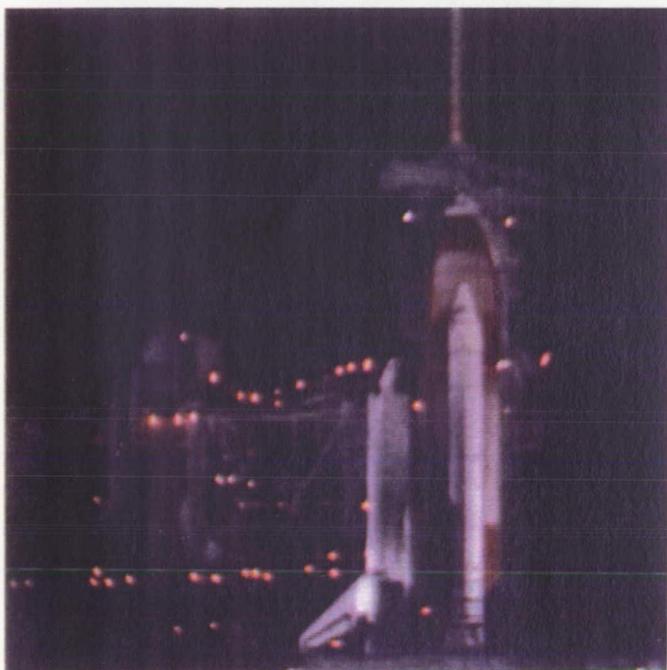
More frost has accumulated on the LO2 and LH2 tanks at the targeted T-0 time as seen on OTV cameras 070, TV-7, 060

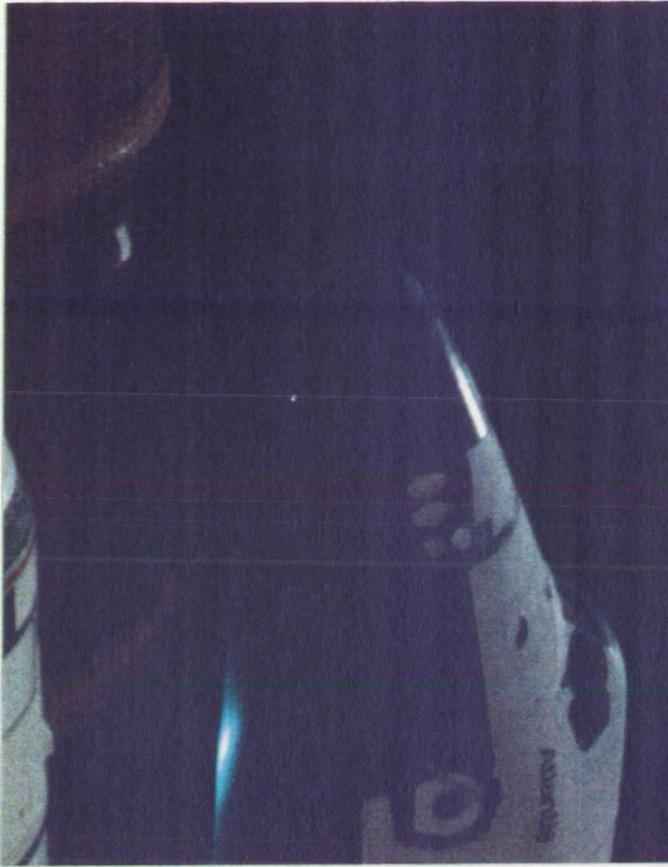
LH FWD RCS thruster paper covers tear just after T-0 and fall past the LH wing at tower clear (E-34, 223)

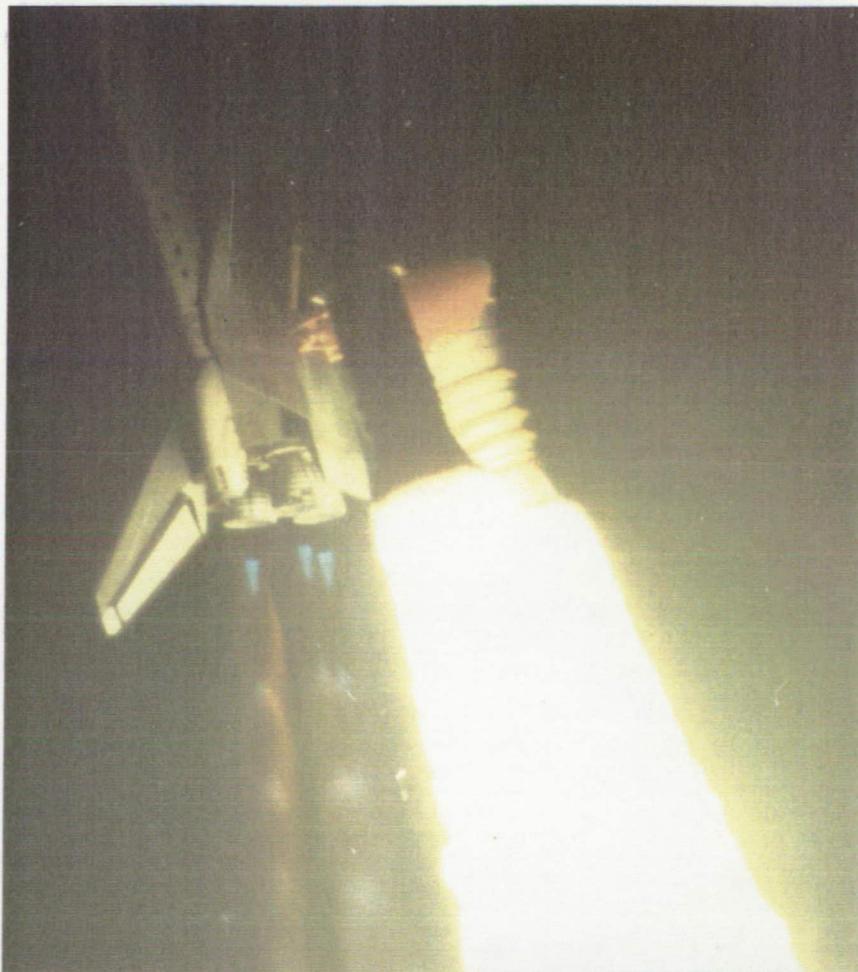
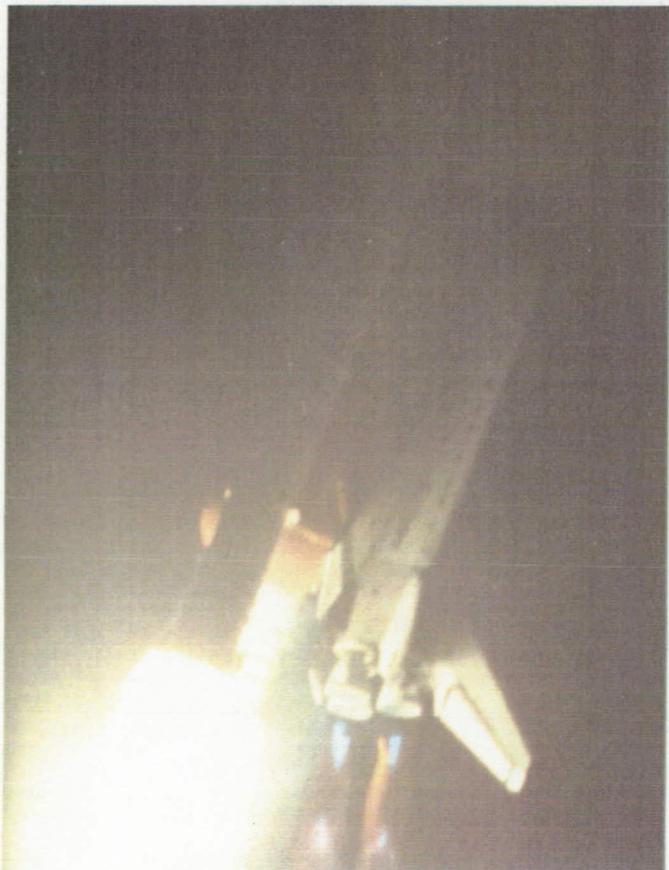
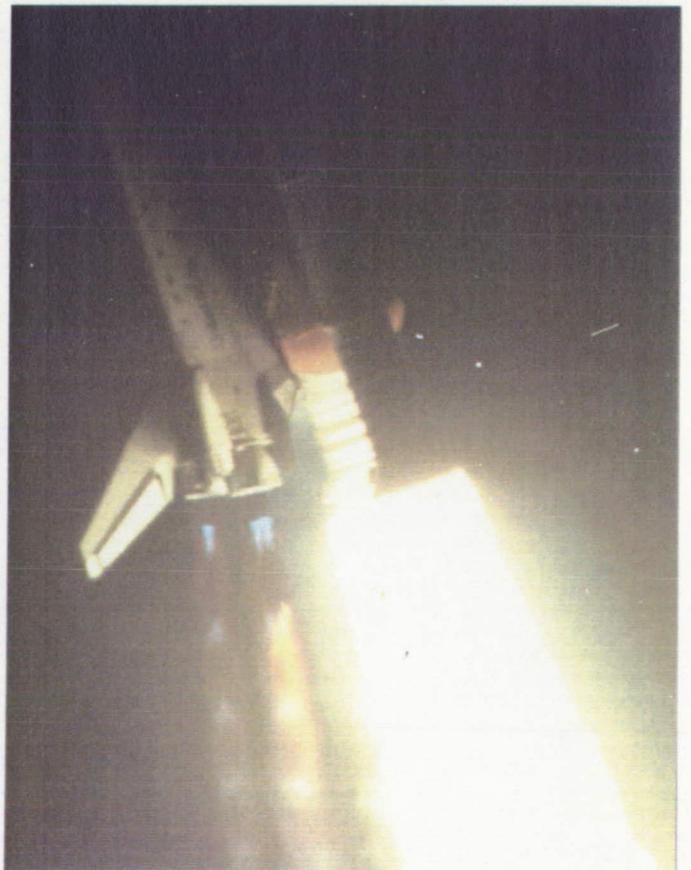
Orange streaks in the SSME plume occur throughout ascent and are caused by pieces of debris entering the plume

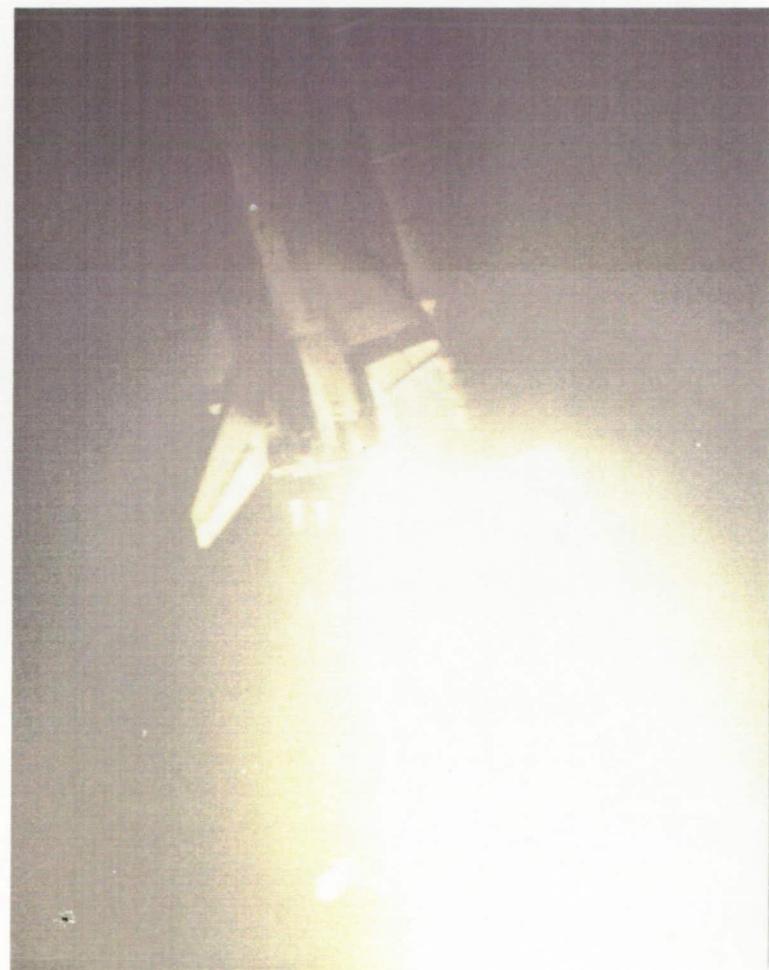
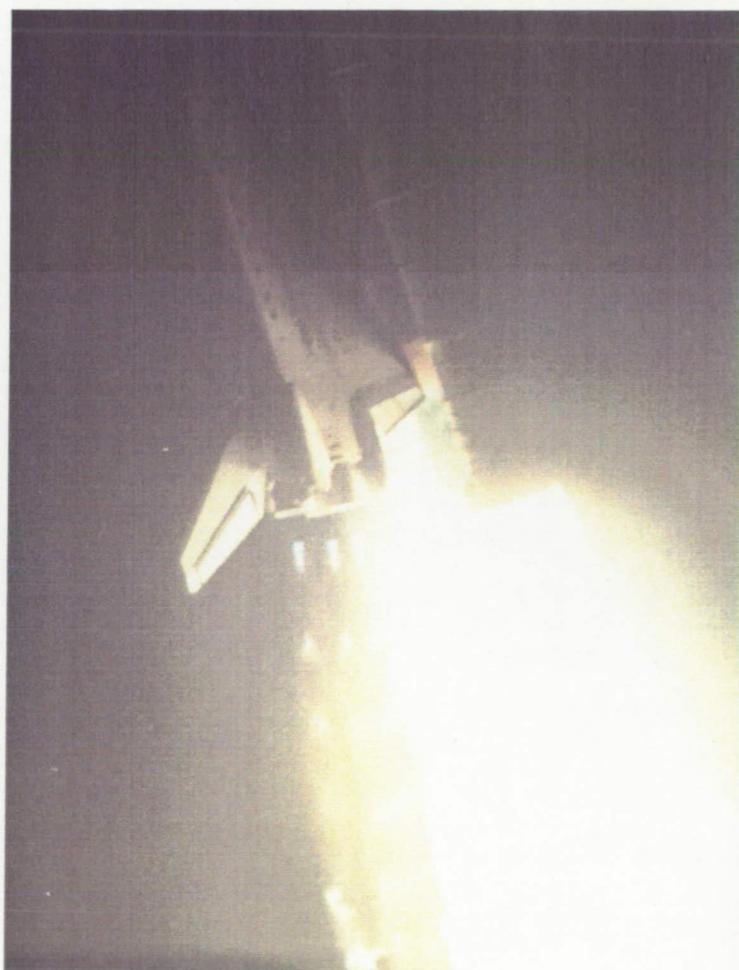
Small pockets of unburned hydrogen may cause these bright puffs in the SSME exhaust plume (E-223)

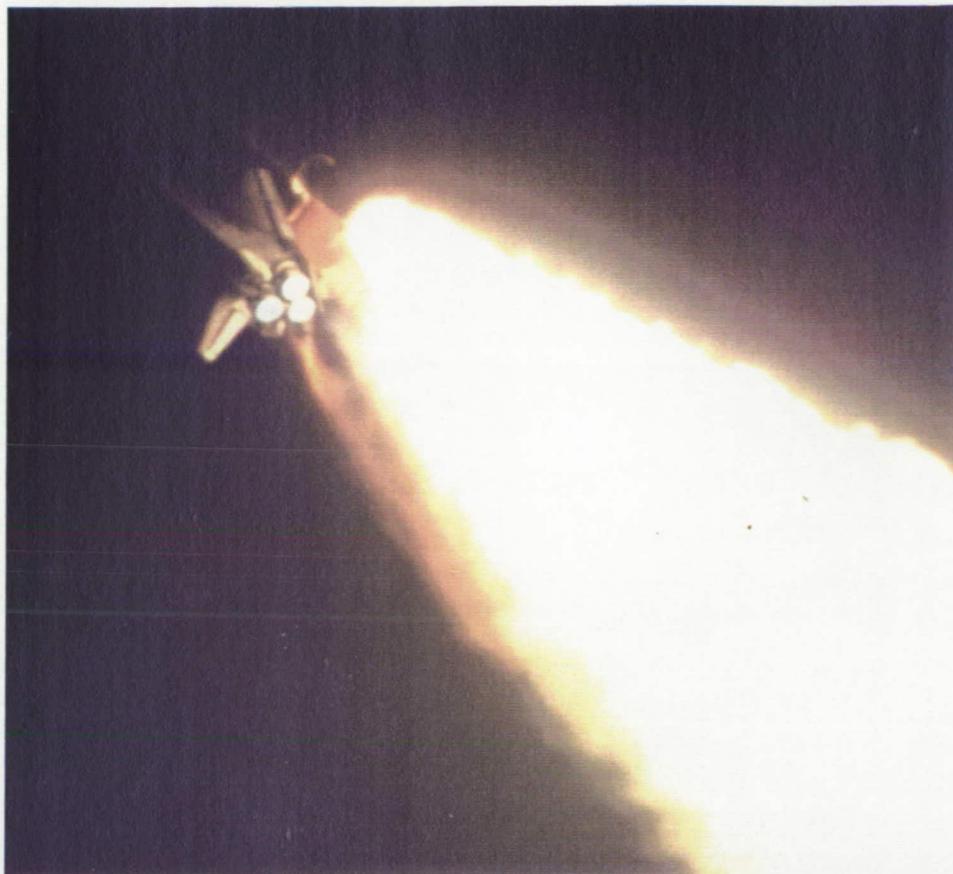
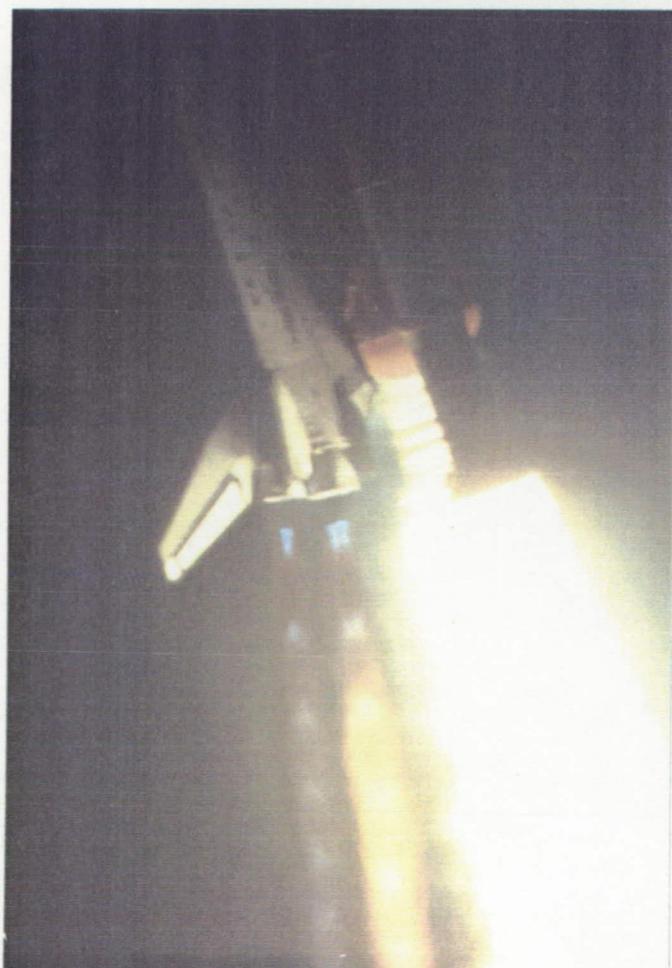
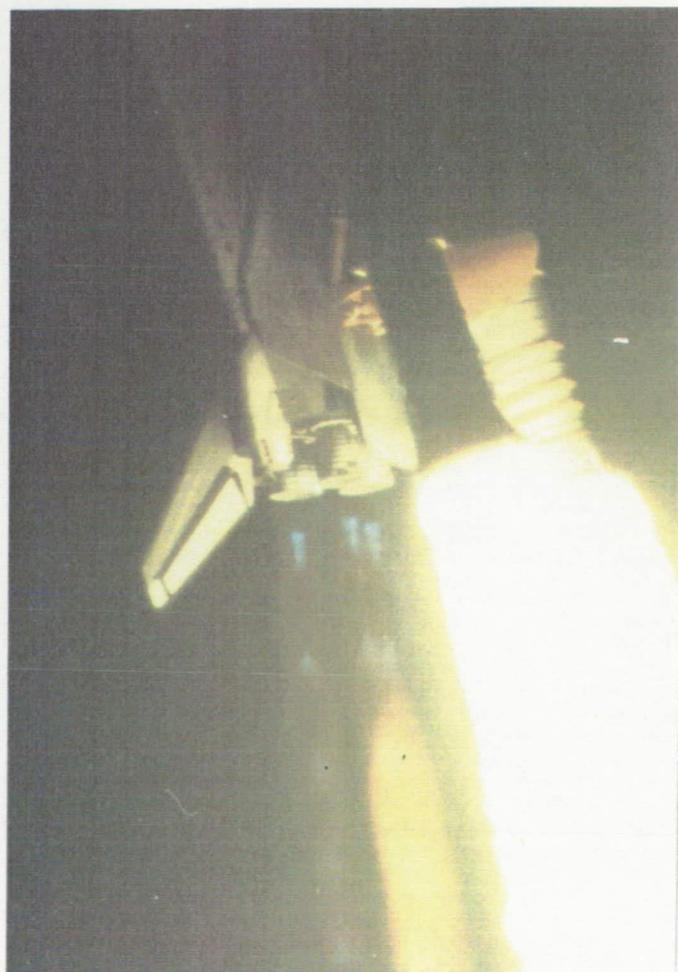
At 54 seconds MET, a large flash occurred in the exhaust plume of either SSME #2 or #3 (E-212, 223)

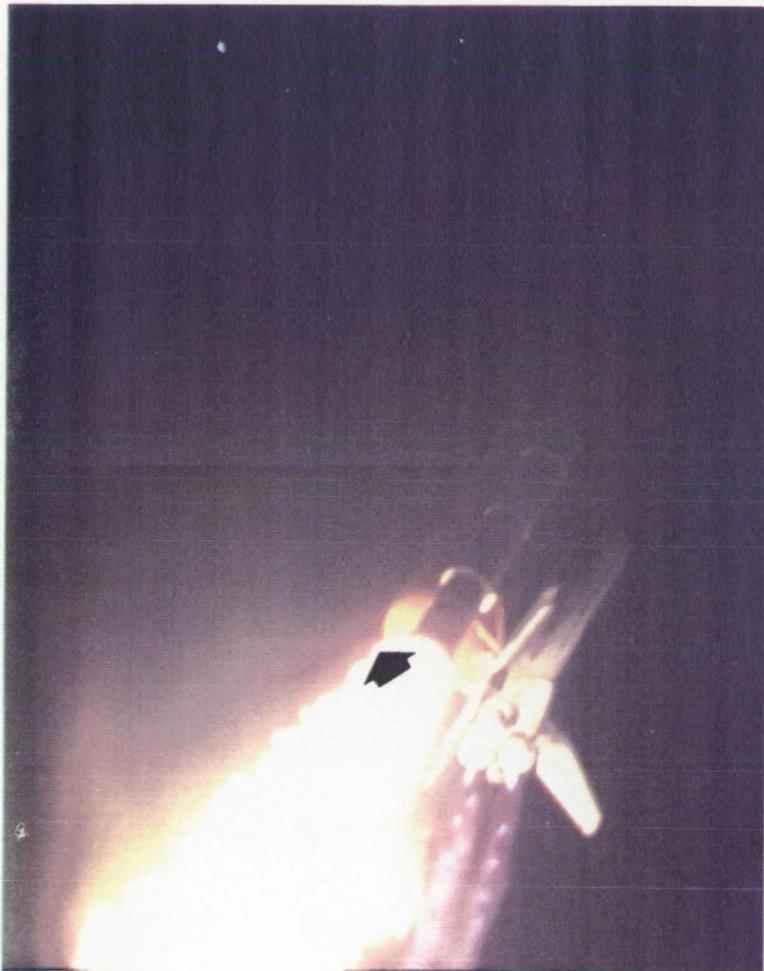
A bright-colored particle fell out of the LH SRB plume near the aft skirt at 33 seconds MET (E-222)

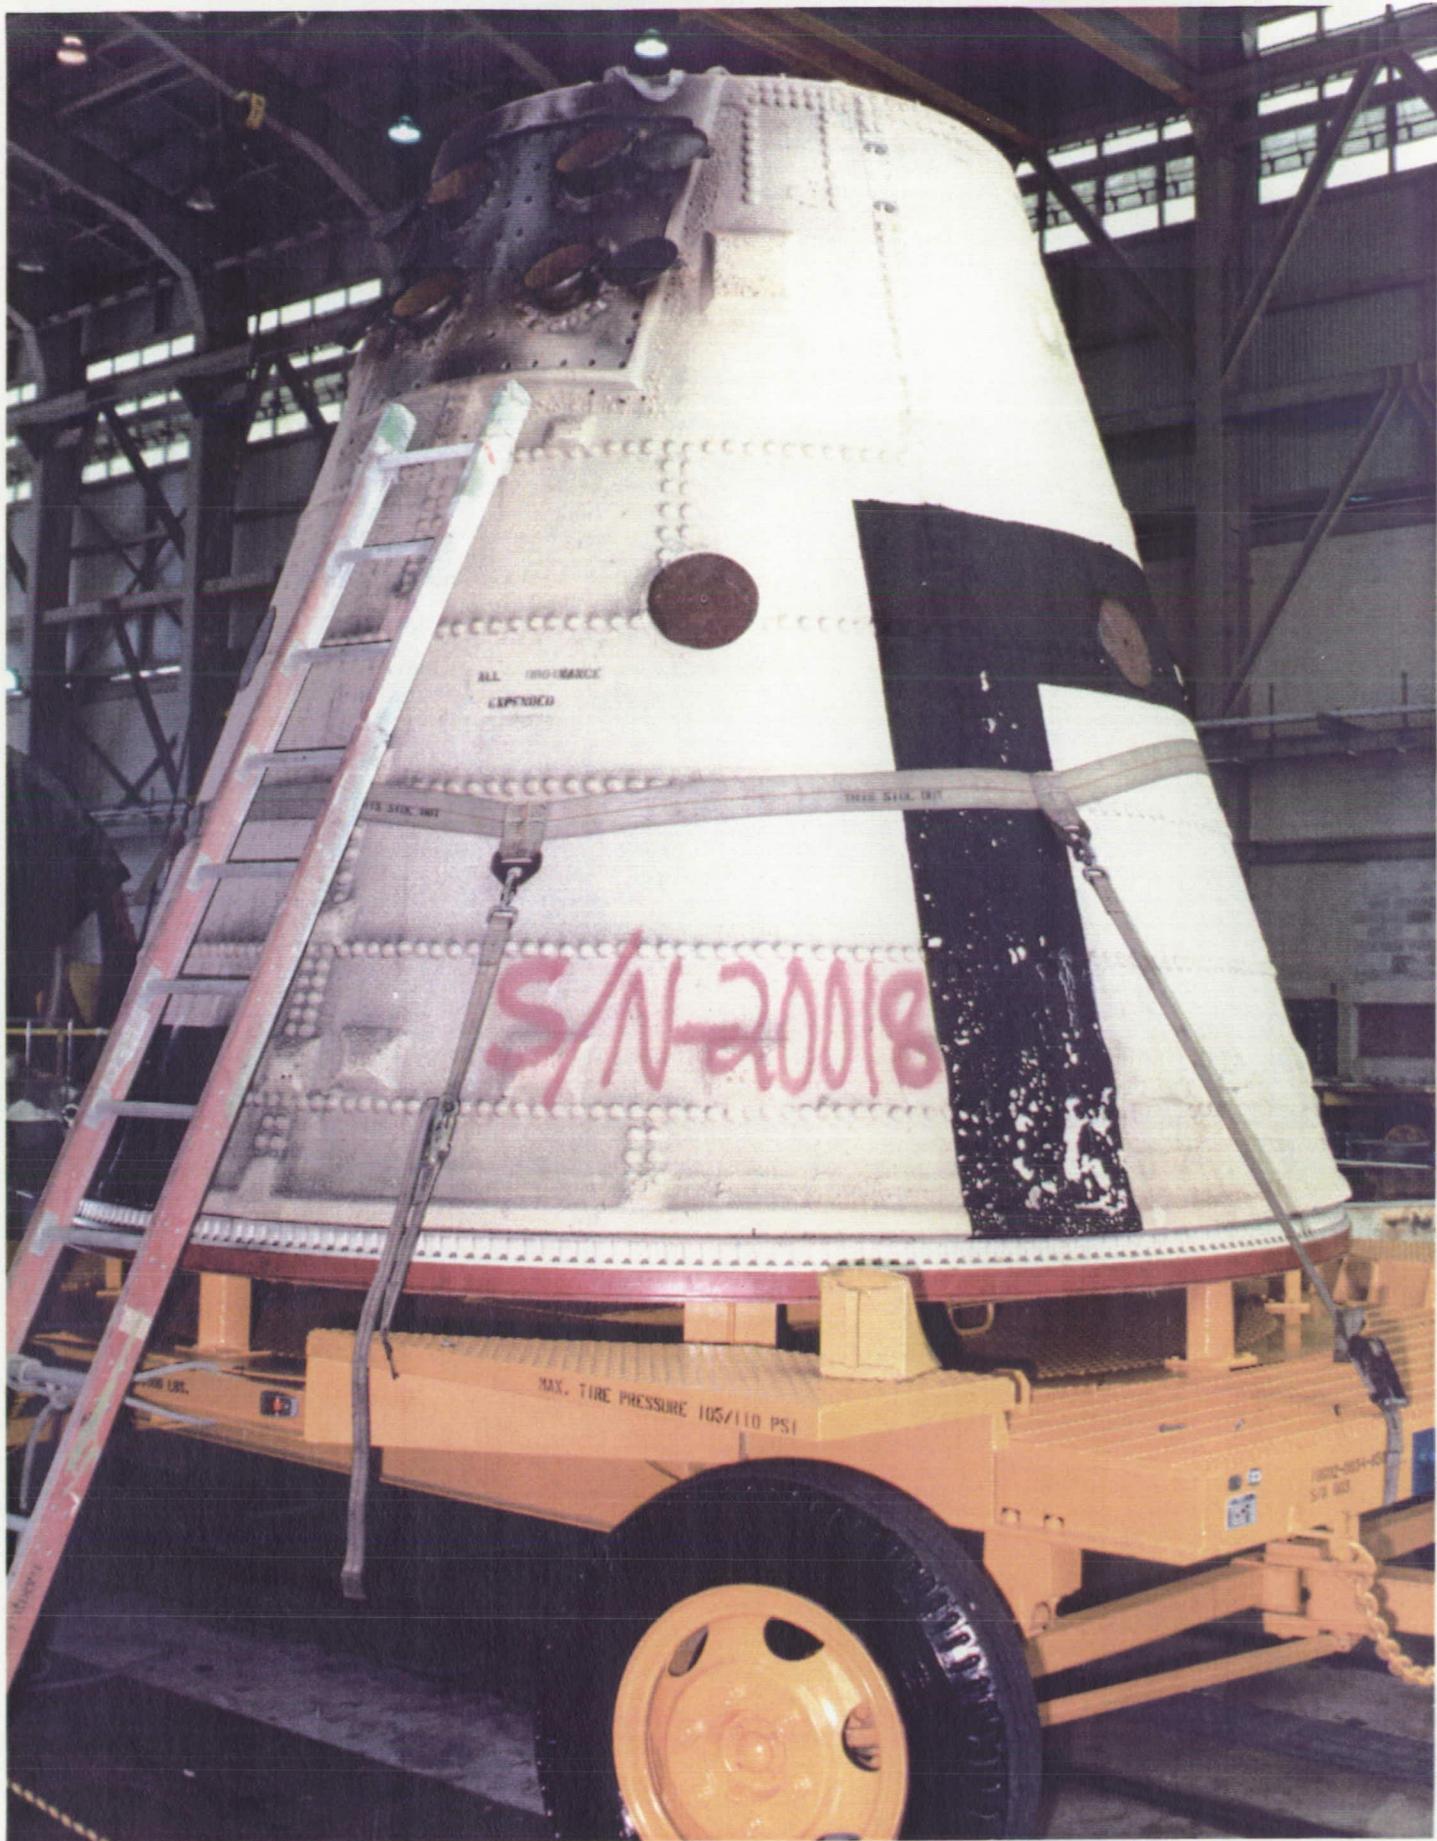
Overall view of LH frustum with localized areas of Hypalon paint blistering in the visibility stripes

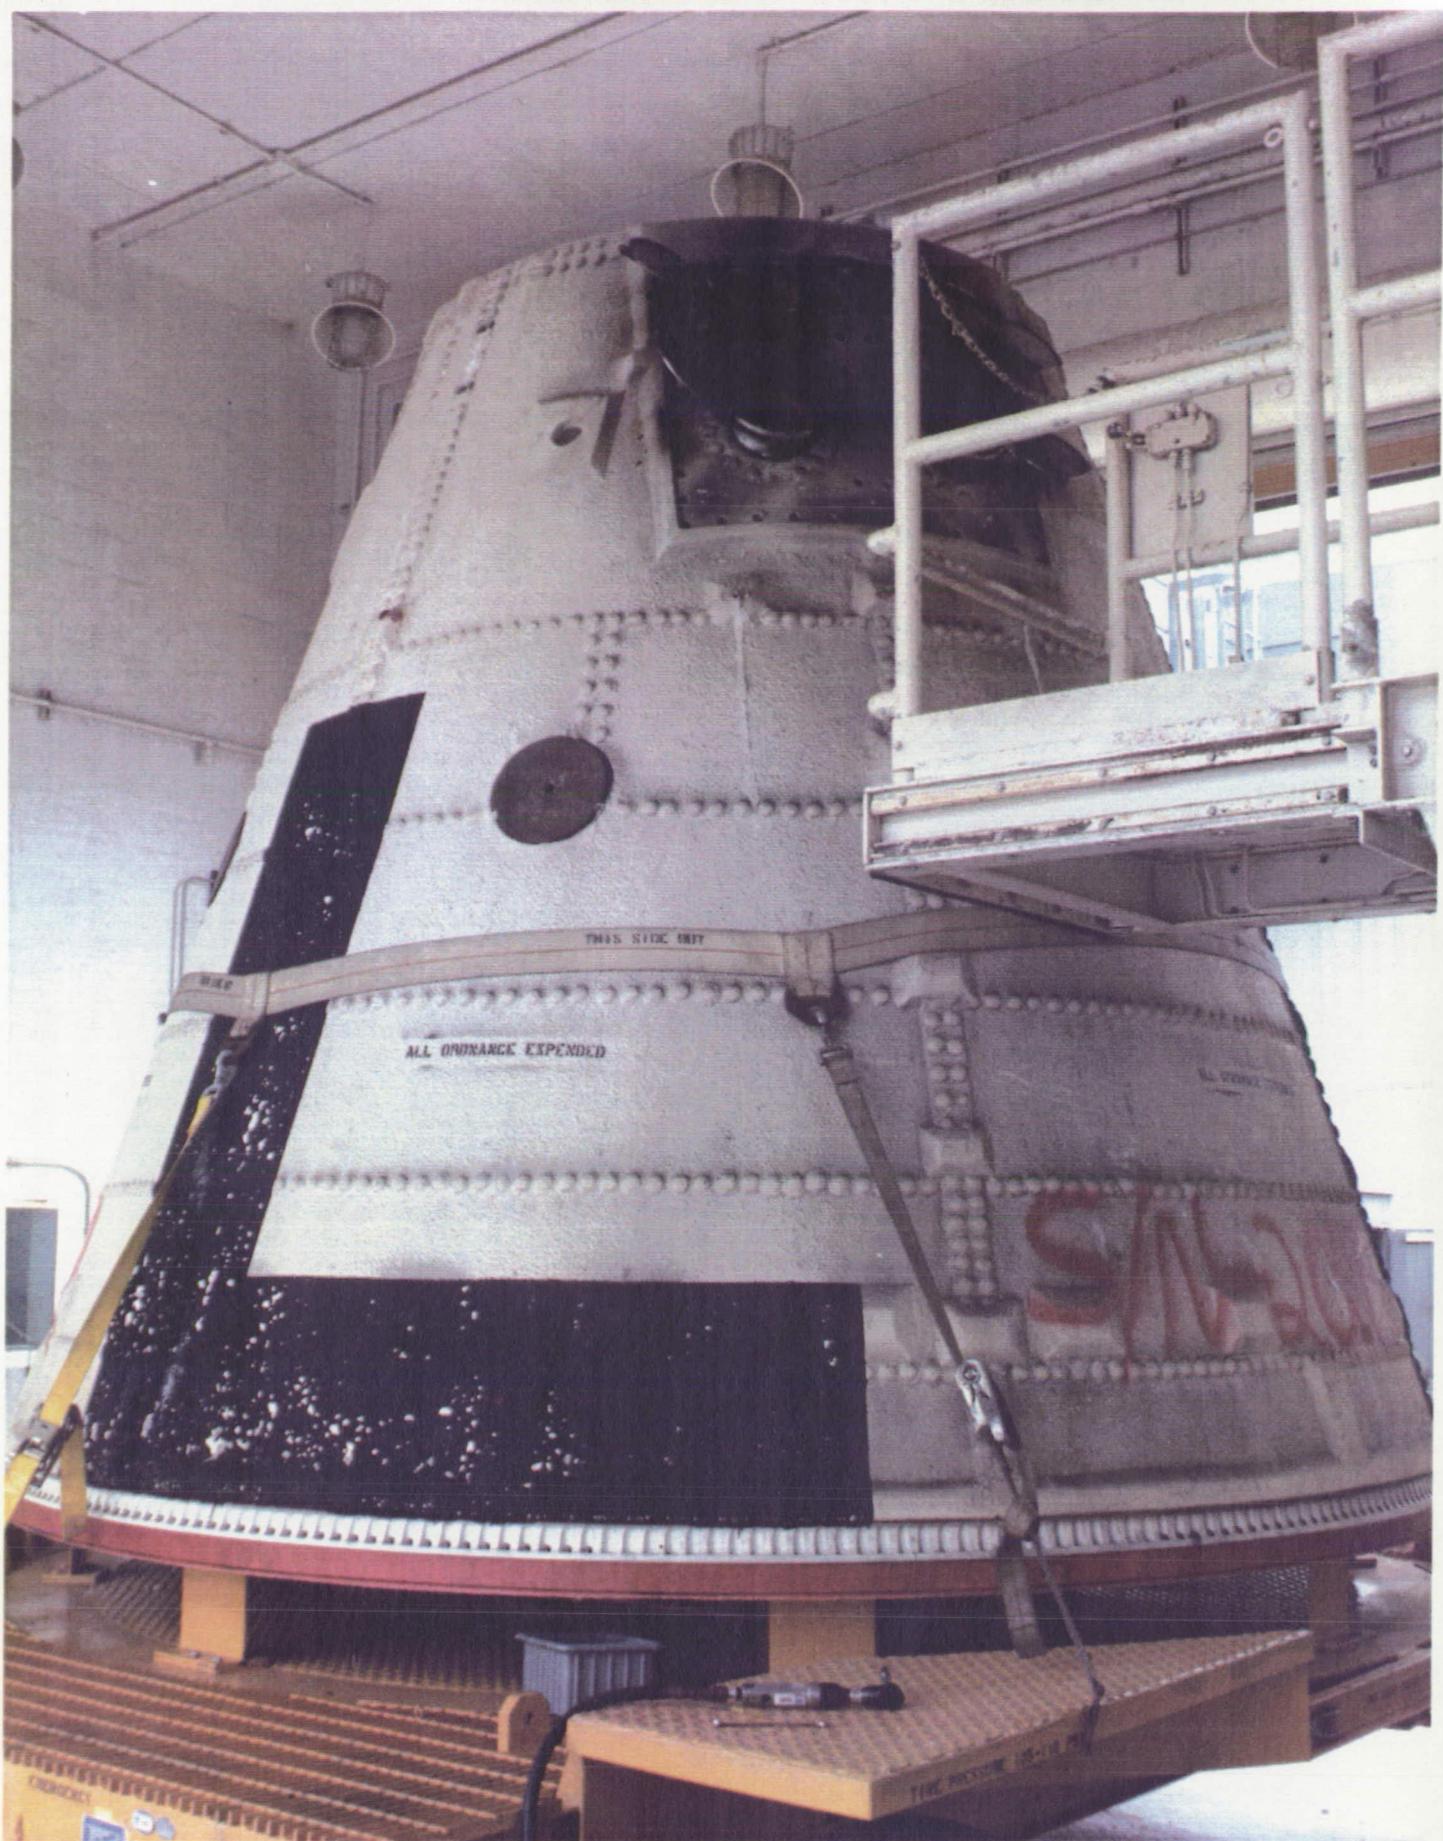
Overall view of RH frustum with localized areas of Hypalon paint blistering in the visibility stripes and 395 ring

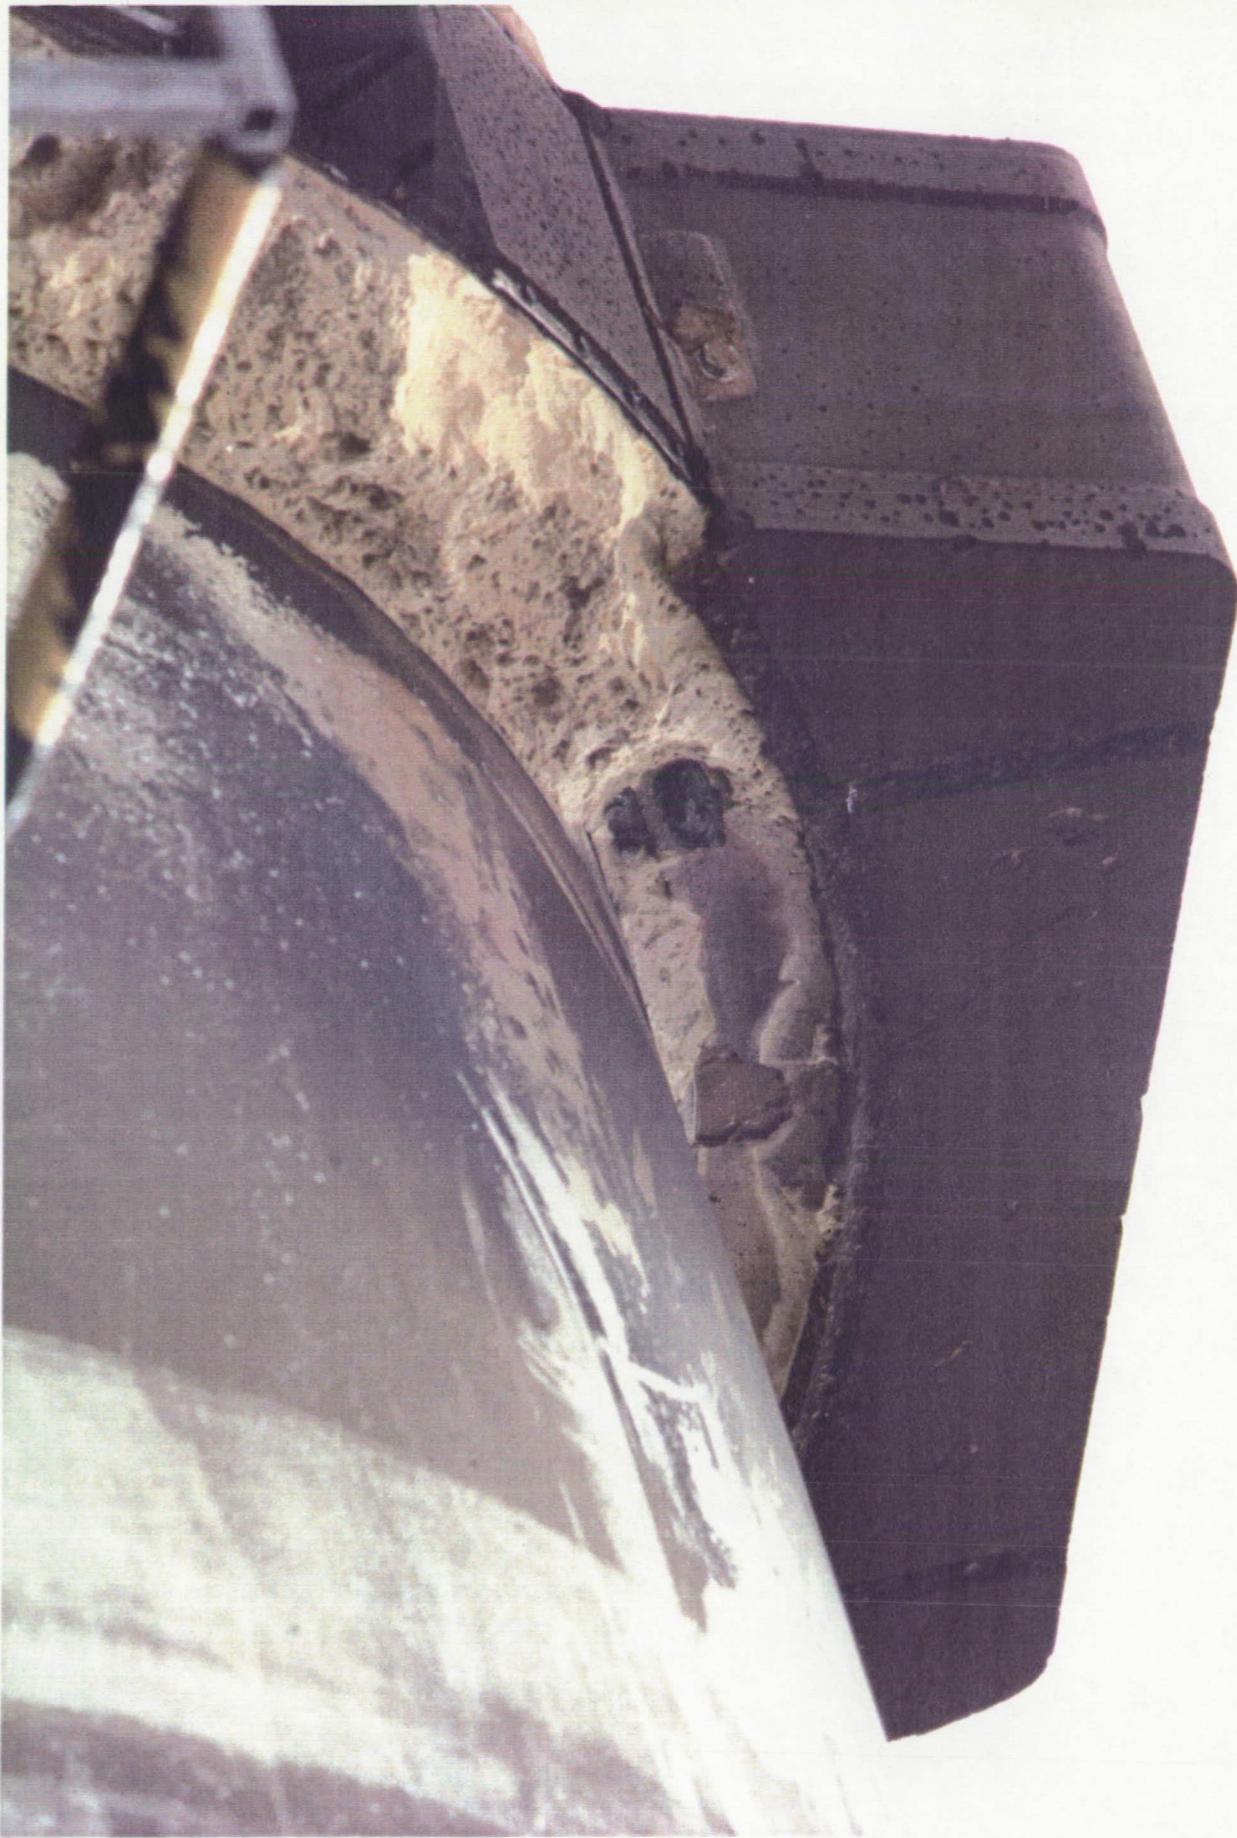
Instafoam aft of the LH IEA was lost prior to water impact

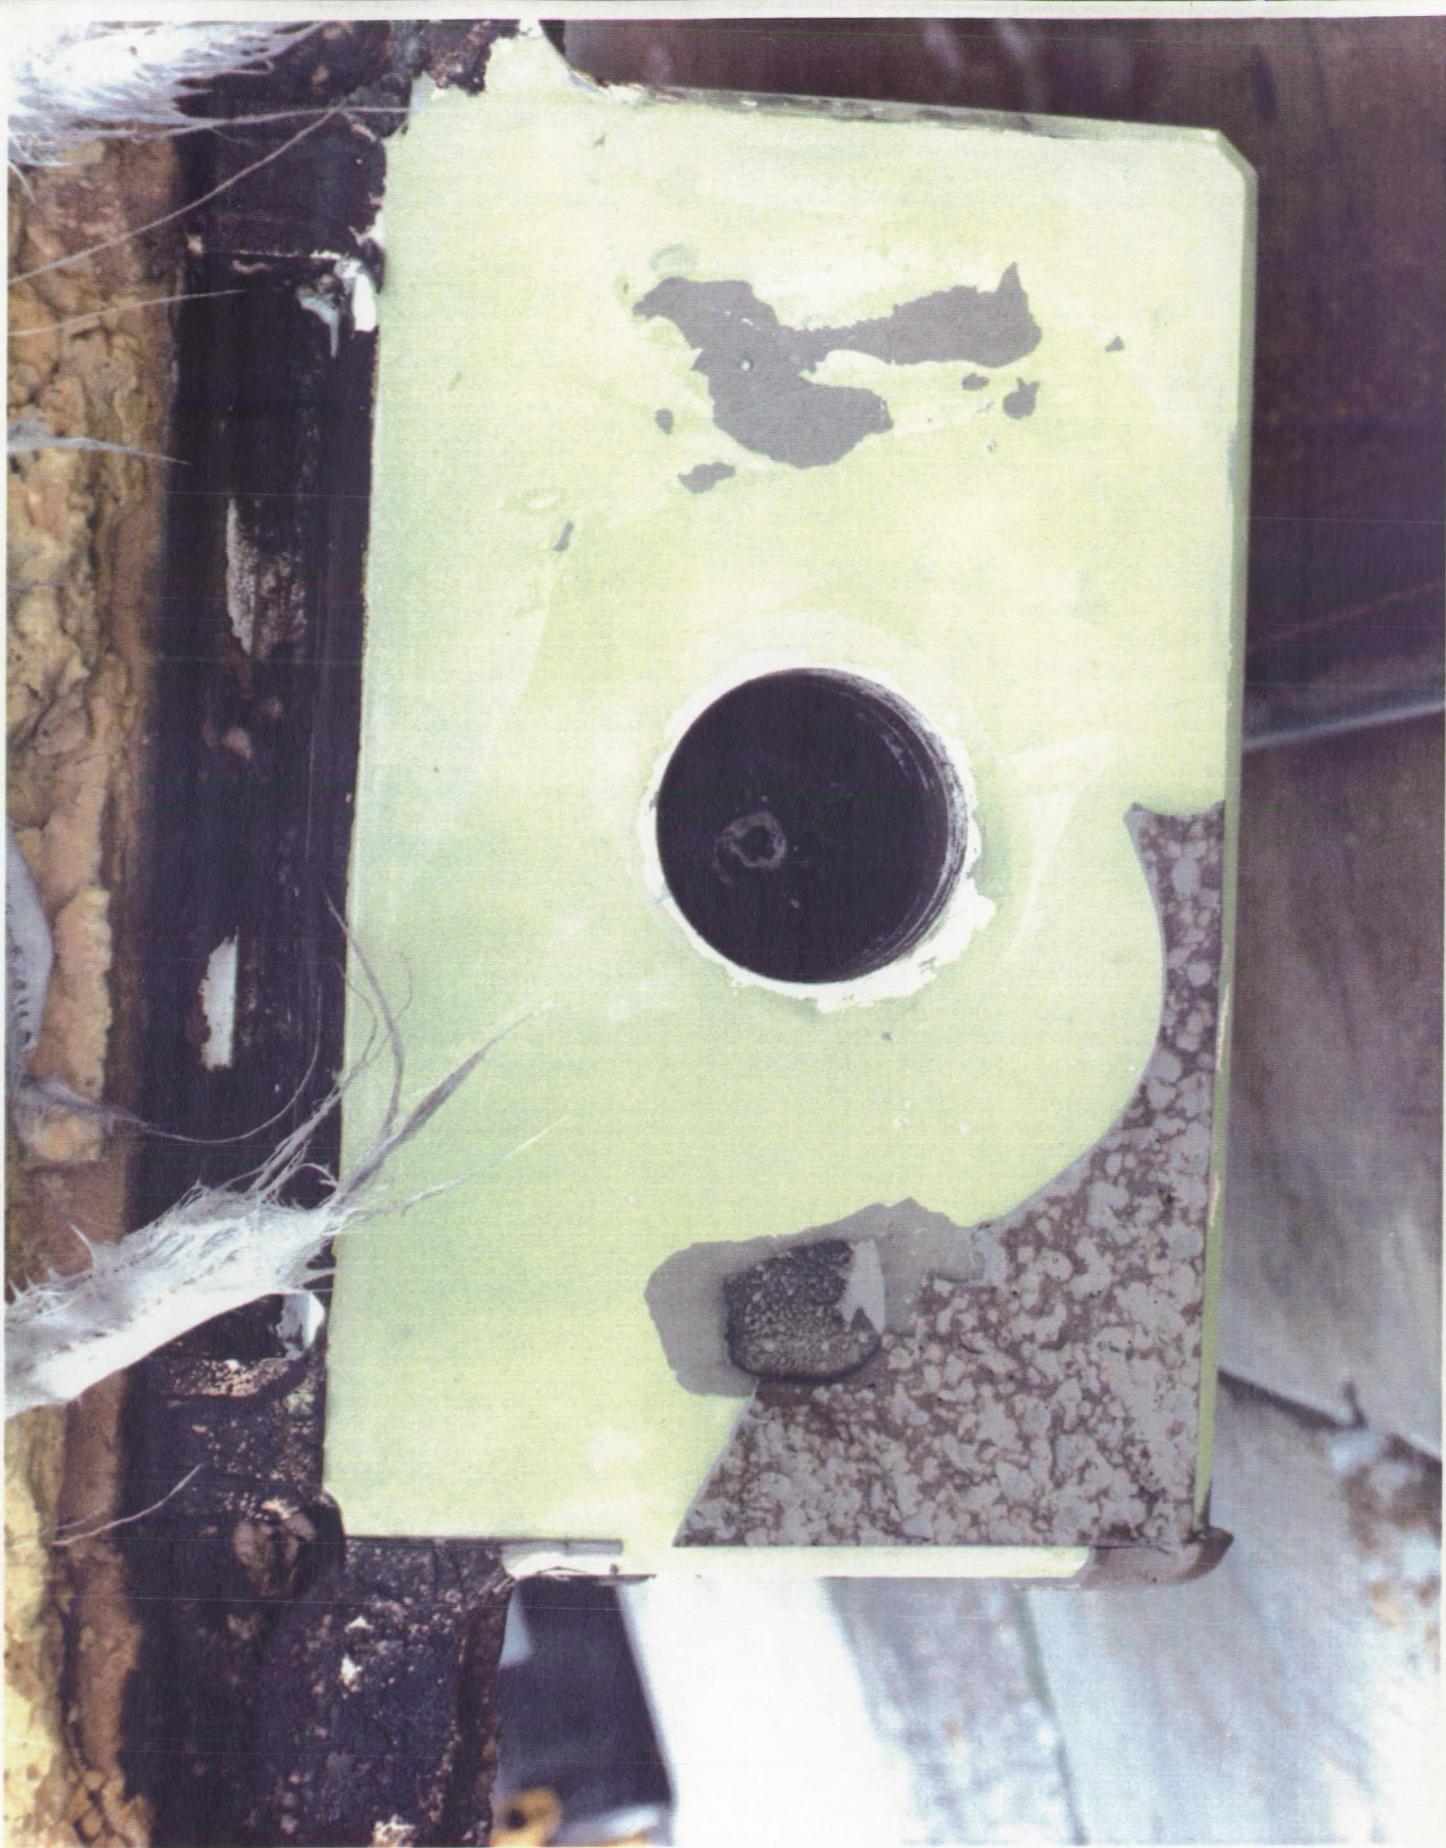
3"x2" piece of Epon shim material was lost prior to
water impact

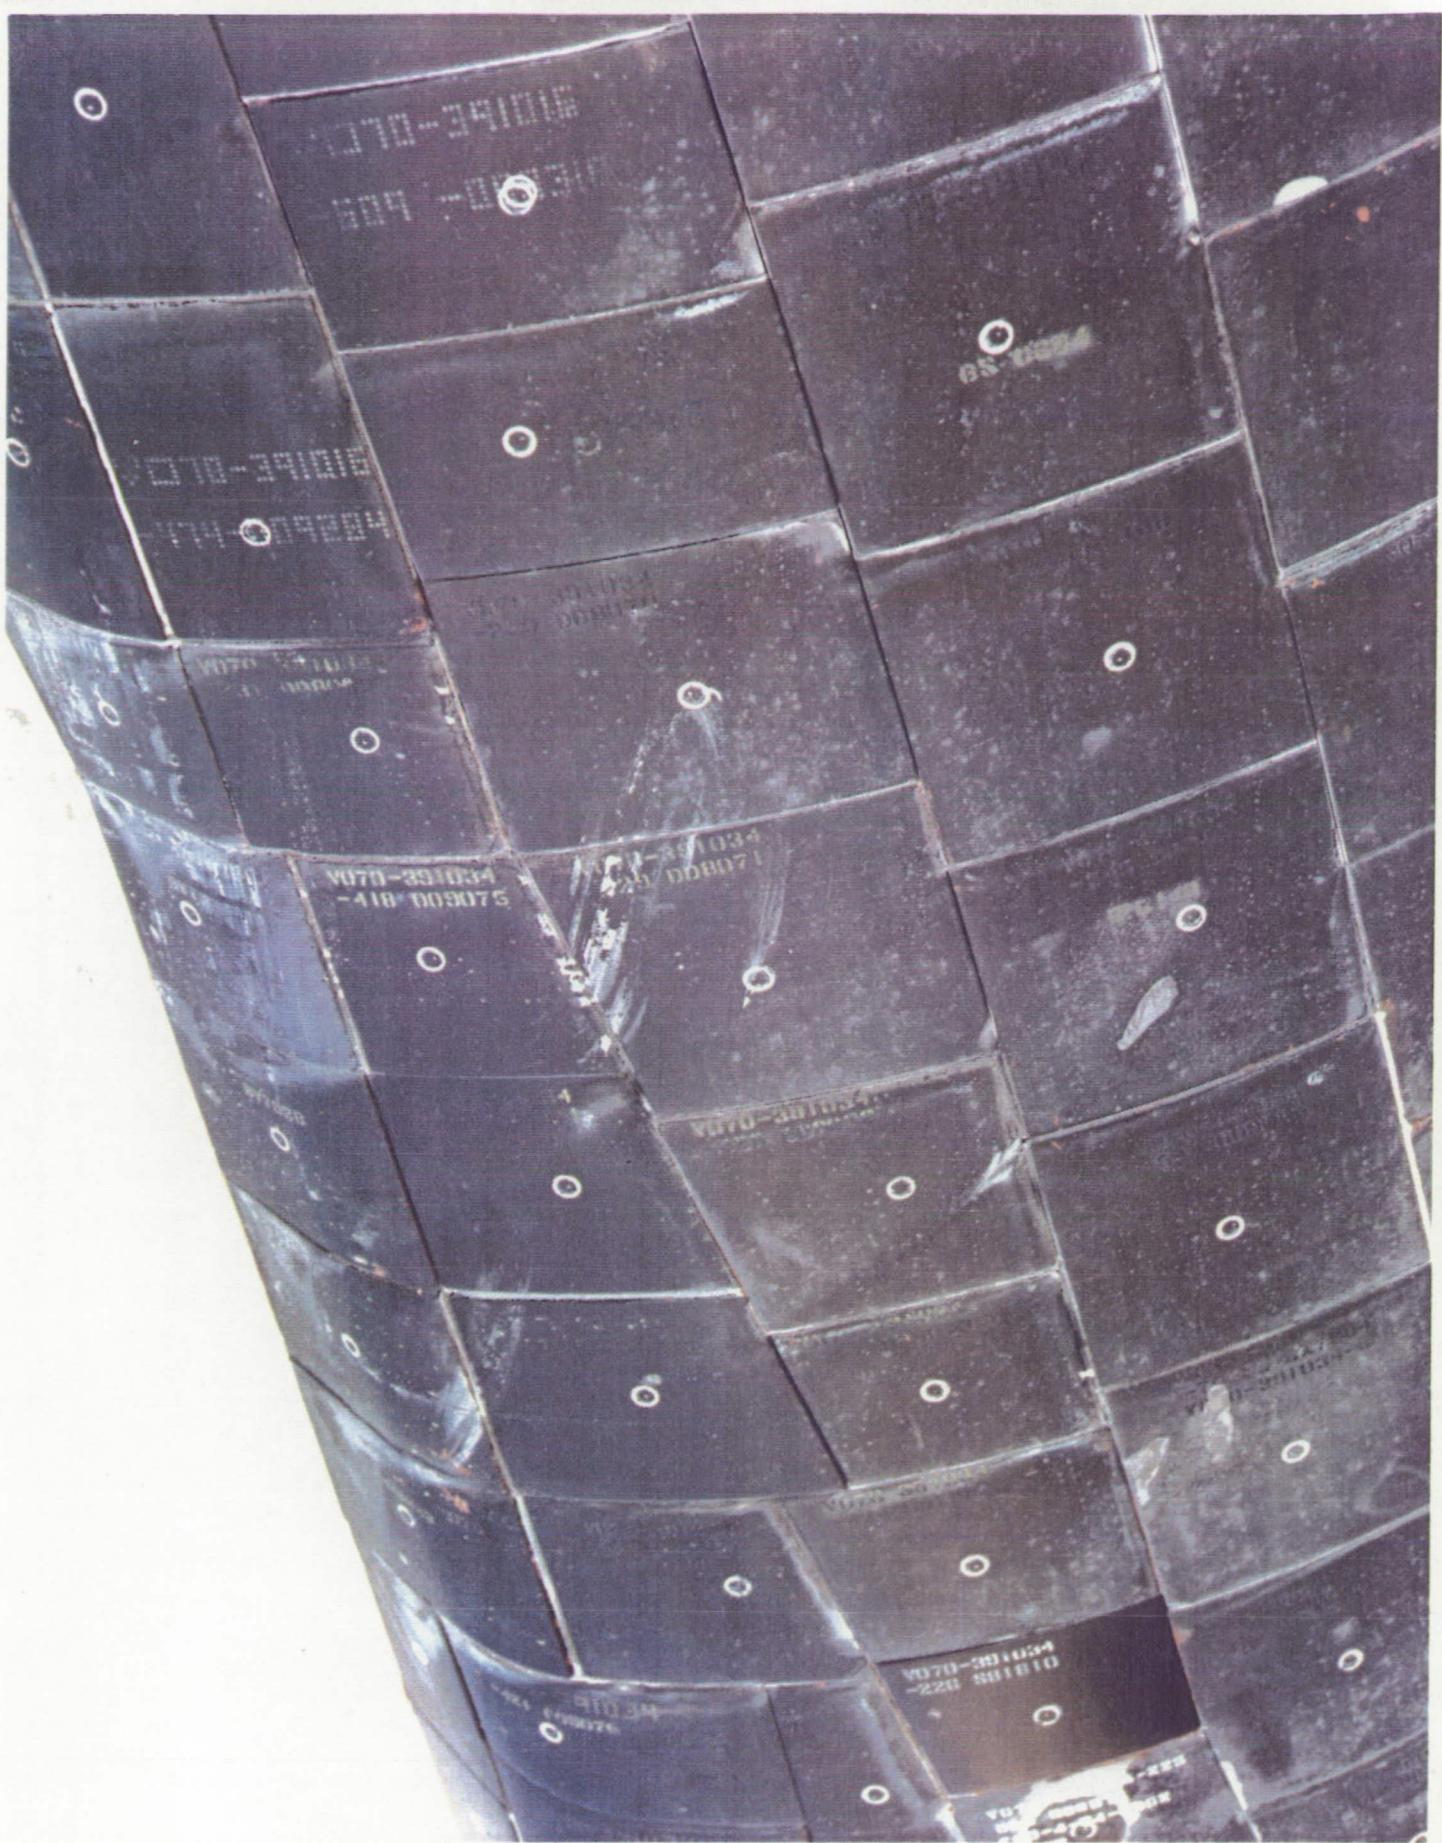
White residue was present on LH chine lower surface tiles
