Debris/Ice/TPS Assessment And Photographic Analysis For Shuttle Mission STS-36

April 1990

DEBRIS/ICE/TPS ASSESSMENT
AND
PHOTOGRAPHIC ANALYSIS
OF
SHUTTLE MISSION STS-36

February 28, 1990

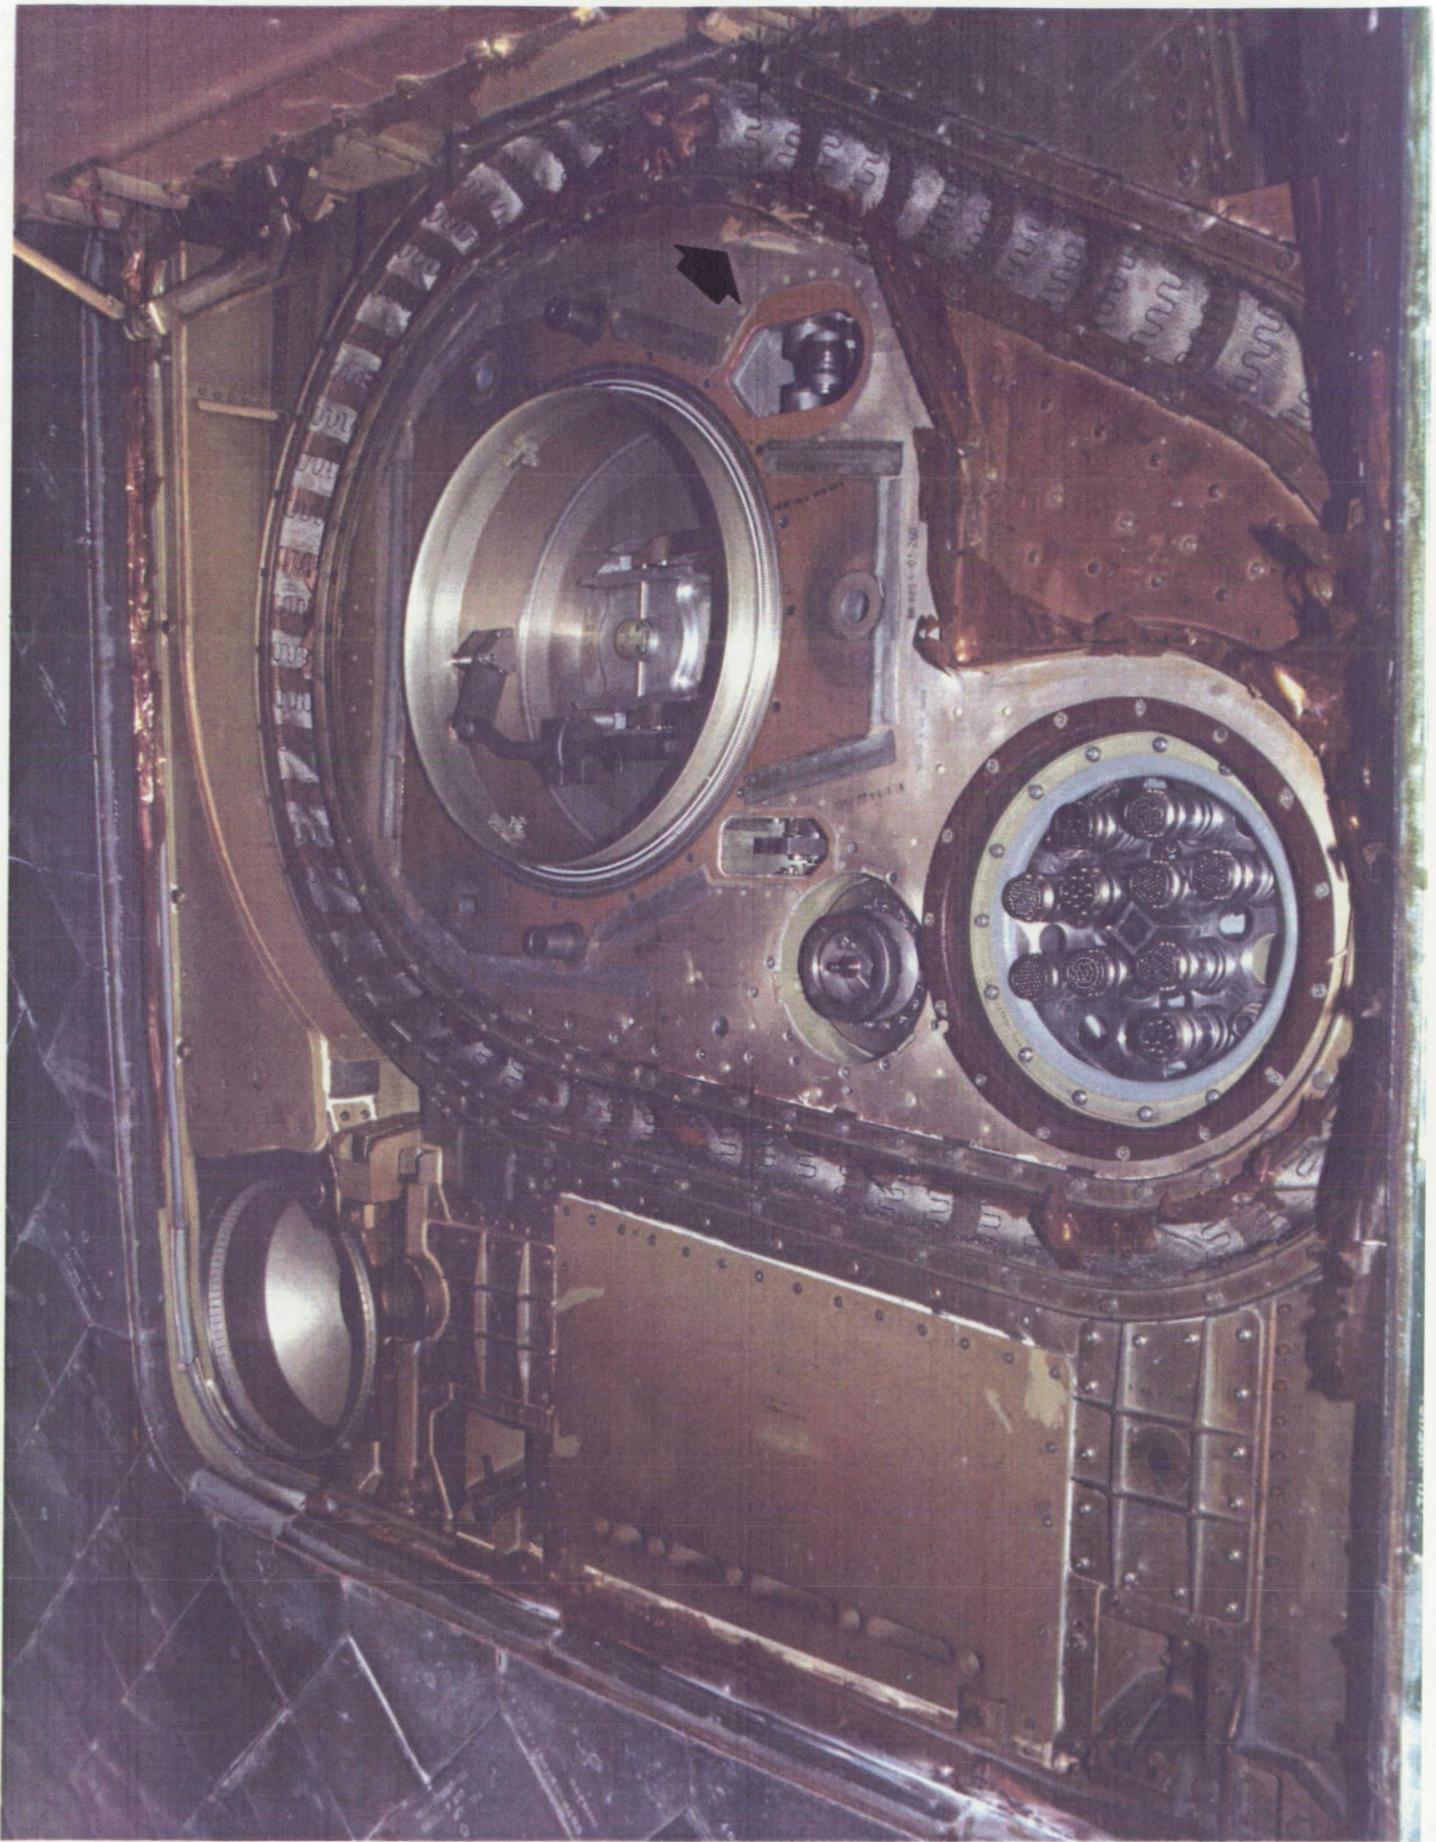
Overall view of the LO2 ET/ORB umbilical cavity. Note remnants of closeout foam intrusion along the umbilical interface
